## **Erosion of Anchor Estates**

This presentation is to demonstrate how, I believe, North Cowichan's Stormwater Management is causing stream bank erosion of Anchor Estates Greenspace and a number of strata properties bordering that Greenspace The following is an email I received in response to my concerns about erosion of Properties and Anchor Estates Greenspace. In the following presentation I hope to challenge the statements in paras one and two. As for para three, the disclosure statement filed by the developer advises that North Cowichan had stated that there is no flooding issues with the Anchor Estates development.

# Erosion

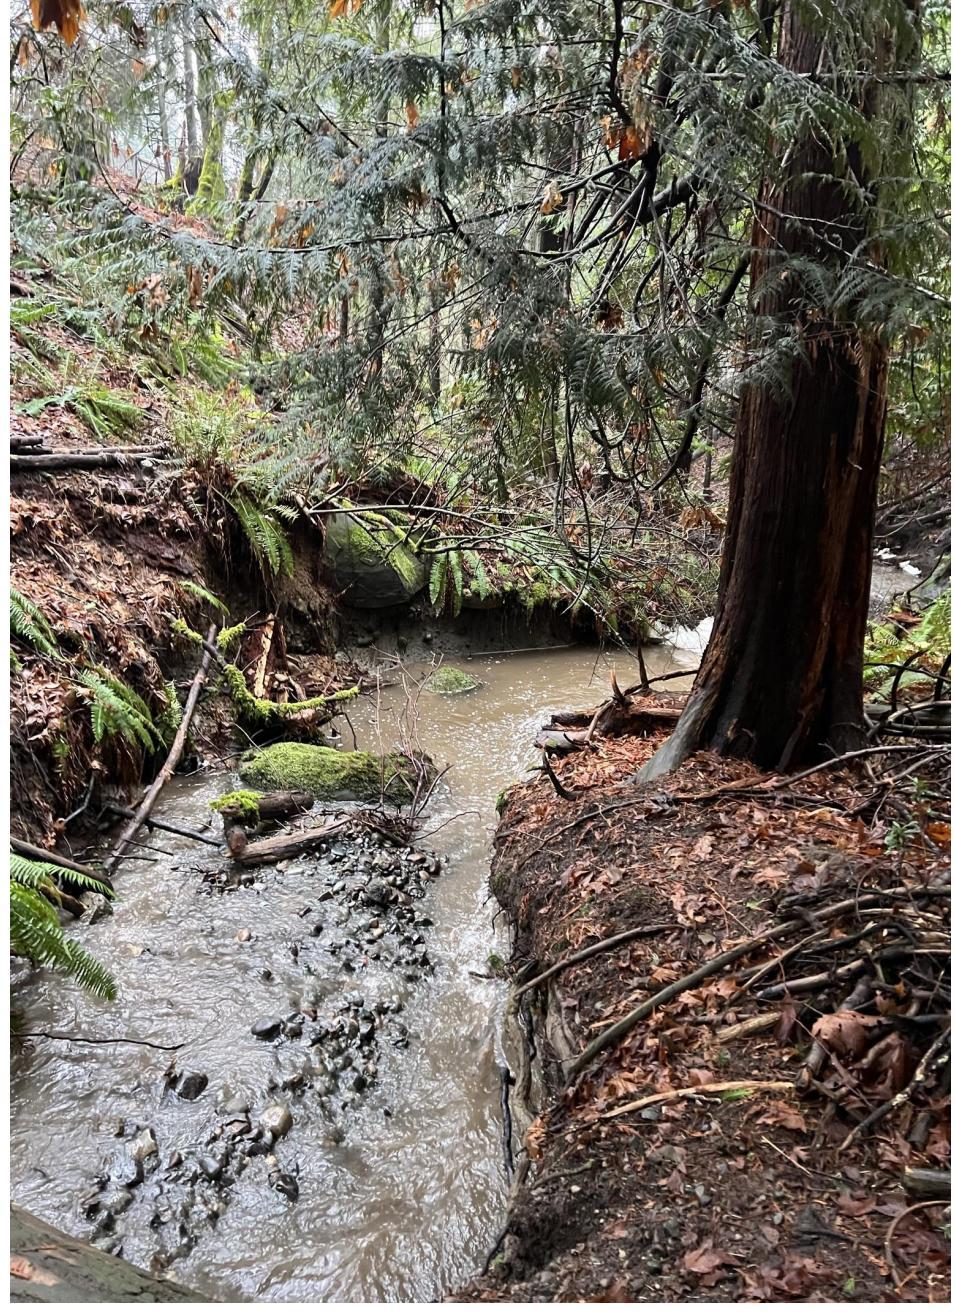
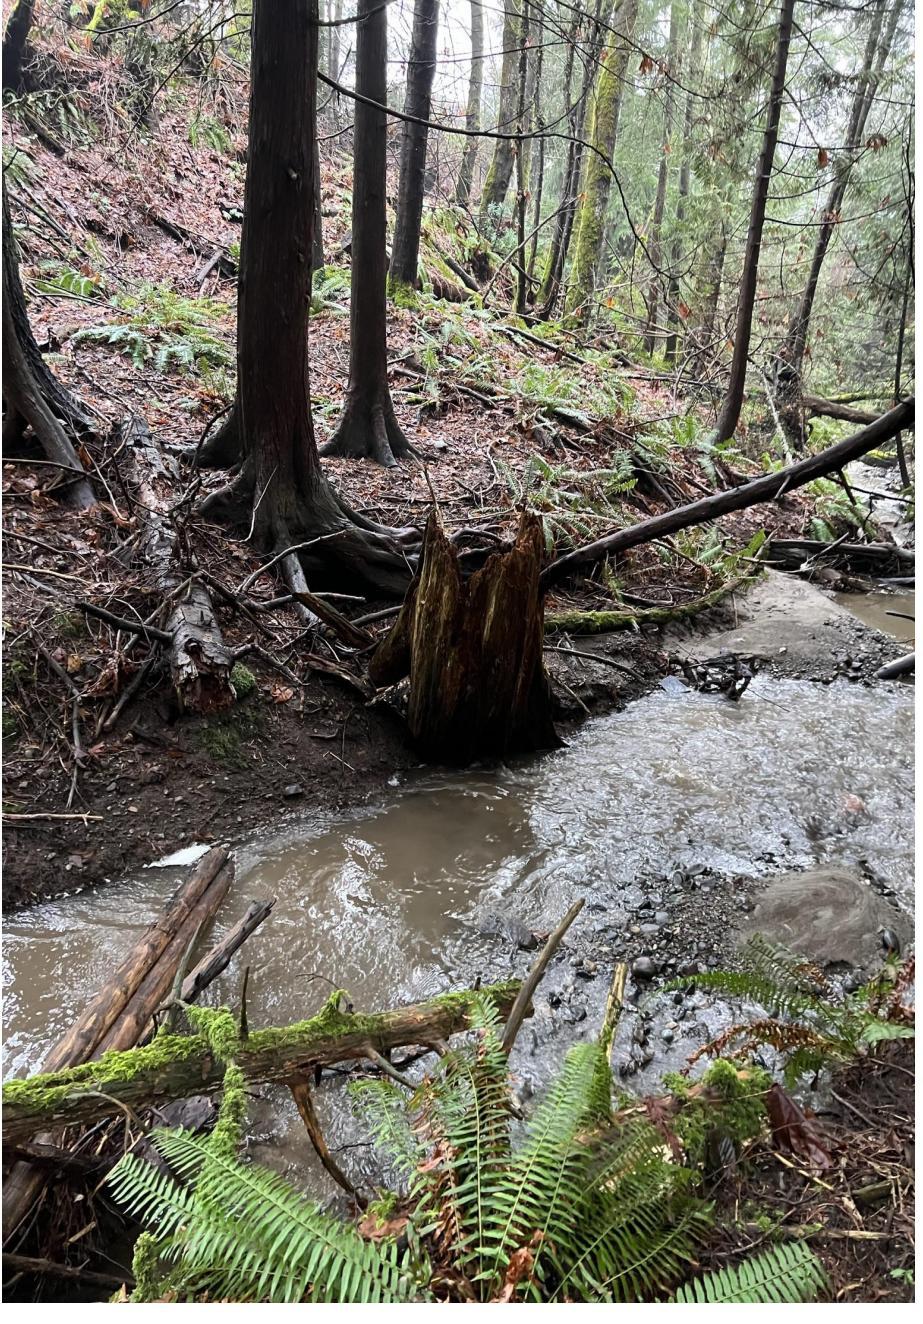
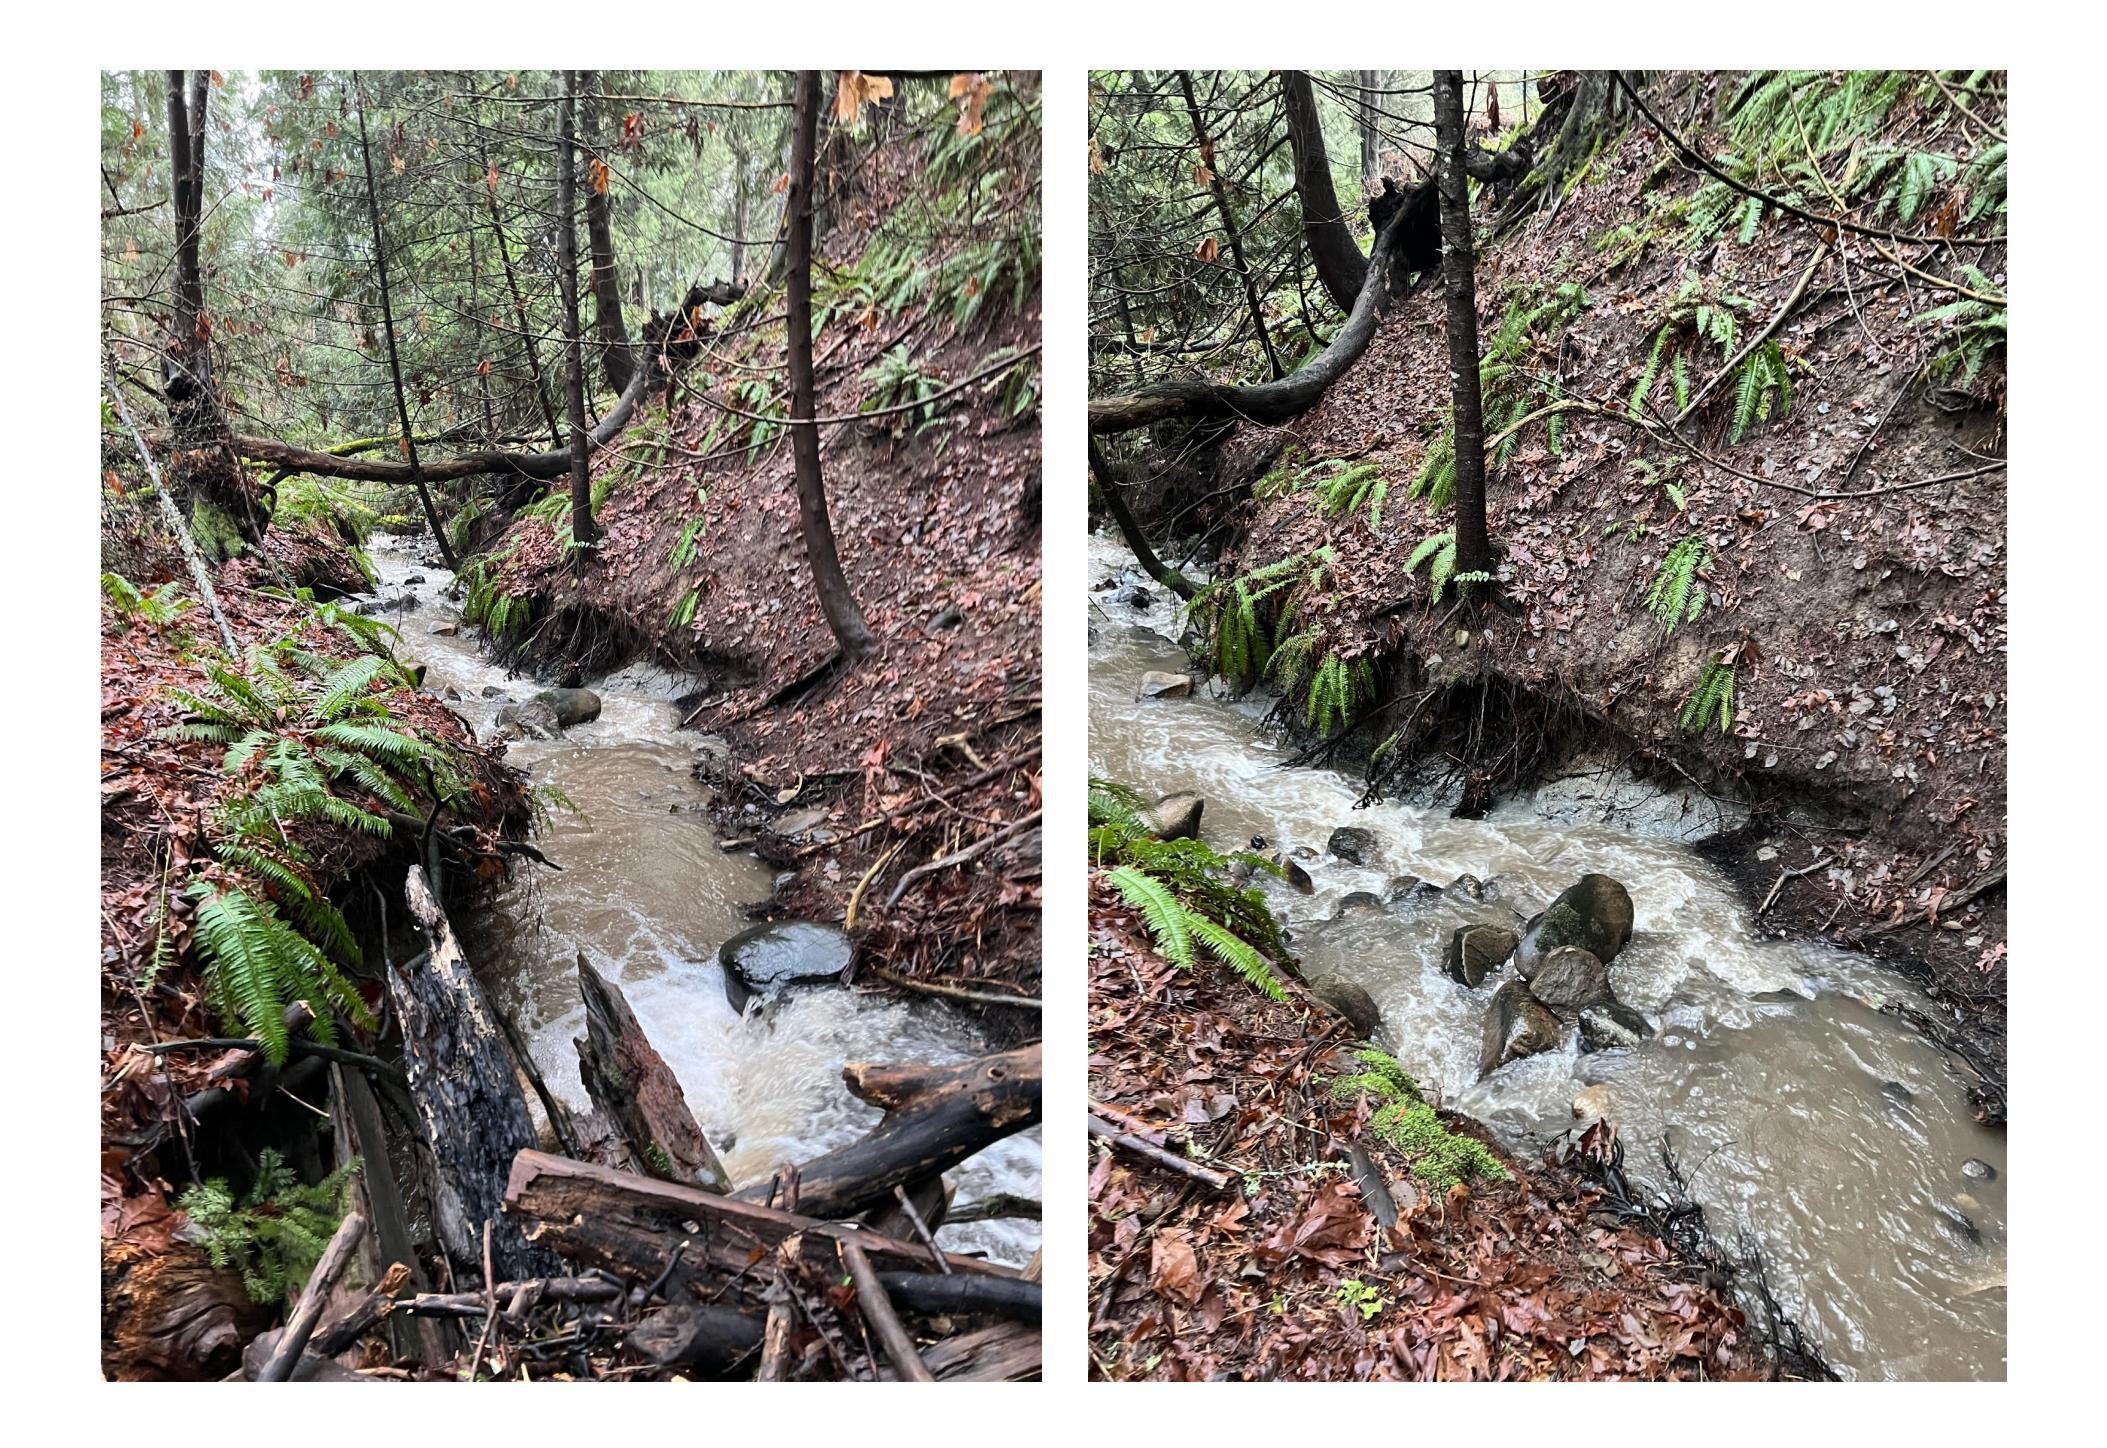
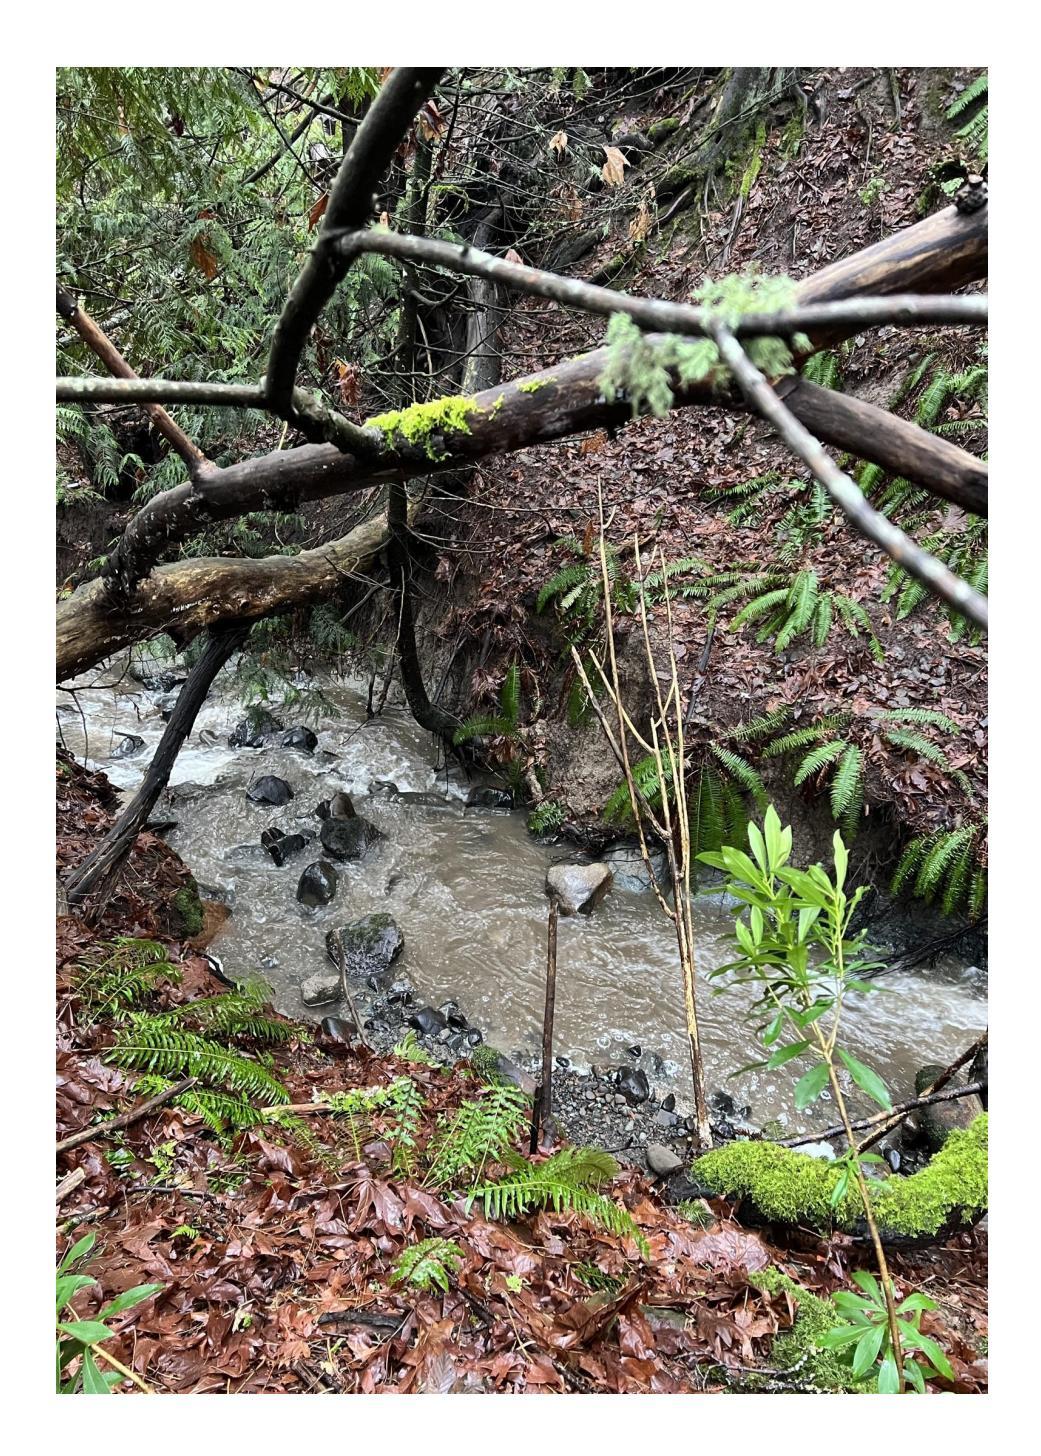
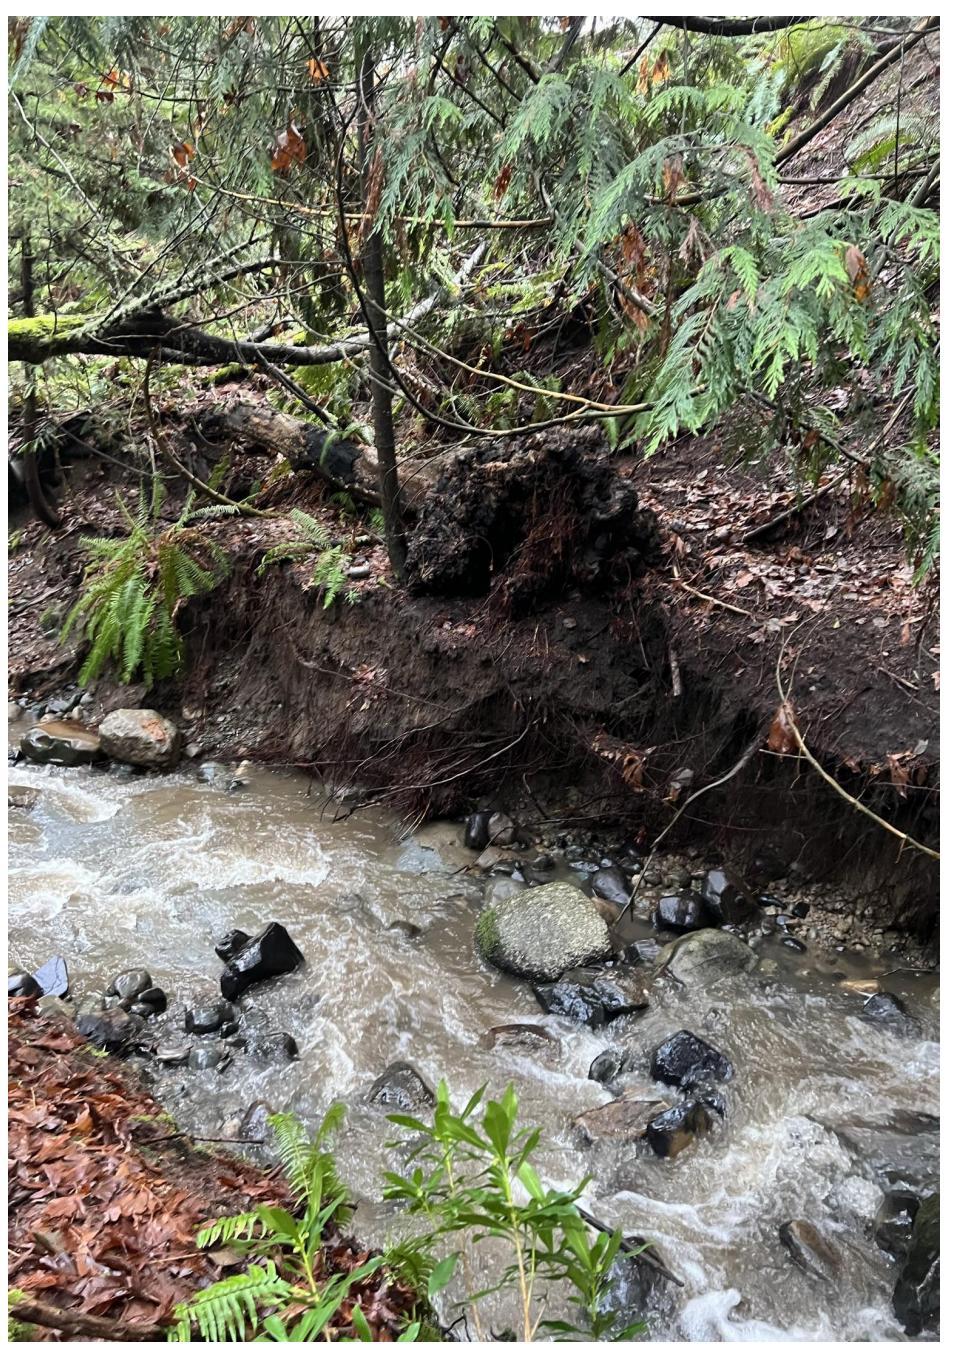
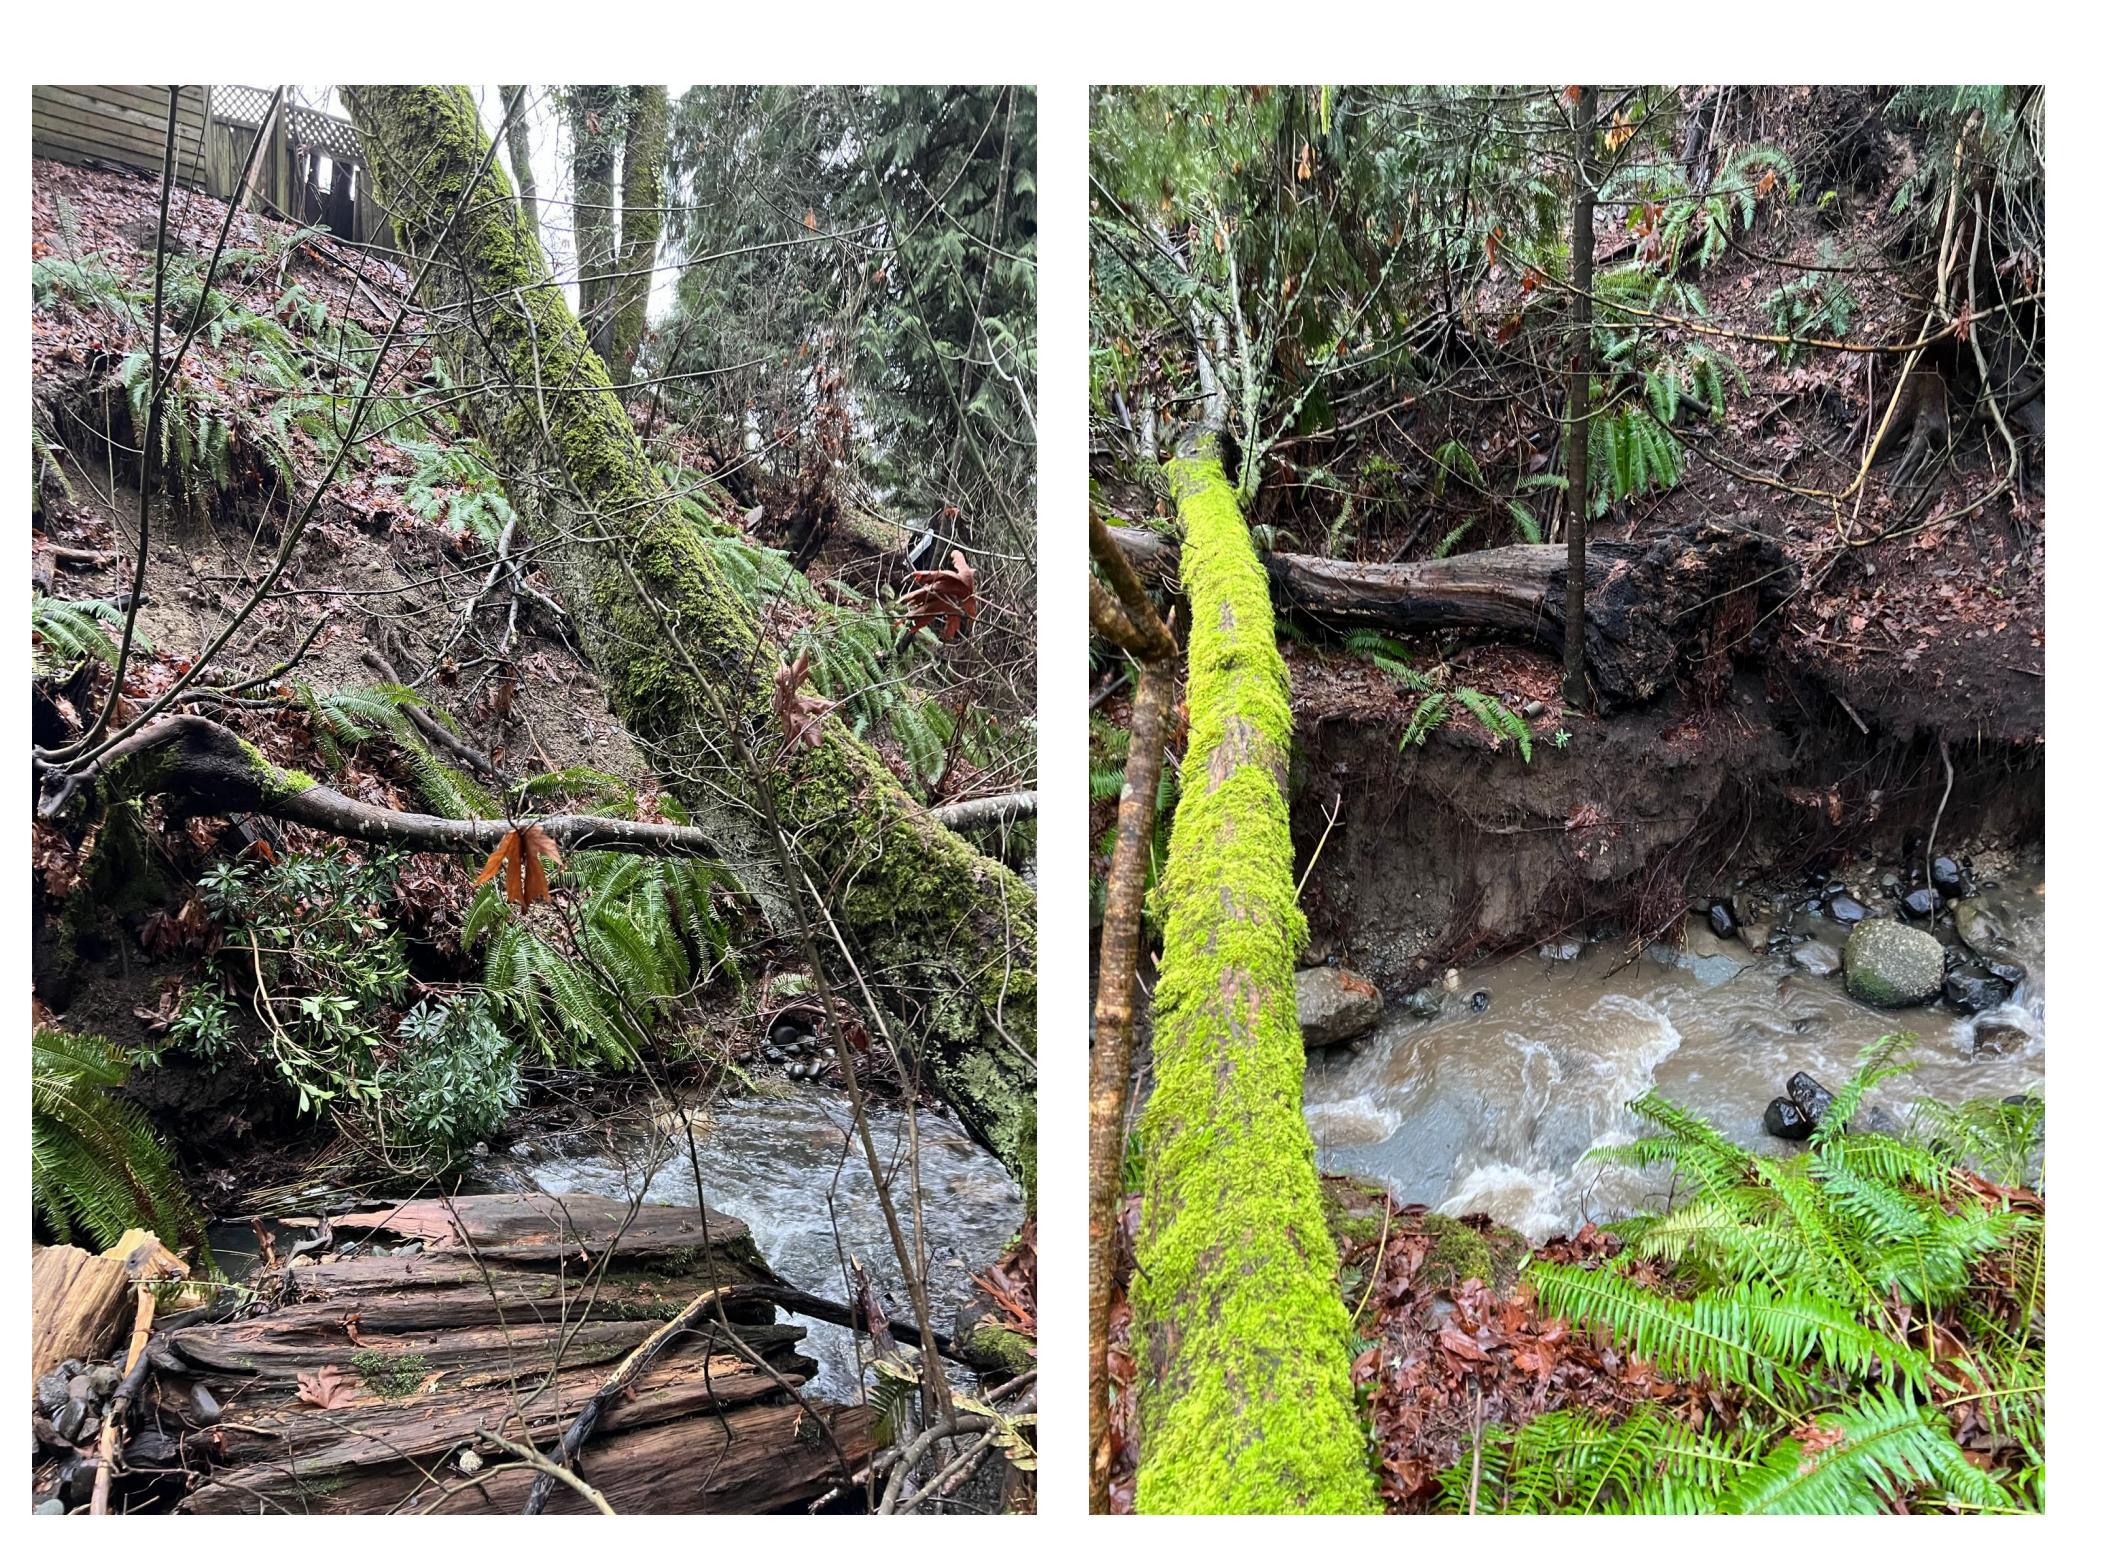
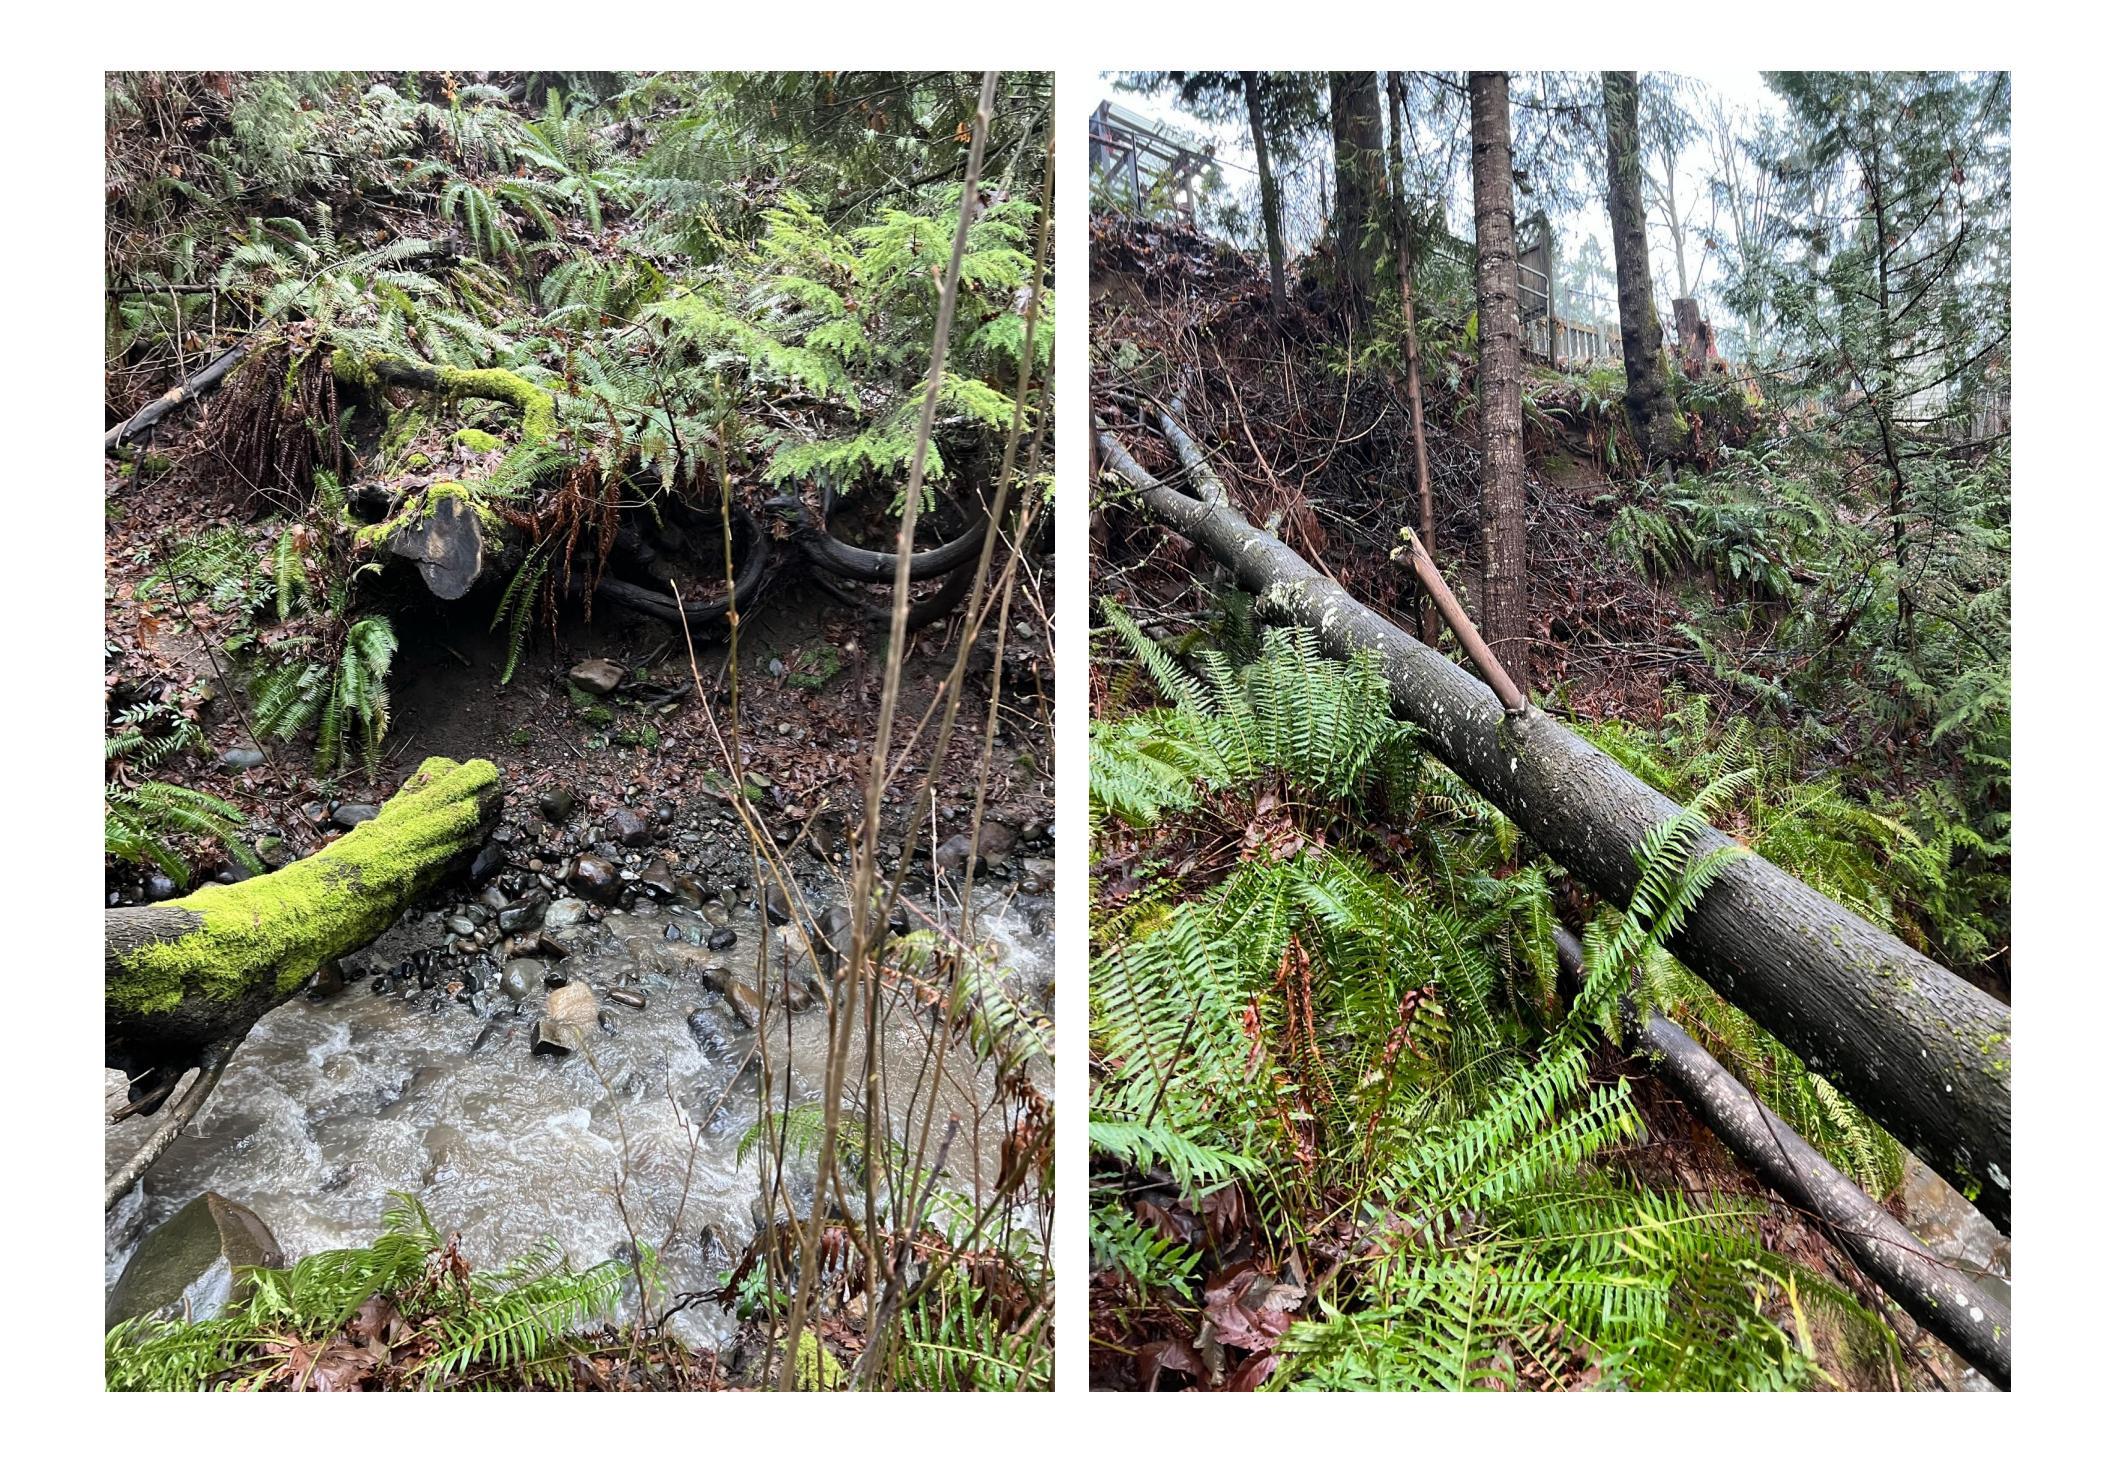
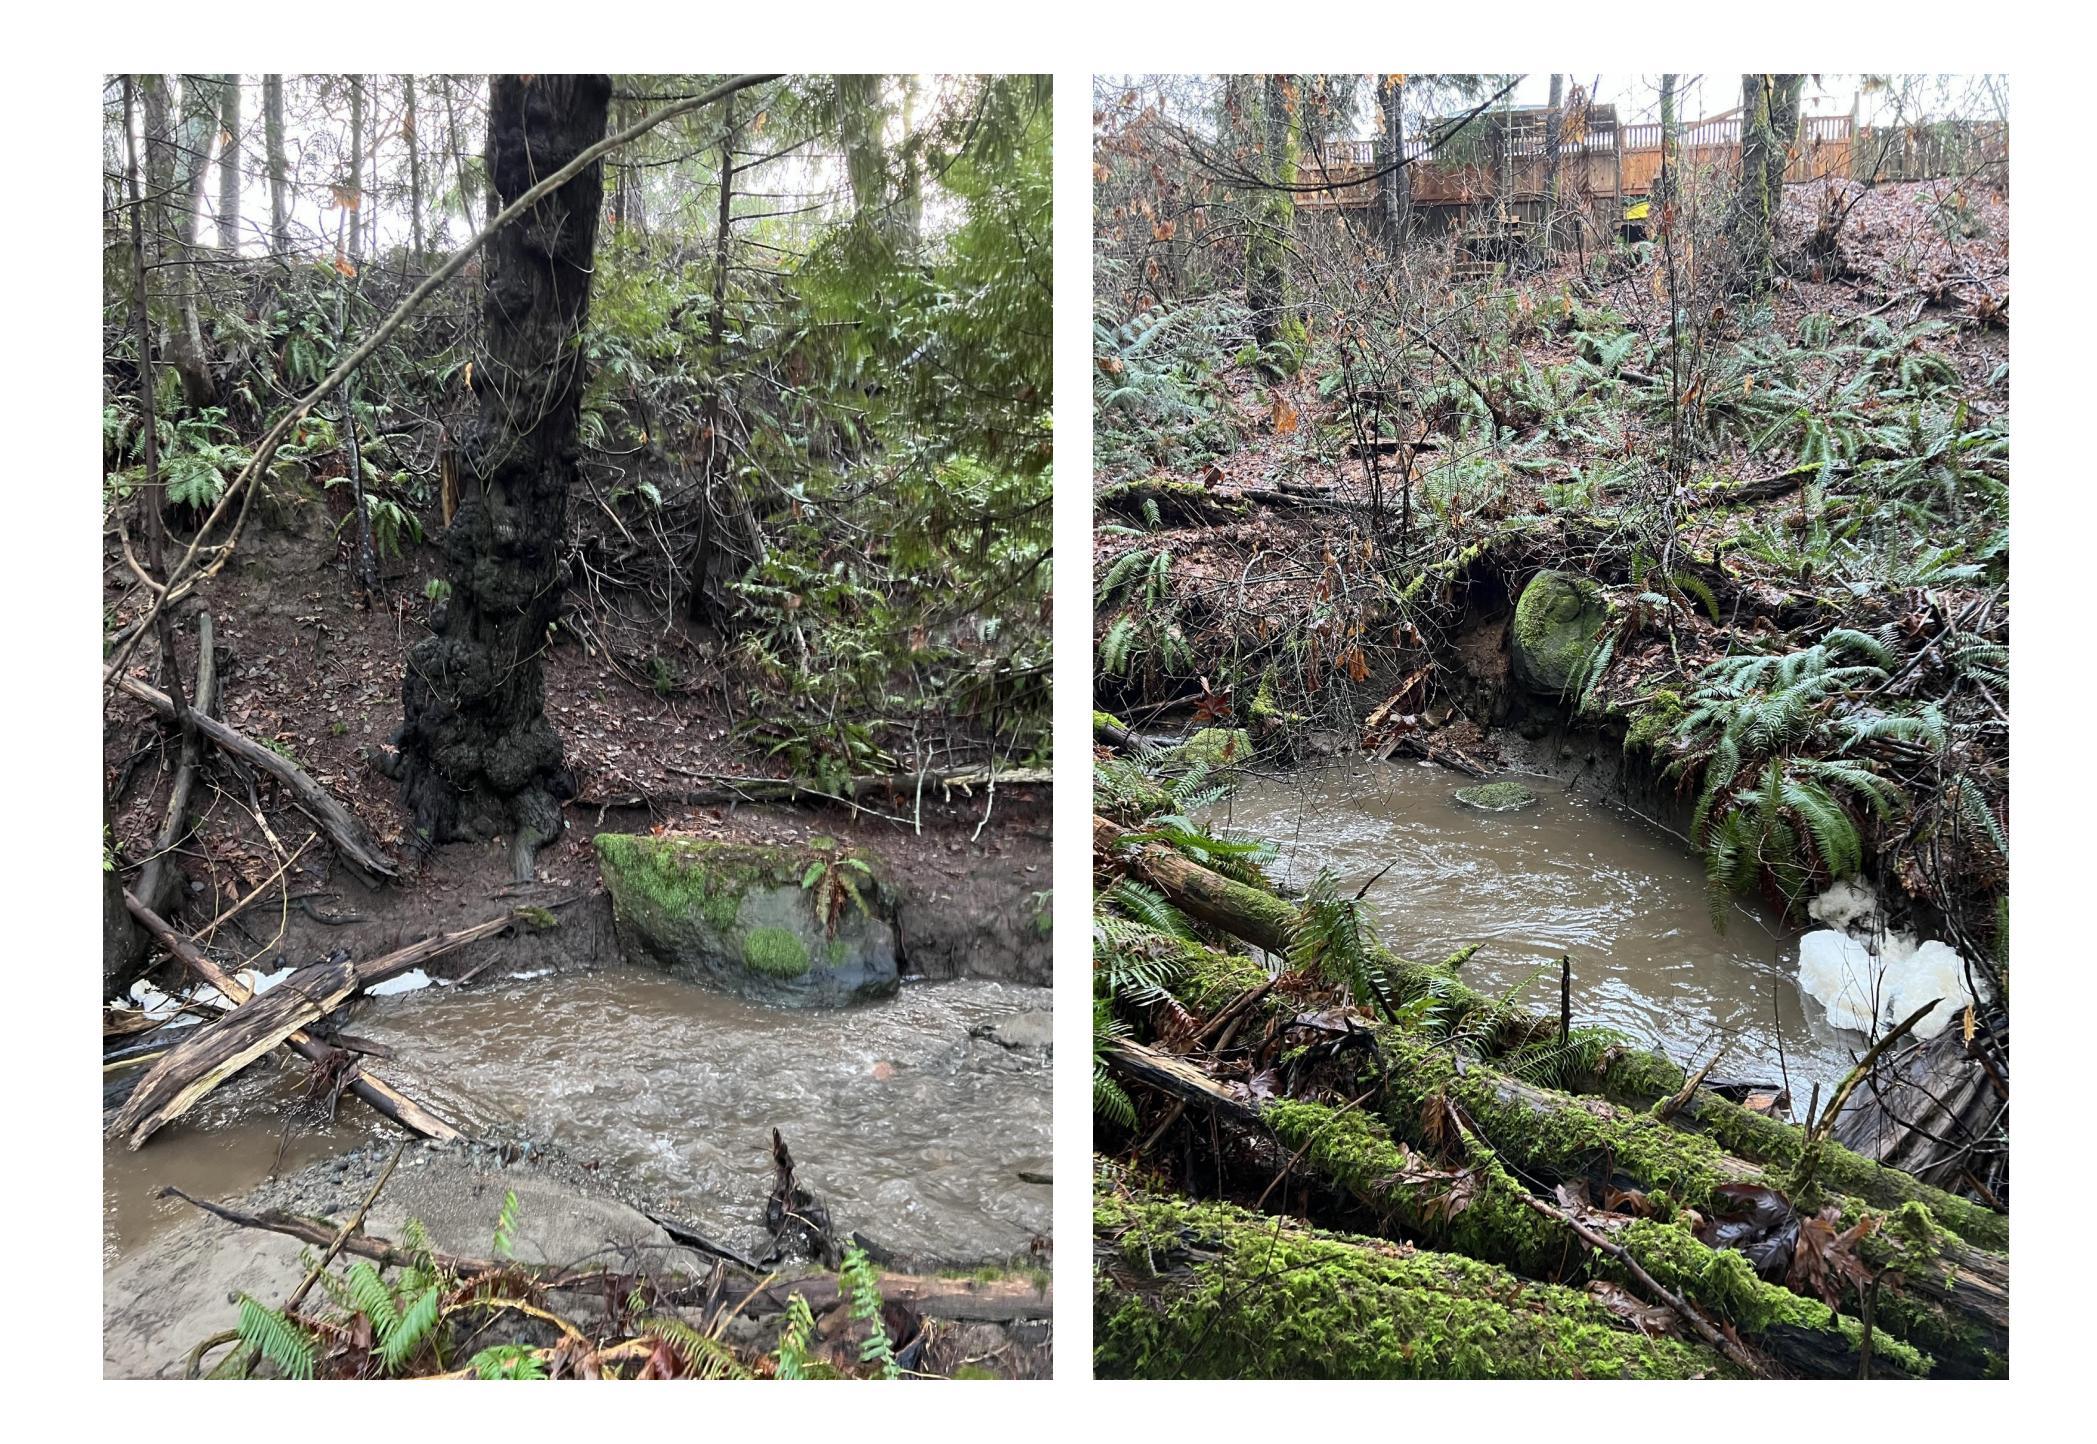
You can see bank erosion and bank slumpage. Over the past few years a number of trees in the Greenspace close to the creek have been undermined. Several have fallen, at least 4 have struck strata lots. You will see more of the same in the following pics.

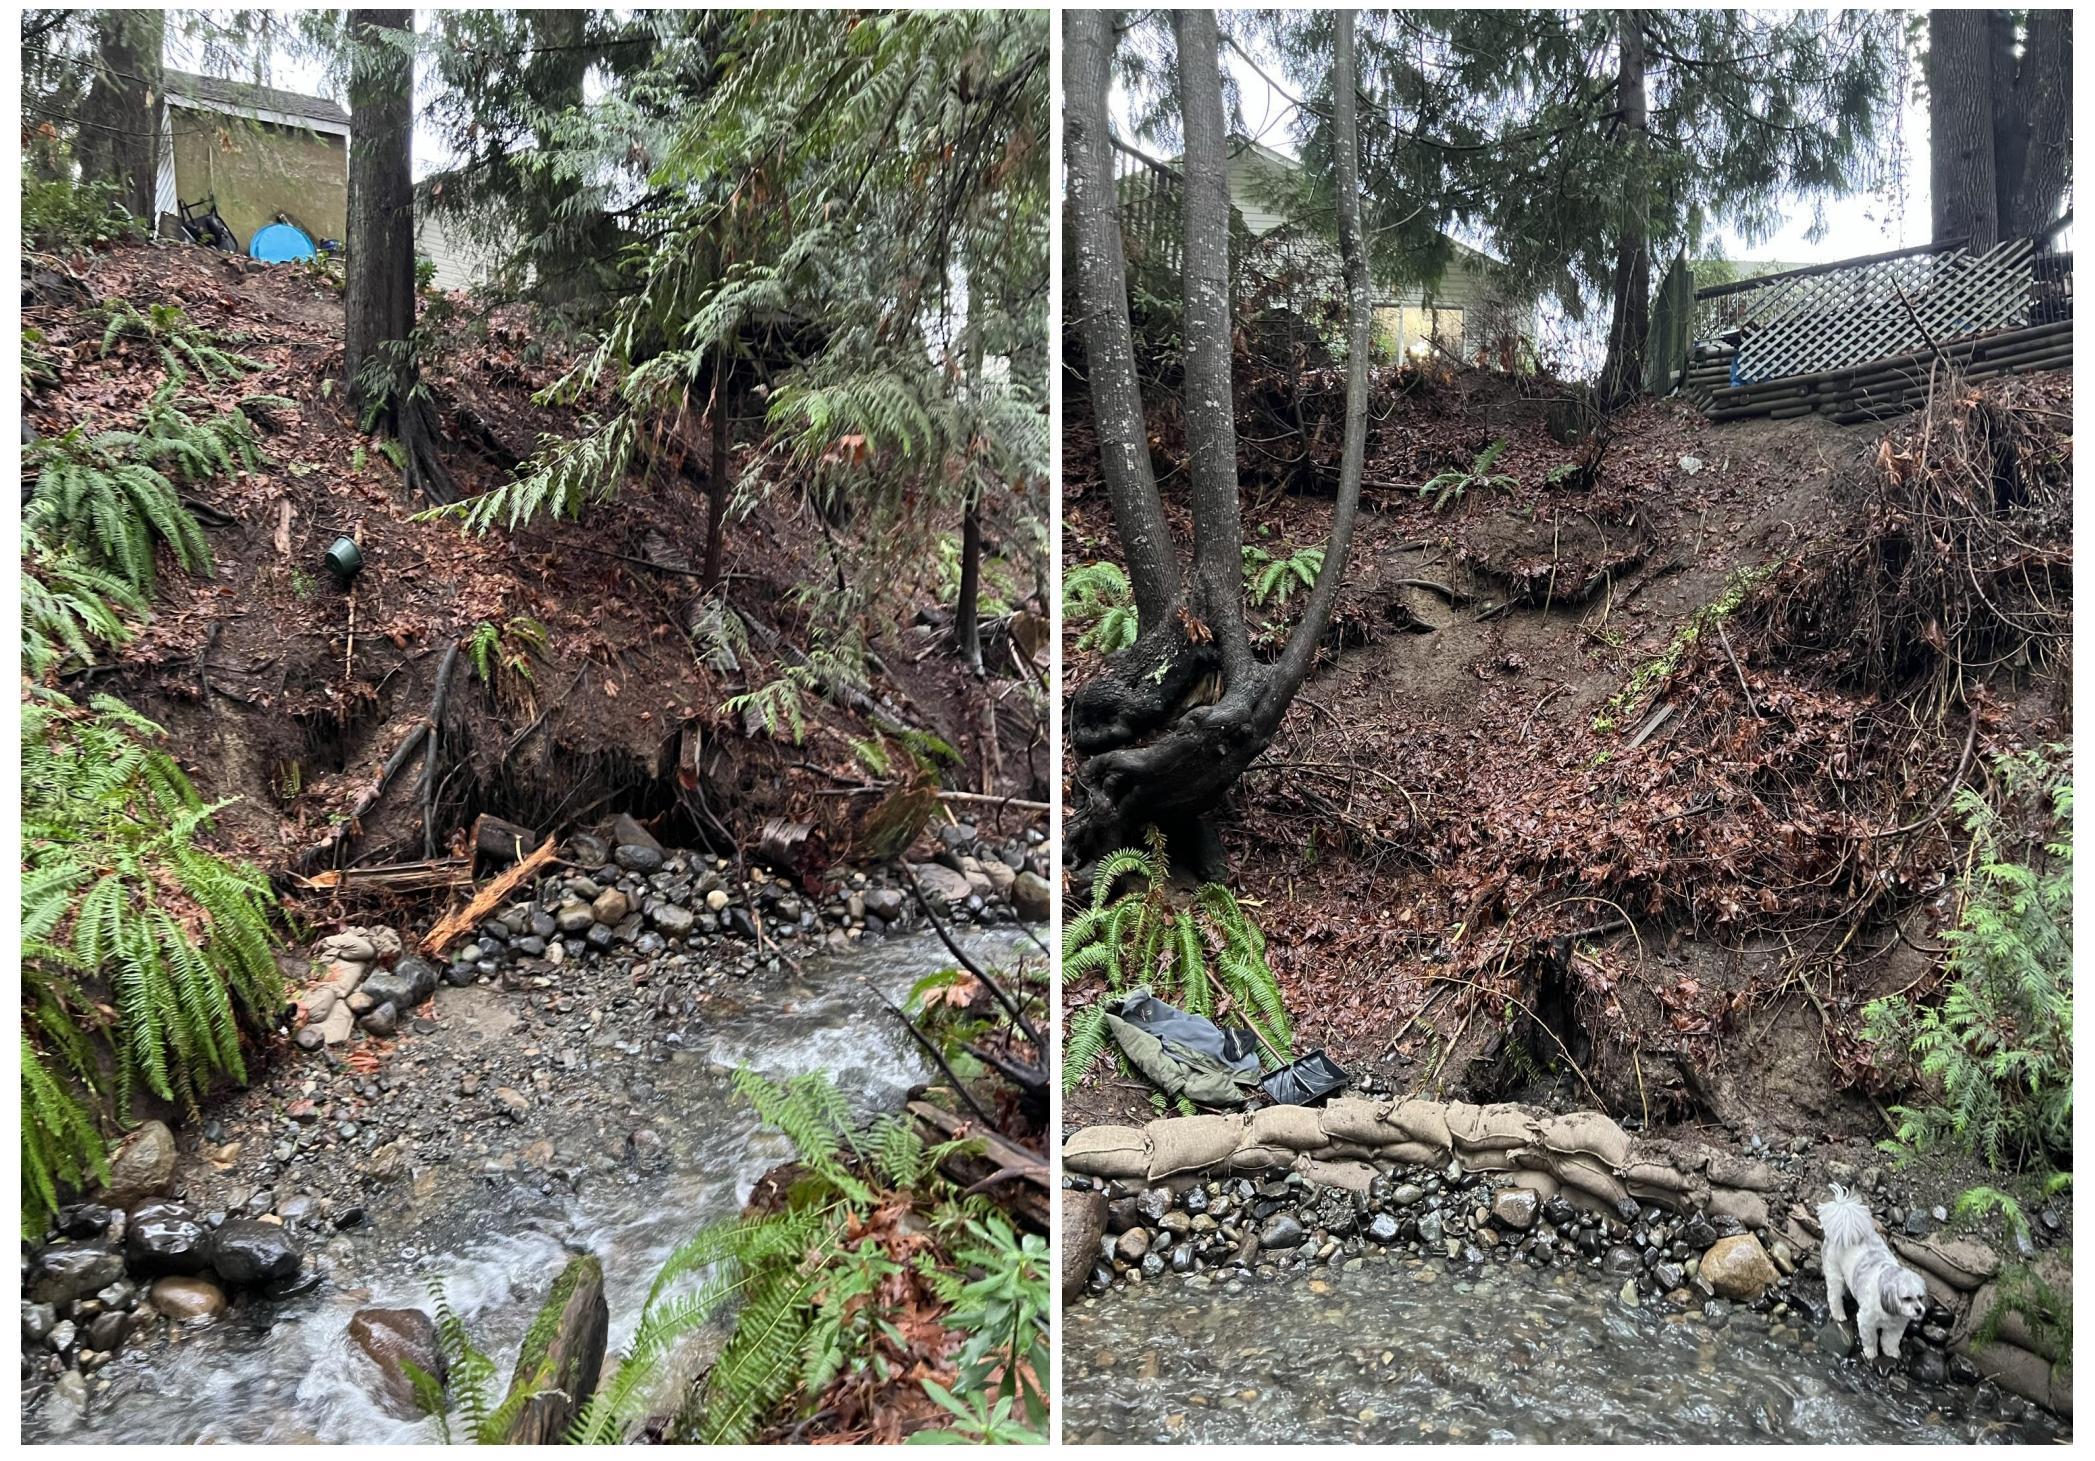
This is my property where I have had to sandbag in an attempt to stop the bank erosion and slumpage. You can see the tree roots exposed and the severity of the erosion.
