## **Erosion of Anchor Estates**

This presentation is to demonstrate how, I believe, North Cowichan's Stormwater Management is causing stream bank erosion of Anchor Estates Greenspace and a number of strata properties bordering that Greenspace The following is an email I received in response to my concerns about erosion of Properties and Anchor Estates Greenspace. In the following presentation I hope to challenge the statements in paras one and two. As for para three, the disclosure statement filed by the developer advises that North Cowichan had stated that there is no flooding issues with the Anchor Estates development.

# Erosion

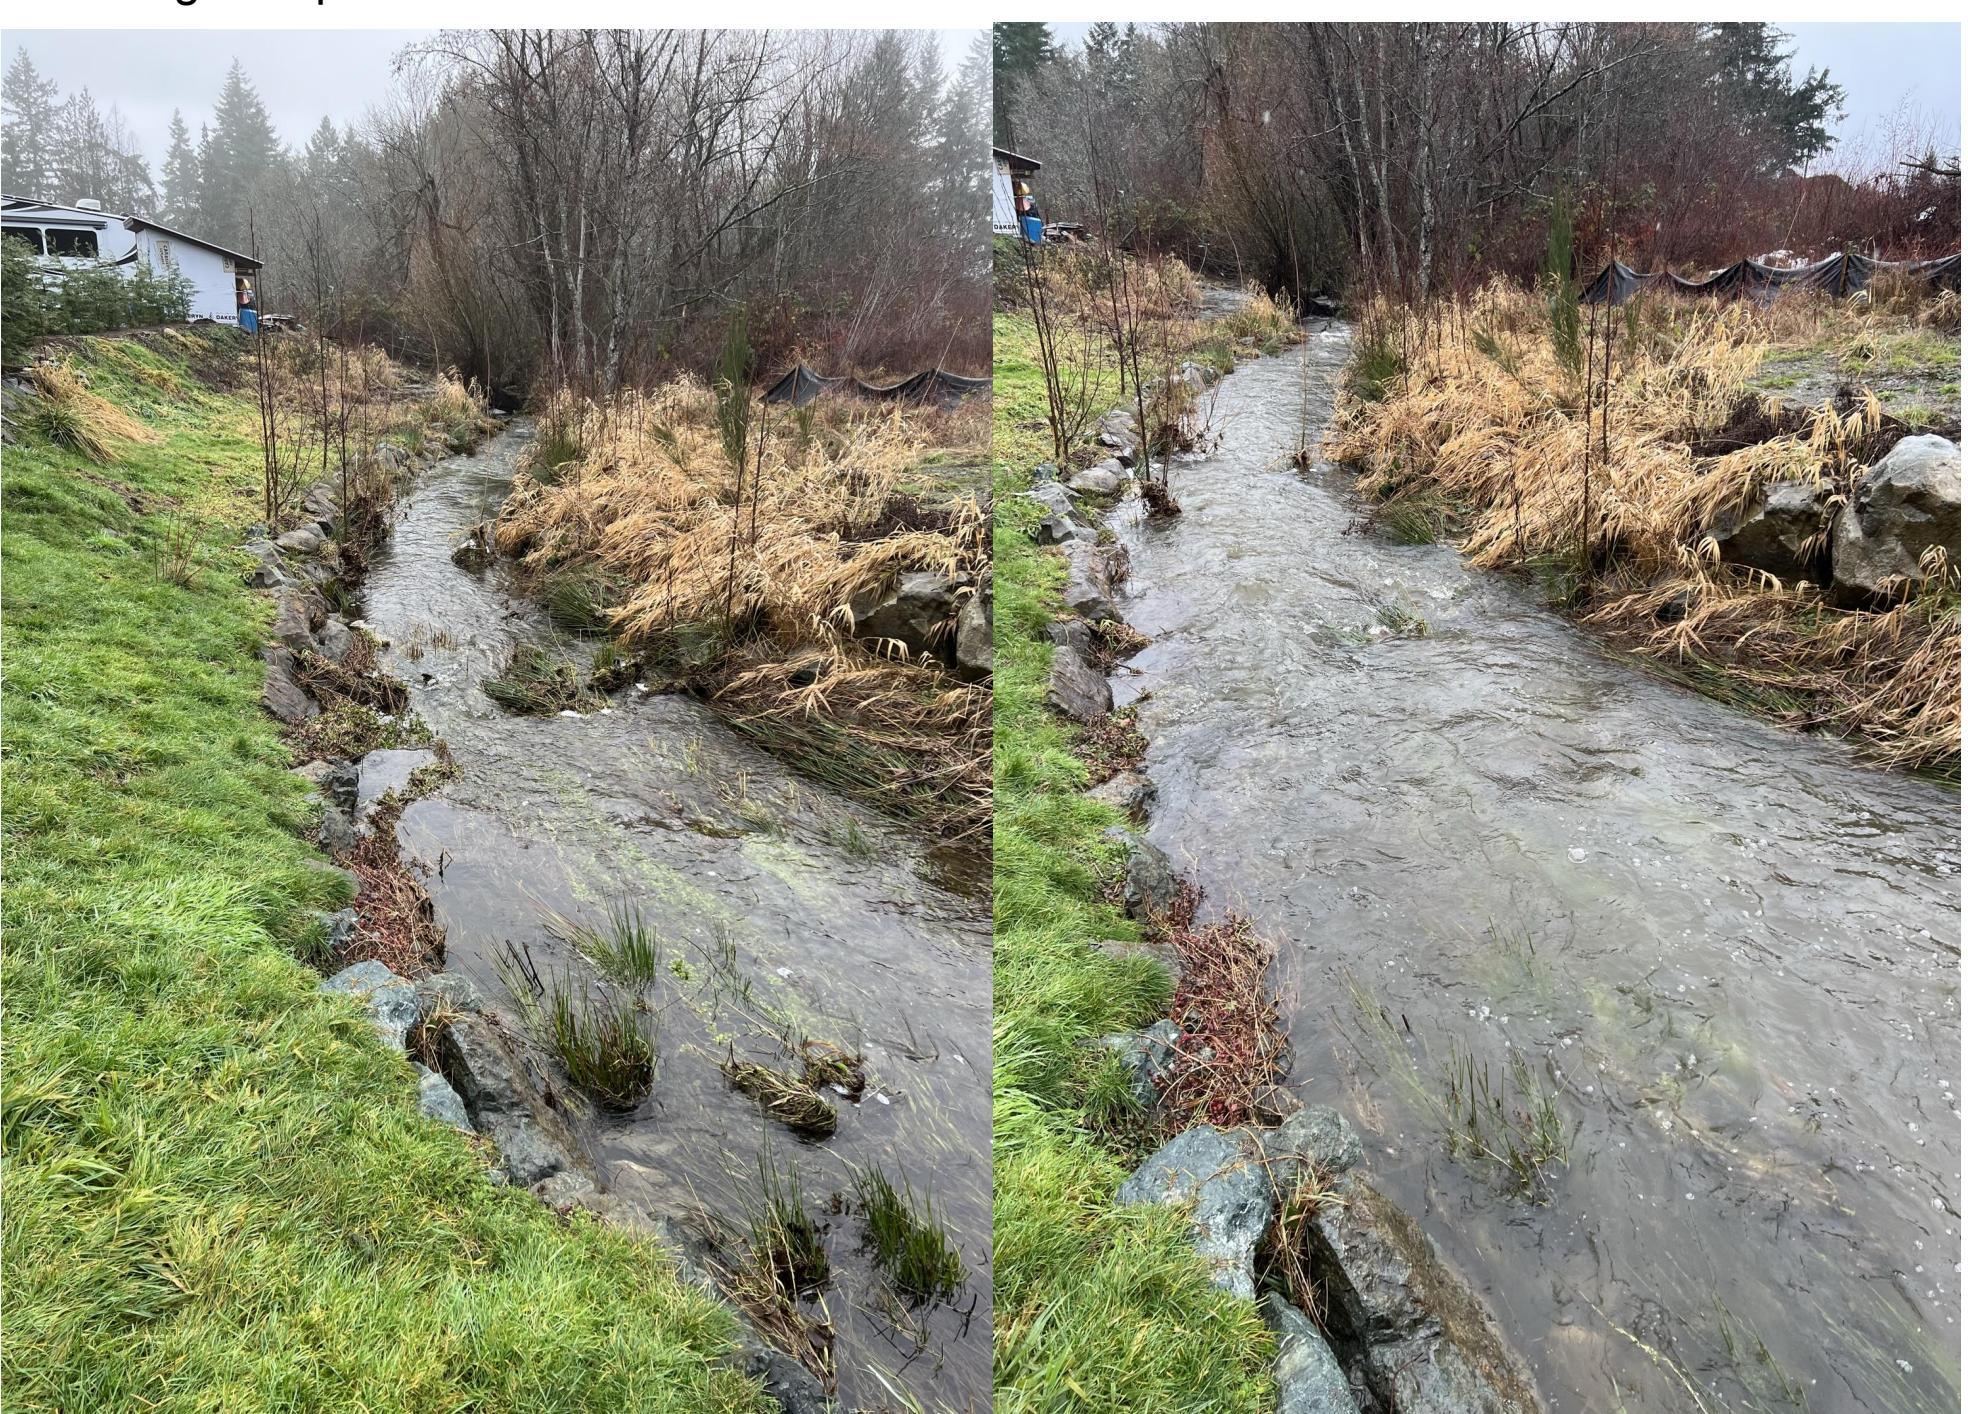
Looking Just past new culvert built above Peterson St before and after Jan 12 Rainfall

These slides show (left) the artificial straightening of the stream along Northview Dr. and on the right is a pic of the stream just before entering the culvert at the top of Northview. Most studies on straightening of stream state the following.

- 1. Flooding may happen downstream of the straightened channel as water is carried there faster.
- 2. There is more erosion downstream because the water is flowing faster.
