**ECOLOGICAL ASSESSMENT FOR PROPOSED
DRIVEWAY**

6824 Stoney Hill Road, Duncan, BC

April 26, 2022

DOSSIER: 22.0066-001

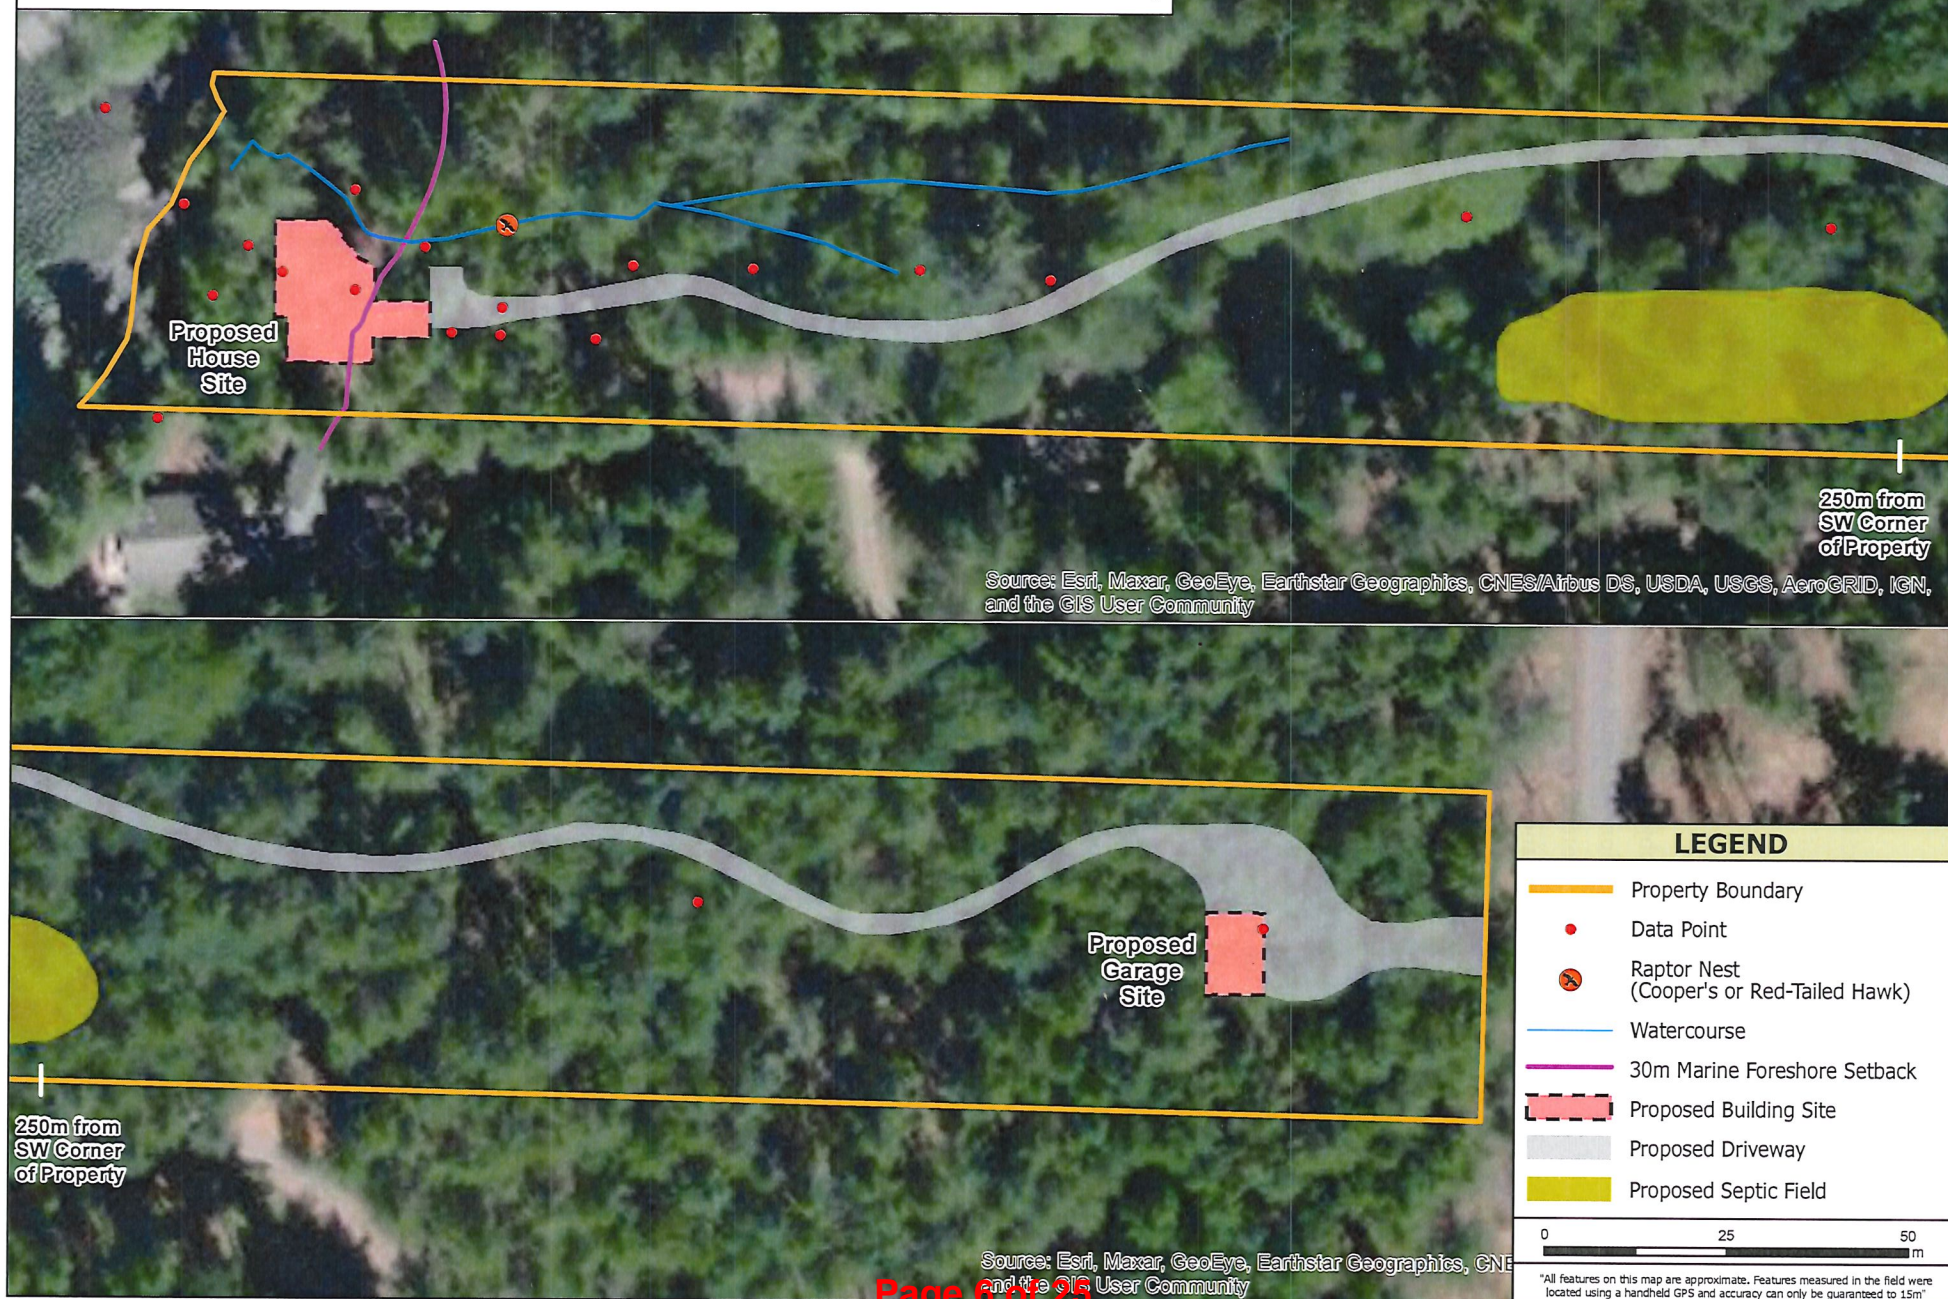
FIGURE 1: Site plan showing location of house, septic field, and driveway

As noted in the 2019 report, an inactive raptor nest does occur in a 35 cm diameter Douglas-fir tree close to the northern property line (Figure 1), but no birds were identified on the nest or in the immediate vicinity during the site visit on March 24, 2022.

The watercourse that was noted in the 2019 report was examined during the 2022 field visit (Figure 1). Water was flowing intermittently in portions of the creek, and there were signs of recent scouring that likely occurred during the high rainfall events of November 2021. However, the watercourse is likely dry during the summer, so it could be described as seasonal. Also, as noted in the 2019 report, due to the existence of a barrier for fish near the beach, under the Riparian Areas Protection Regulation (RAPR), this watercourse is not classified as a stream. The watercourse runs roughly parallel to the northern property line in the western portion of the property. Despite not being applicable to the RAPR, the drainage still represents a “watercourse” as per local government bylaws and will require a protective setback.

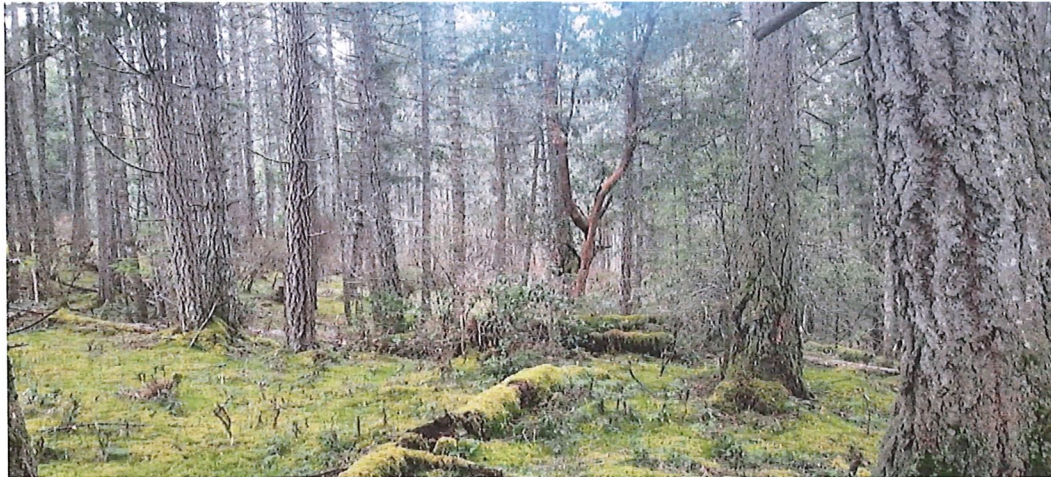
Photo of the forest in the eastern portion of the property near Stoney Hill Road. The forest is dominated by young Douglas-fir trees with an age range of 35-65 years. Less windfall has occurred on this portion of the property compared to exposed areas closer to the water. The soils in this area are shallow, with bedrock close to the surface.

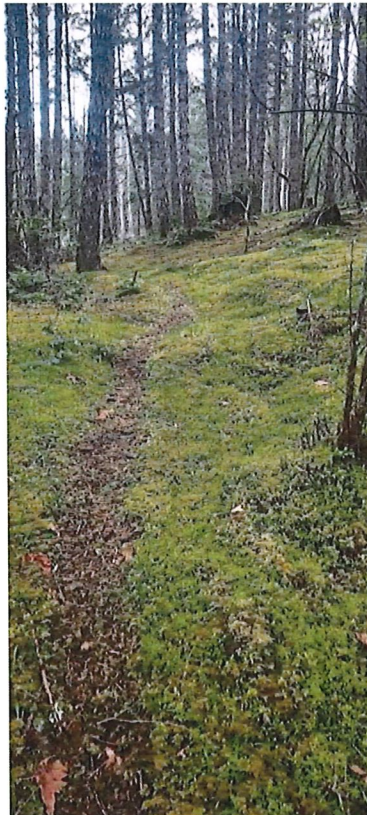
Photo of the property close to Stoney Hill Road showing an existing trail that the driveway will follow. Tree clearing must be kept to a minimum and the driveway route chosen to avoid as many trees as possible.

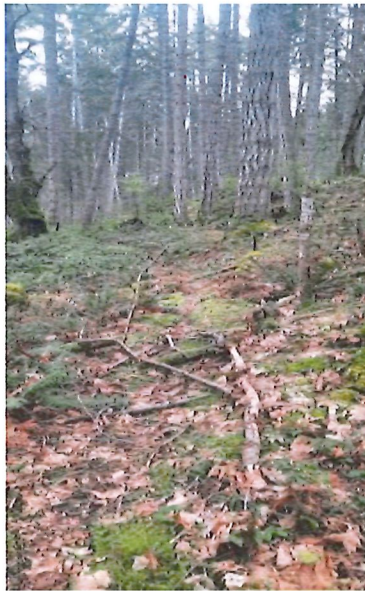
In this area the driveway will skirt the sides of bedrock outcrop. Some additional fill for the road-bed may be required in this location. The dominant trees in this area are Douglas-fir, with scattered big leaf maple and arbutus.

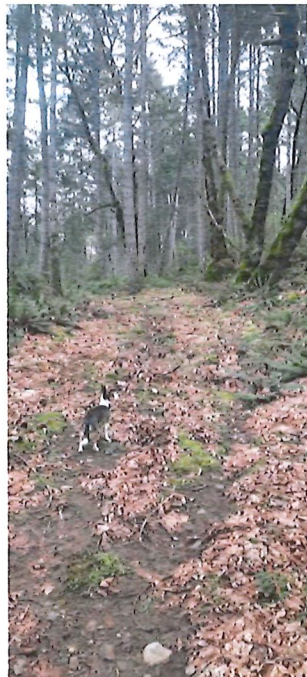
View of an existing road on the property that was built when the original subdivision was established. The driveway will be built on this existing road footprint for approximately 1/3 of the distance.

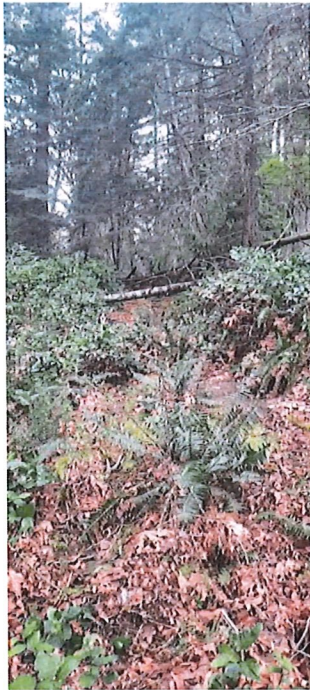
Above and below: photos of the existing old road to be followed by the driveway. No watercourses were seen along the eastern portion of the proposed driveway route. A watercourse does occur on the property, but closer to the northern property line.

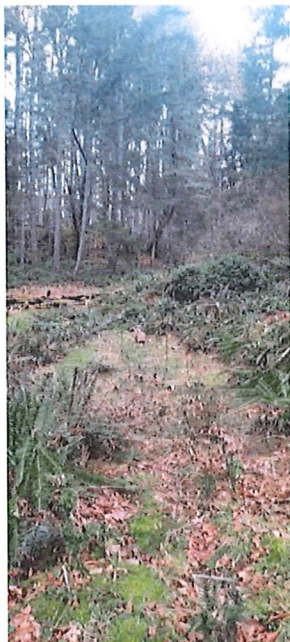
This portion of the driveway will likely require a culvert.

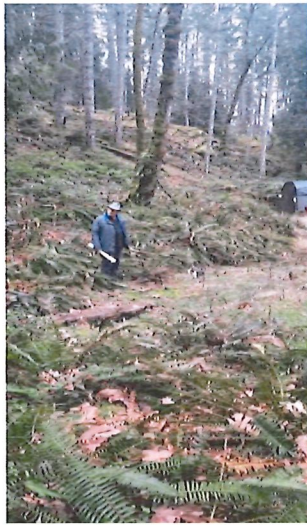
Another view of the area where a small diameter culvert will be required.

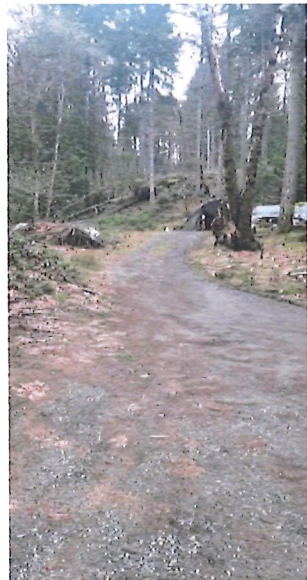
Closer to the proposed house site, the driveway will be positioned parallel to the existing driveway that extends on to the neighbouring property.

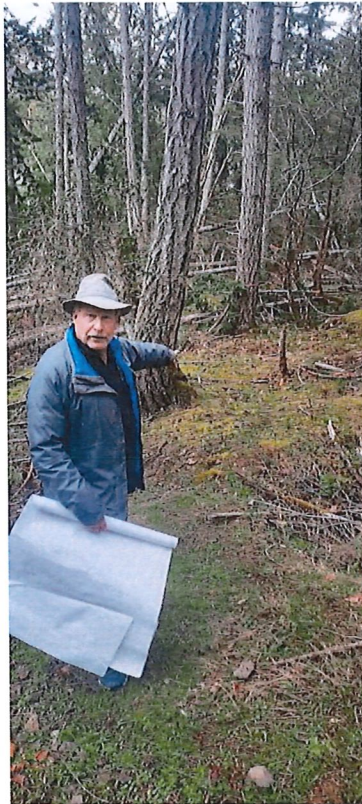
View of driveway location close to the proposed residence.
