ECOLOGICAL ASSESSMENT (EA)

6824 Stoney Hill Road, Duncan, BC

May 9, 2019

DOSSIER: 19.0125

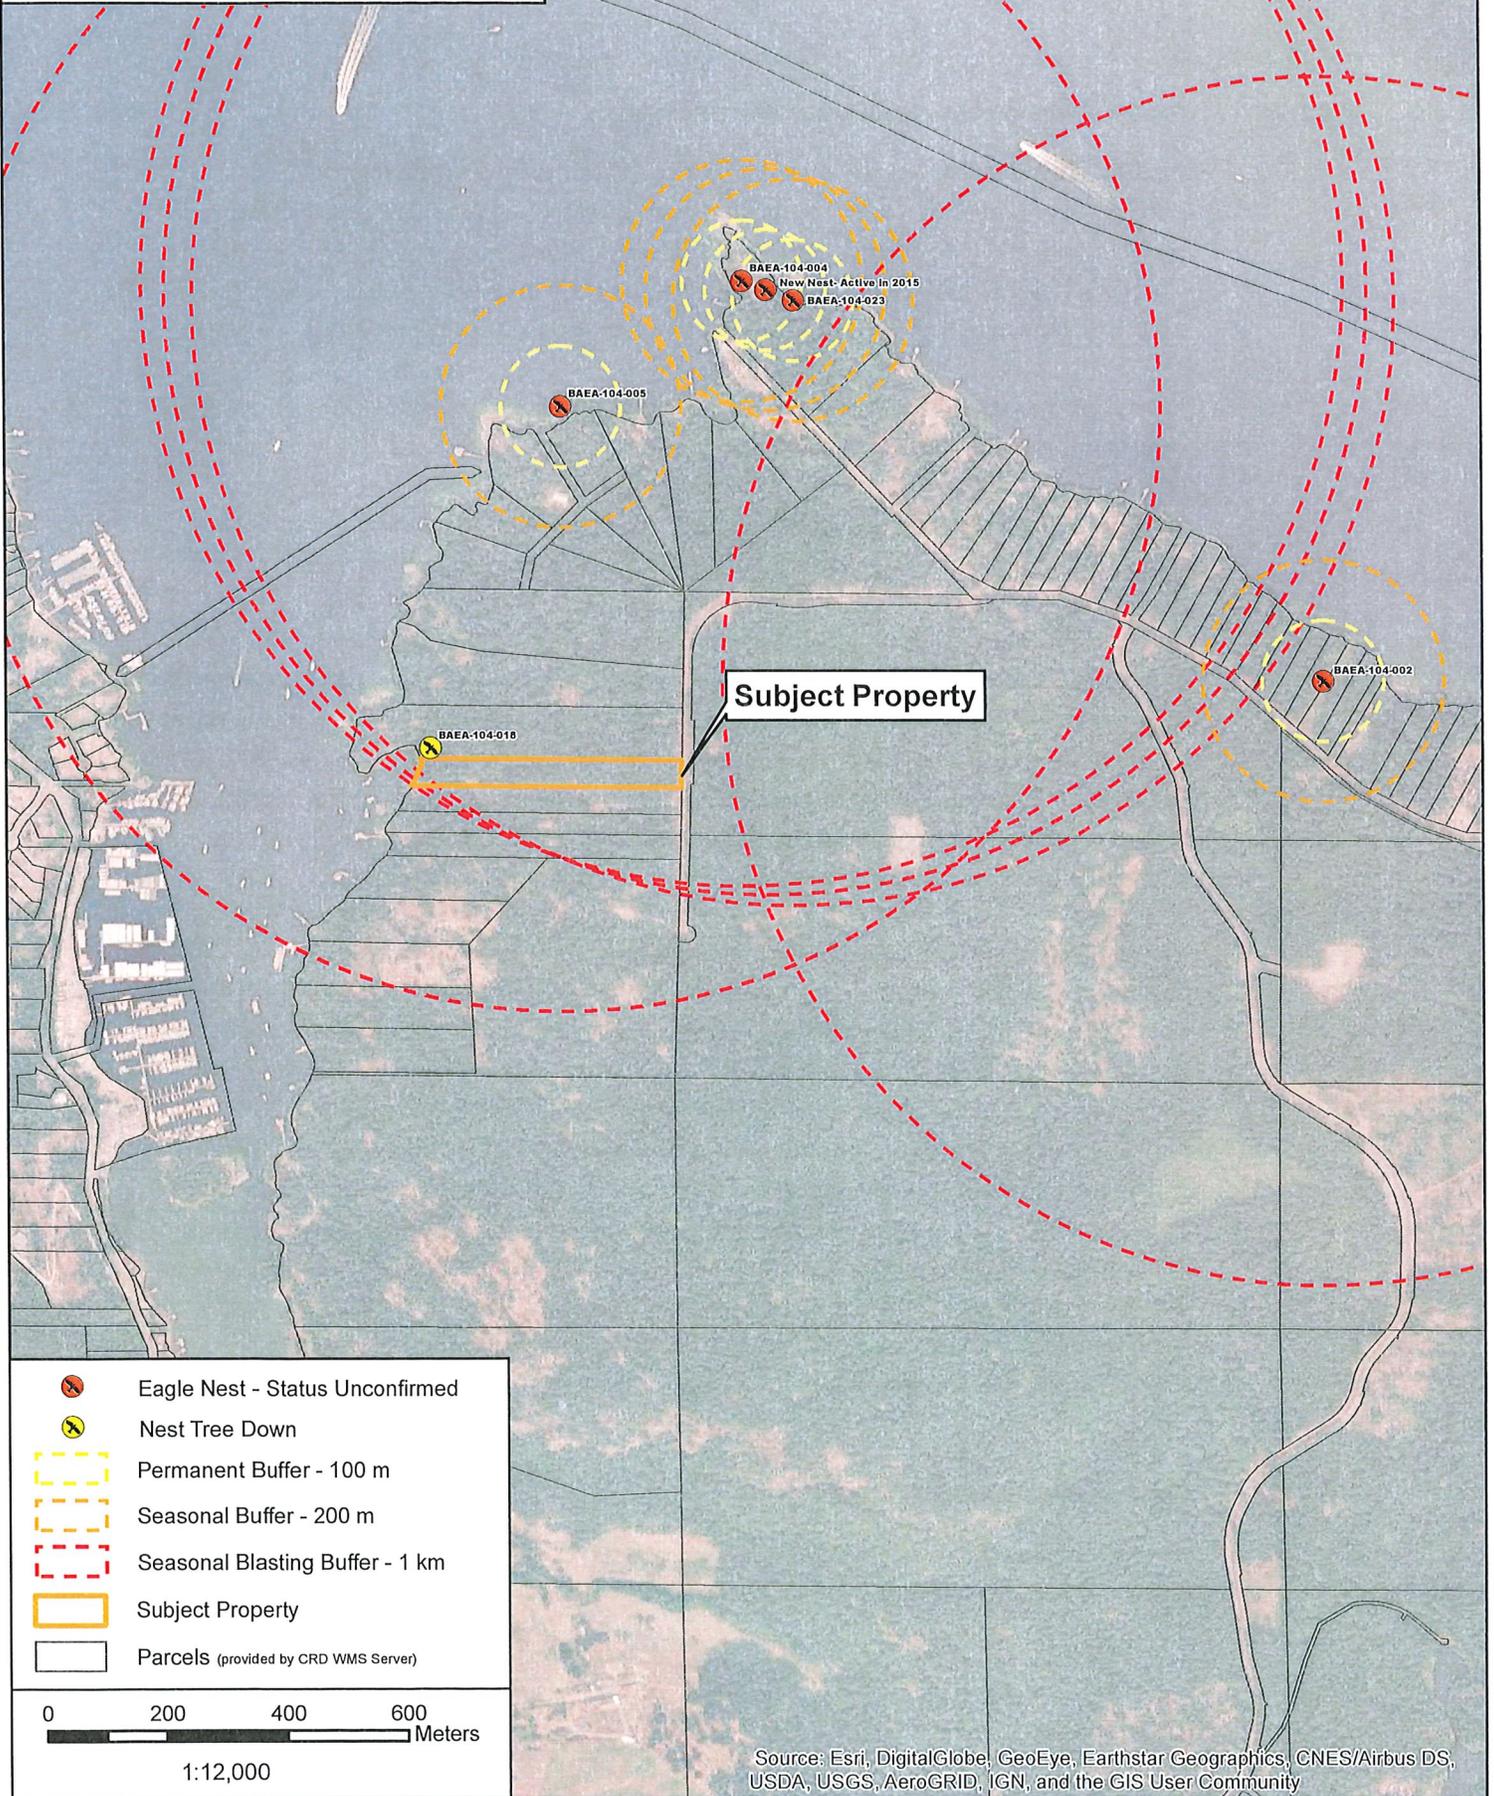
FIGURE 3: Bald Eagle Nests and Protective Buffers

As noted in Section 5.1.3, there are several recorded Bald Eagle nests on Stoney Hill Point including Nest BAEA-104-018, which was recorded close to the north-western corner of the property (Figure 3). As noted, field work and communications with the current residents indicate that this nest tree has blown down, with the trunk lying on the beach (confirmed during the field assessment).

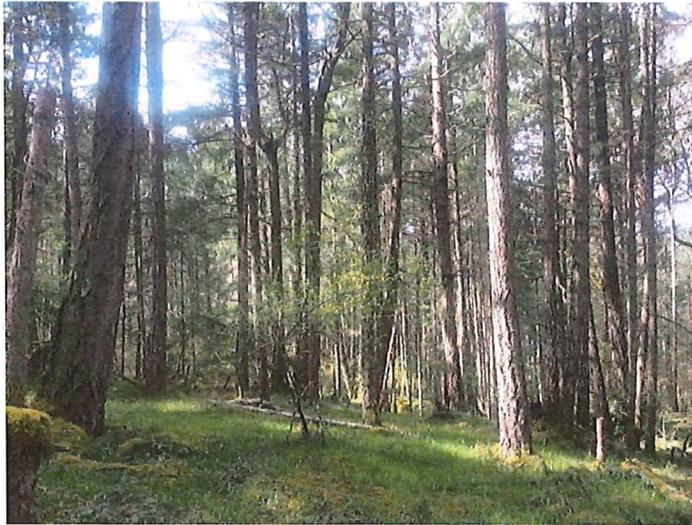
Typical forest in eastern portion of the property. The forest is dominated by young Douglas-fir trees with an age range of 35-60 years. Less windfall has occurred in this area compared to areas that are closer to the water.

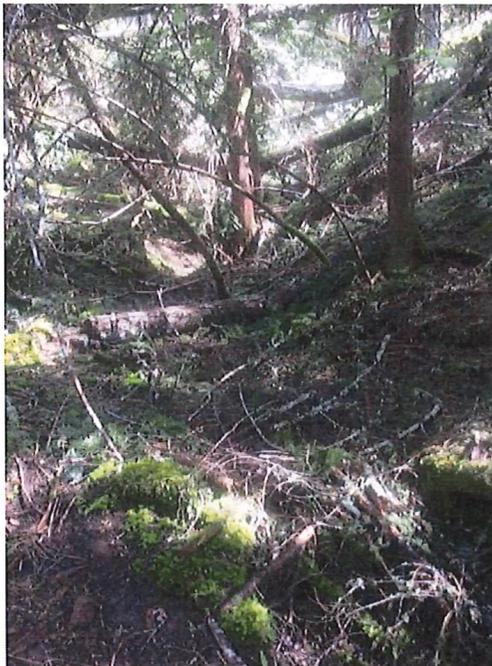
The watercourse noted by the landowner was found on the property during the site assessment, and its location is shown on Figures 1 and 2. There were signs of water movement in a few places – such as scouring – but there was no water flowing in the creek at the time of the site visit. The wetted width of the watercourse varies between 50 – 75 cm. Furthermore, at about the edge of the 30 m DPA, any ephemerally-flowing water appears to go to ground, with no obvious channel occurring. In addition, any surface water would drop over a short but steep bank down to the beach. The surrounding vegetation lacks any well-developed riparian vegetation. Instead, the composition of the riparian zone mirrors the vegetation of the surrounding forest.

Based on the fact that the steep bank occurring at tidewater represents a physical barrier that prevents fish from accessing the drainage and there is no perennially-available habitat anywhere in the system, the drainage is not considered a “stream” under the Riparian Areas Regulation. Despite not being applicable to the Riparian Areas Regulation, the drainage still represents a “watercourse” as per local government bylaws (discussed in more detail in Section 6.1.8).

Photo of the small seasonal watercourse. Water is only present in the creek after storm events. The drainage follows a shallow gully down towards the ocean. Close to the house site the watercourse goes to ground with only a poorly defined channel beyond. The creek goes over a steep bank and down onto the beach. It was confirmed that the watercourse is not applicable to the RAR.

Considering the characteristics of the watercourse, and paucity of potential building sites on the property, we think it is acceptable for the house footprint to be placed within 4 m of the watercourse. North Cowichan may also consider a variance whereby the house setback from the southern property line could be reduced and the house footprint shifted in that direction accordingly. Other measures that are recommended include:

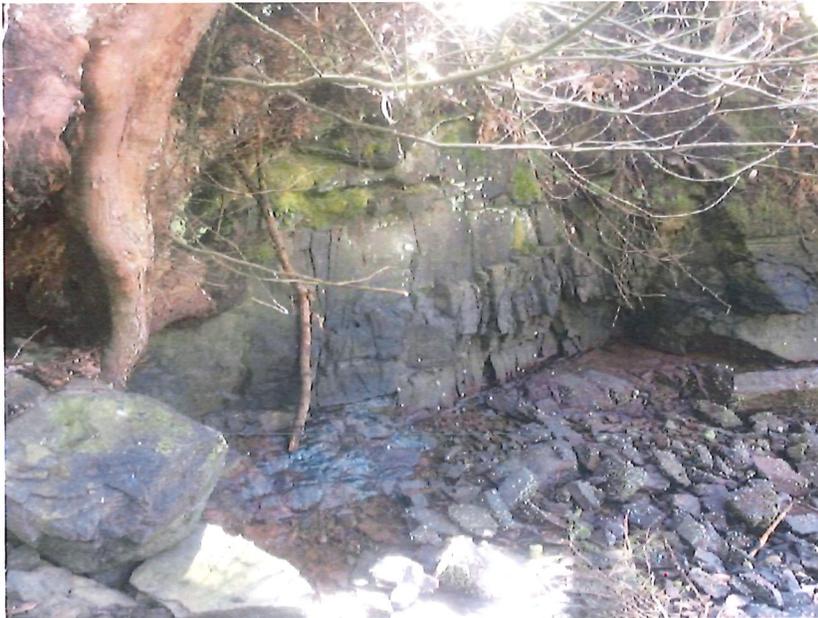
The upper beach area and lower bank was examined for any shell fragments and shell middens (informal assessment only). None were found, the bank being largely composed of fractured bedrock with pockets of mineral soil.

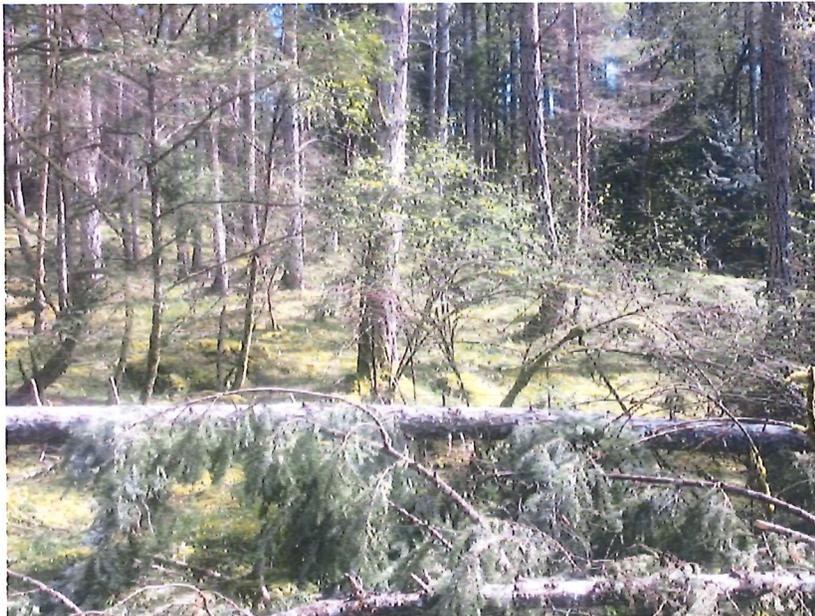
View of the house site from the top of bank – looking east. The house site lies on a gently sloping area covered in scattered Douglas-fir trees. In this and subsequent photos, windfall Douglas-fir tree can be seen – falling as a result of the windstorm in December 2018.

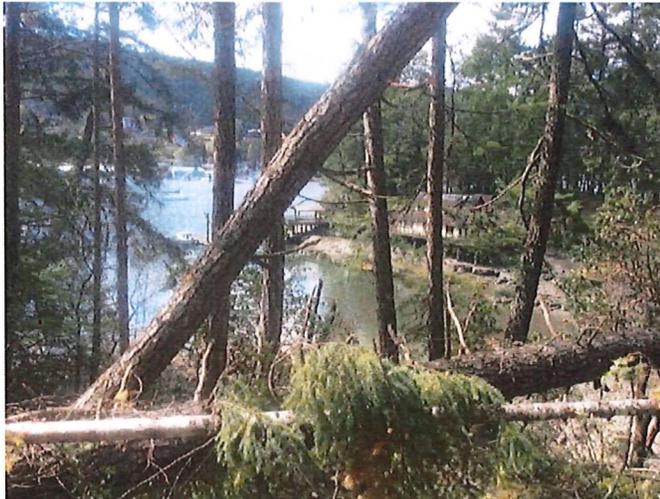
At the time of the field assessment, numerous windfall trees were present, resulting from the severe windstorm in December 2018. Removing these trees would create further damage to the forest, and the financial return from selling the wood would be negligible.

View of Bird's Eye Cove from the proposed house site. Note the abundant windfall.

- The wood cleared from the house site can be cut into firewood length and stored for later use, shared with the neighbours, or donated
- Branches and greenery remaining in the house site after tree removal should be chipped and stockpiled for use in erosion and sediment control
- Wood within other parts of the DPA and elsewhere on the property can be bucked into 4' lengths and left on the forest floor to decay; and
- Avoid excessive trampling and/or disturbance to the native vegetation while completing the work on the downed trees.

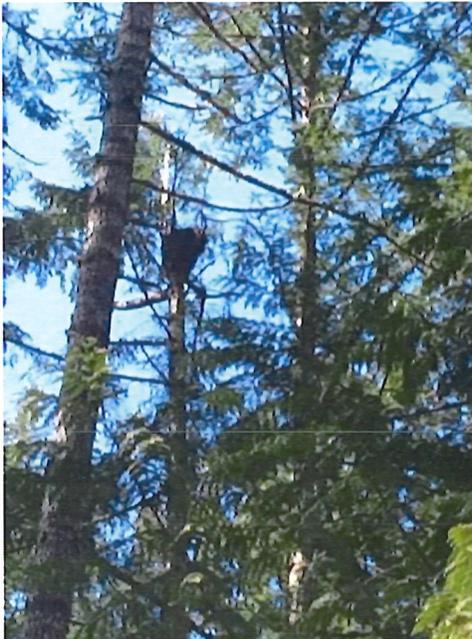
A raptor nest was found in a 35 cm diameter Douglas-fir tree close to the northern property line (Figure 1), but no birds were identified on the nest or in the immediate vicinity. No recent signs of use (e.g. whitewash, pellets and/or prey remains) were noted underneath the nest. Based on the time of year, evidence of use around the base of the tree would likely be scarce - even if the nest were active. It is also possible that an incubating female could have been on the nest, due to the fact that it was difficult to look into the nest, because of its height. The dimensions of the structure suggests that the most likely species to use the nest would be either Cooper’s Hawk (*Accipiter cooperii*), or Red-Tailed Hawk (*Buteo jamaicensis*).

View of hawk nest. It is thought to be have been built by either a Cooper's or Red-Tailed hawk. It was not confirmed whether the nest was actively being used or not. The nest tree occurs close to the northern boundary of the property and is a 35 cm diameter Douglas-fir with a broken top.

With regard to the raptor nest on the subject property, the status of the nest could not be confirmed, meaning that the default is to consider it active. As per the Guidelines for Raptor Conservation (MoE 2013), a 100 m permanent buffer is recommended around nests belonging to species that have a moderate to high ability to co-exist. A seasonal "quiet" buffer of 200 m is recommended during the breeding season. As per Figure 1, both these buffers encompass the proposed construction area. Based on the width of the property, the limited distribution of potential building sites and the understandable desire of the landowner to take advantage of the oceanfront property, constructing inside the 100 m buffer is deemed acceptable in this case. The majority of the buffer would remain intact on the subject property, due to the fact that one of the main recommendations of the EA is to maintain the balance of the forested stands on the property beyond the construction footprint. There will be an undisturbed buffer of approximately 12-15 m between the northern edge of the development area and the nest tree.
