April 13th, 2023, Site Photos

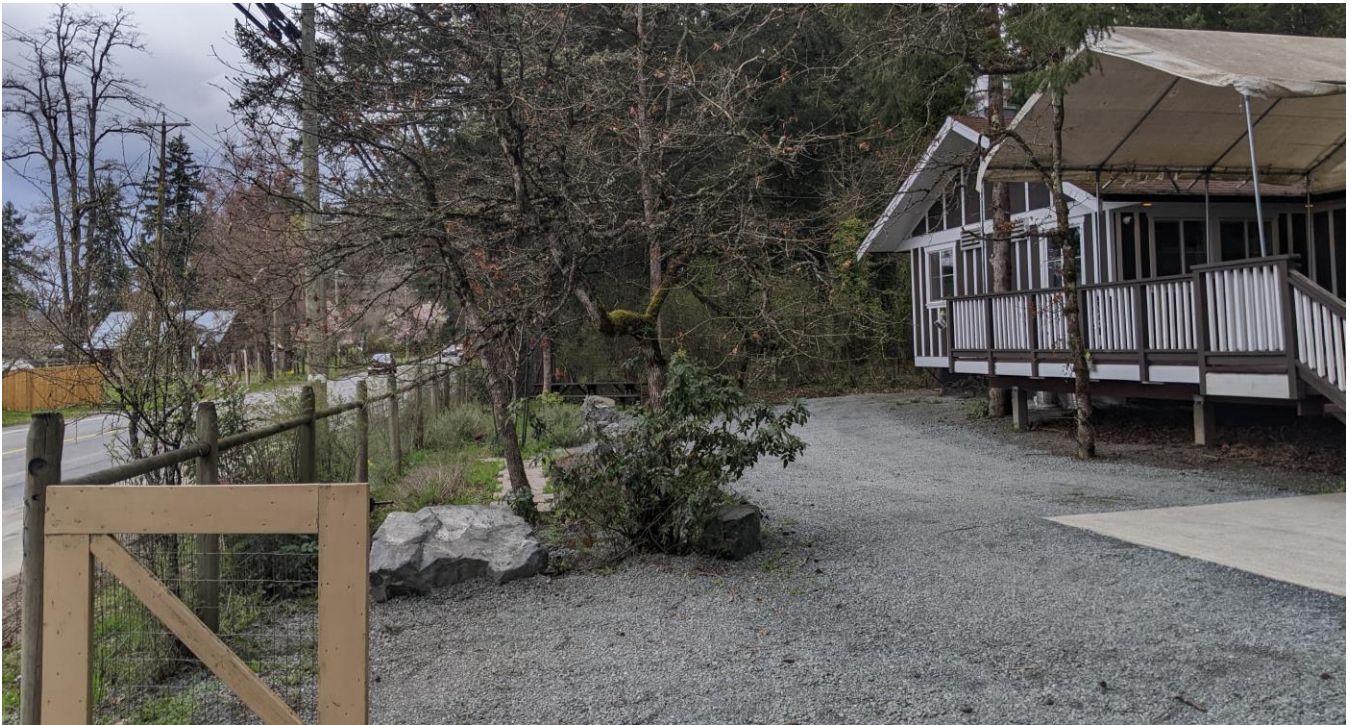
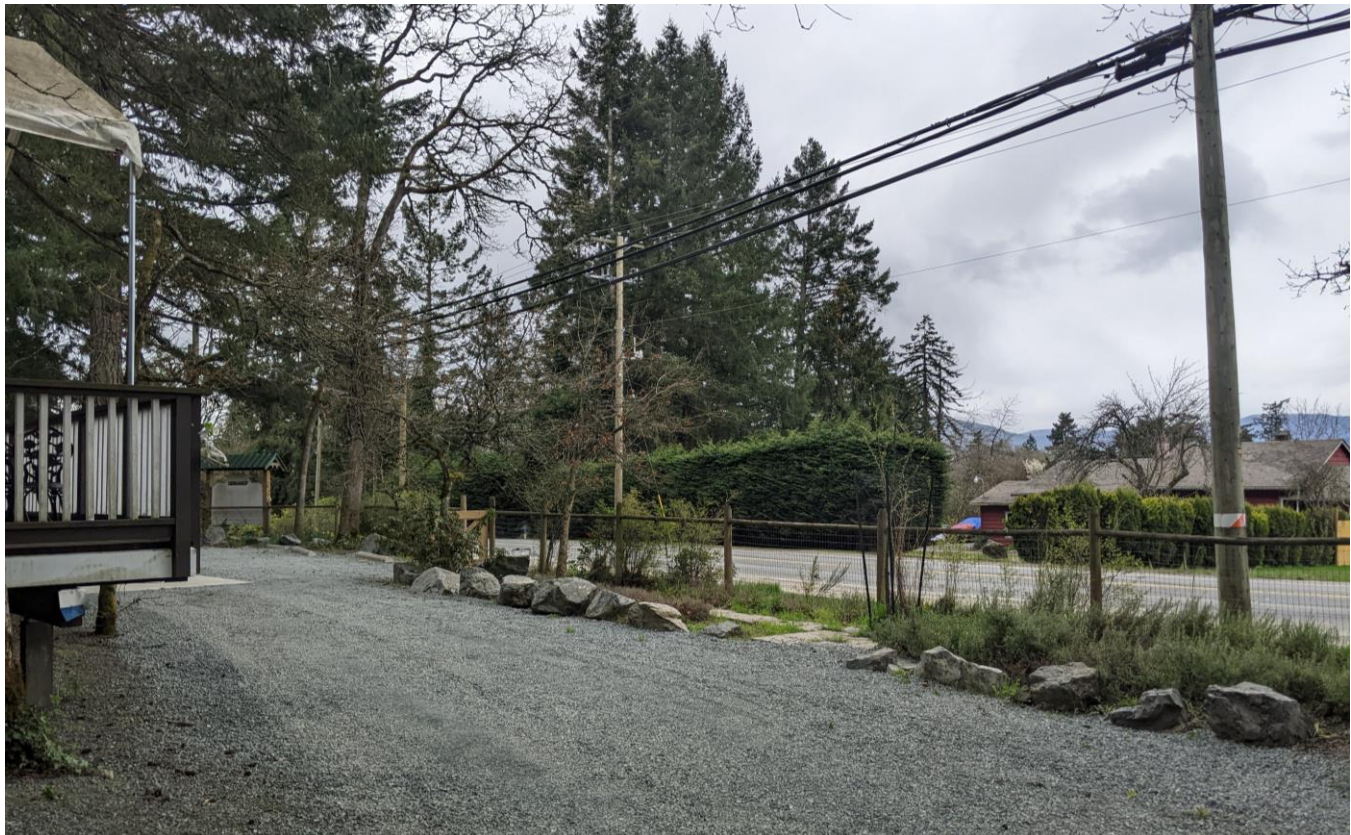
Photos 1 & 2 – 8.7 metre separation distance (setback) between the front property line to the existing Italian Kitchen and Deli.

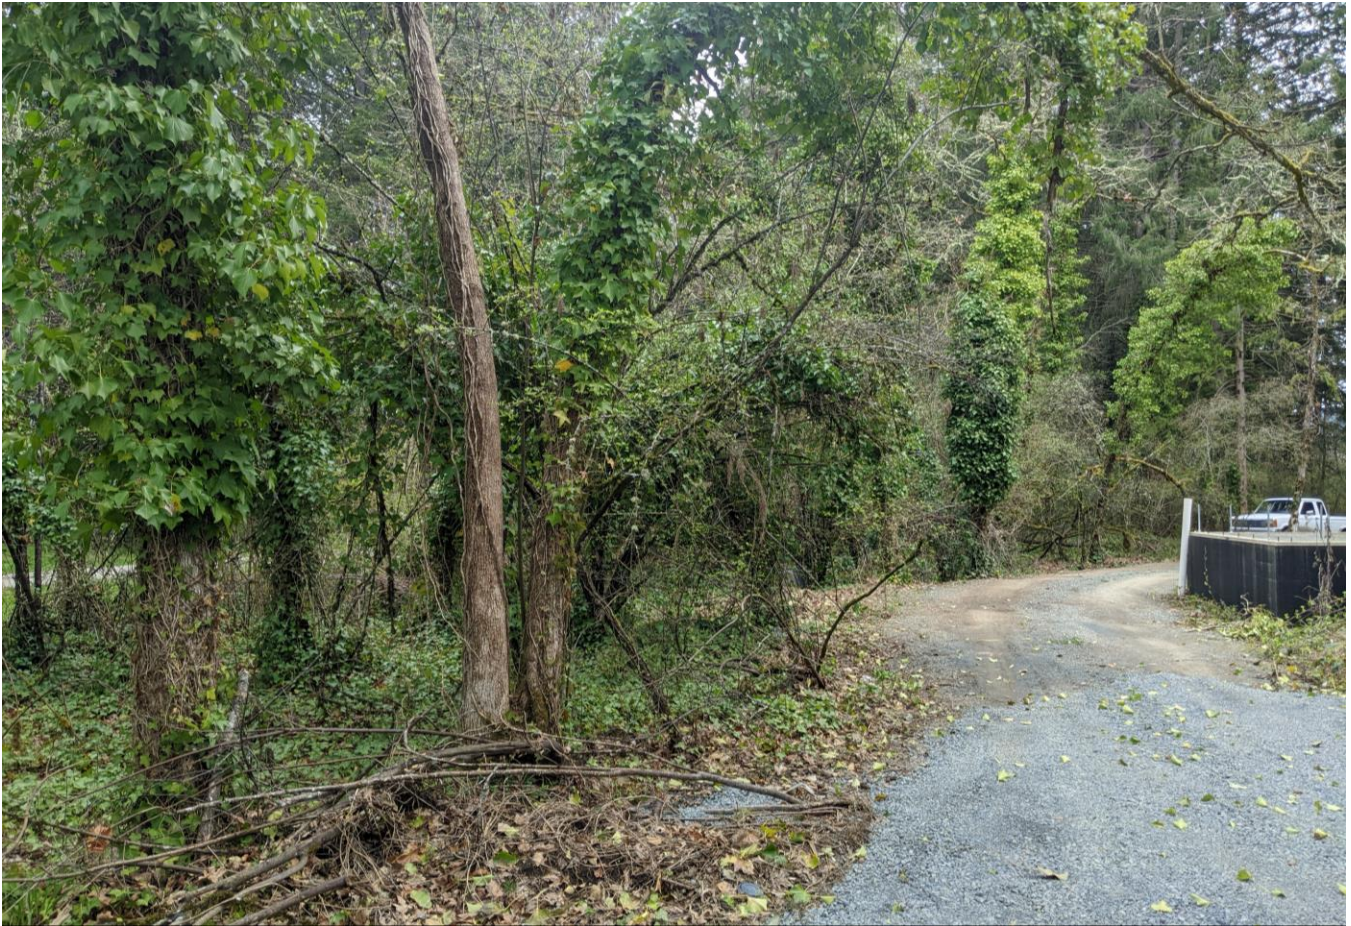
Photo 3 – Screening provided by mature vegetation along the northern property boundary and 14.3 side yard setback from the northern property line.

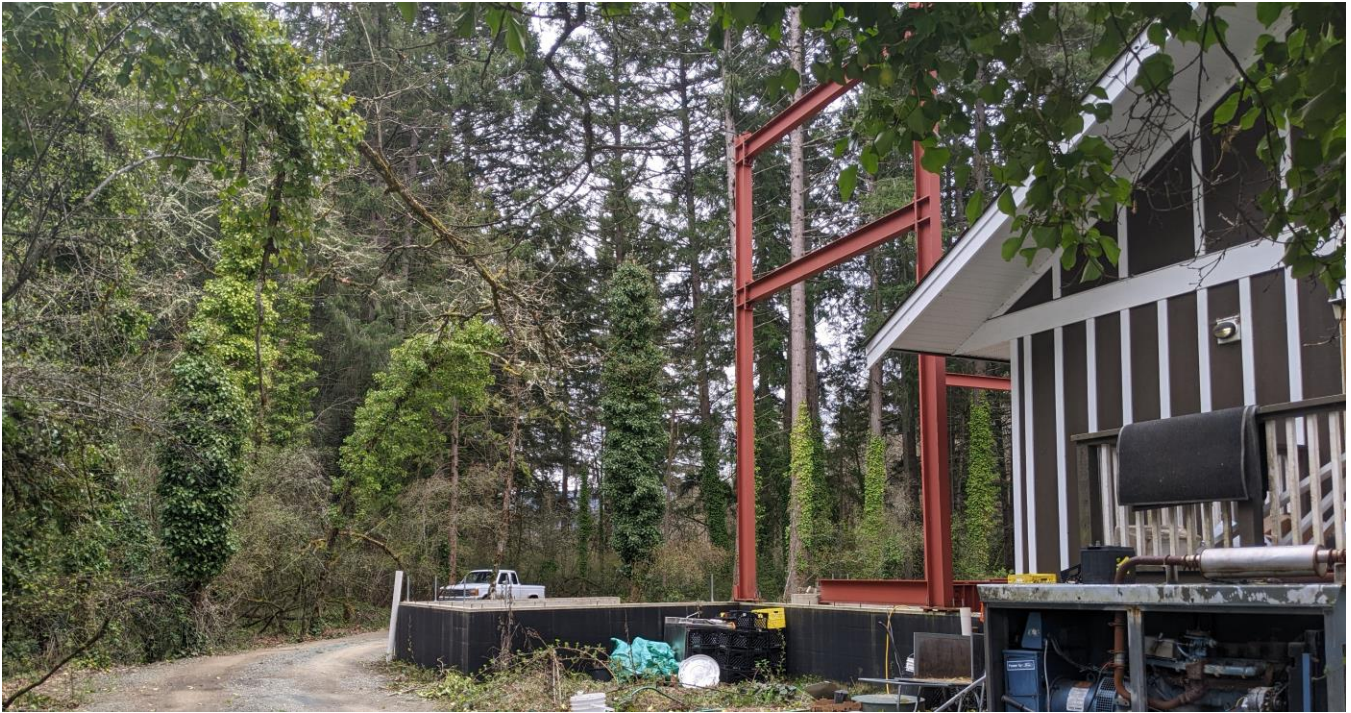
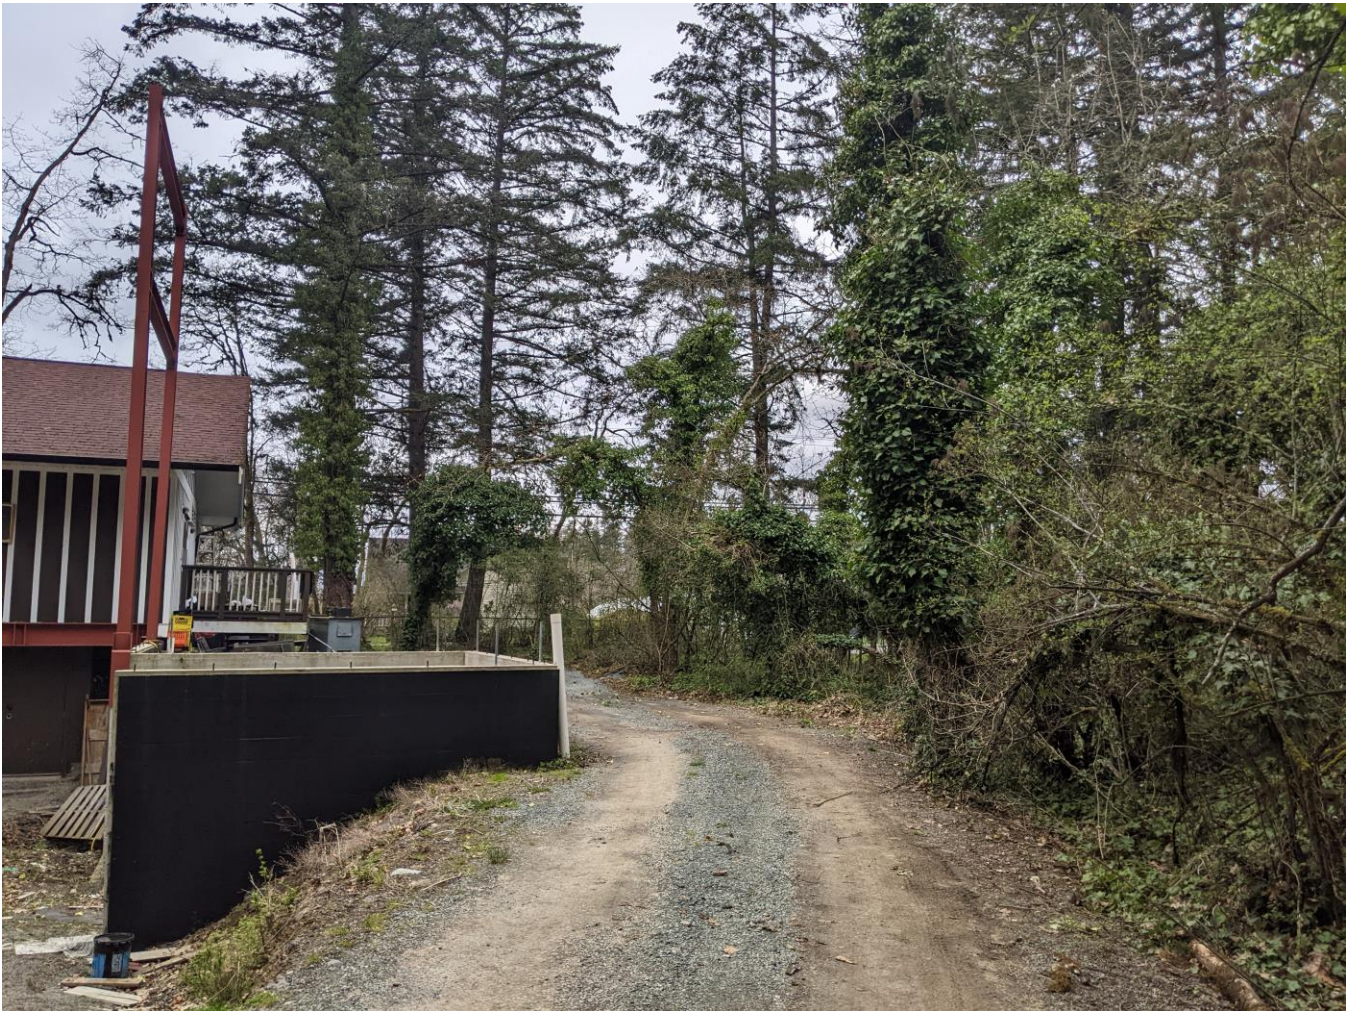
Photos 4 & 5 – Siting of the cold storage building addition behind the Italian Kitchen and Deli and separation from northern property line.

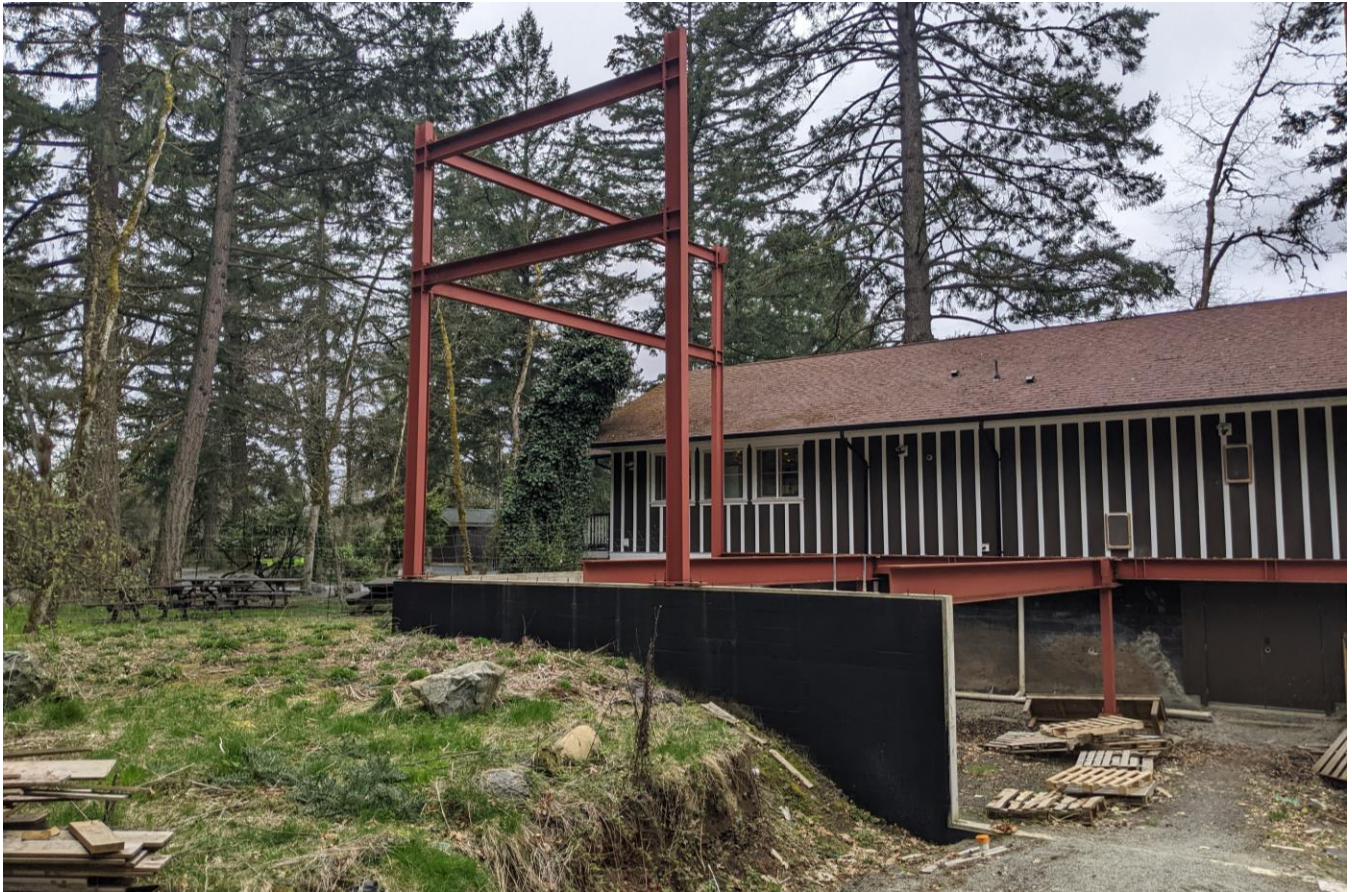
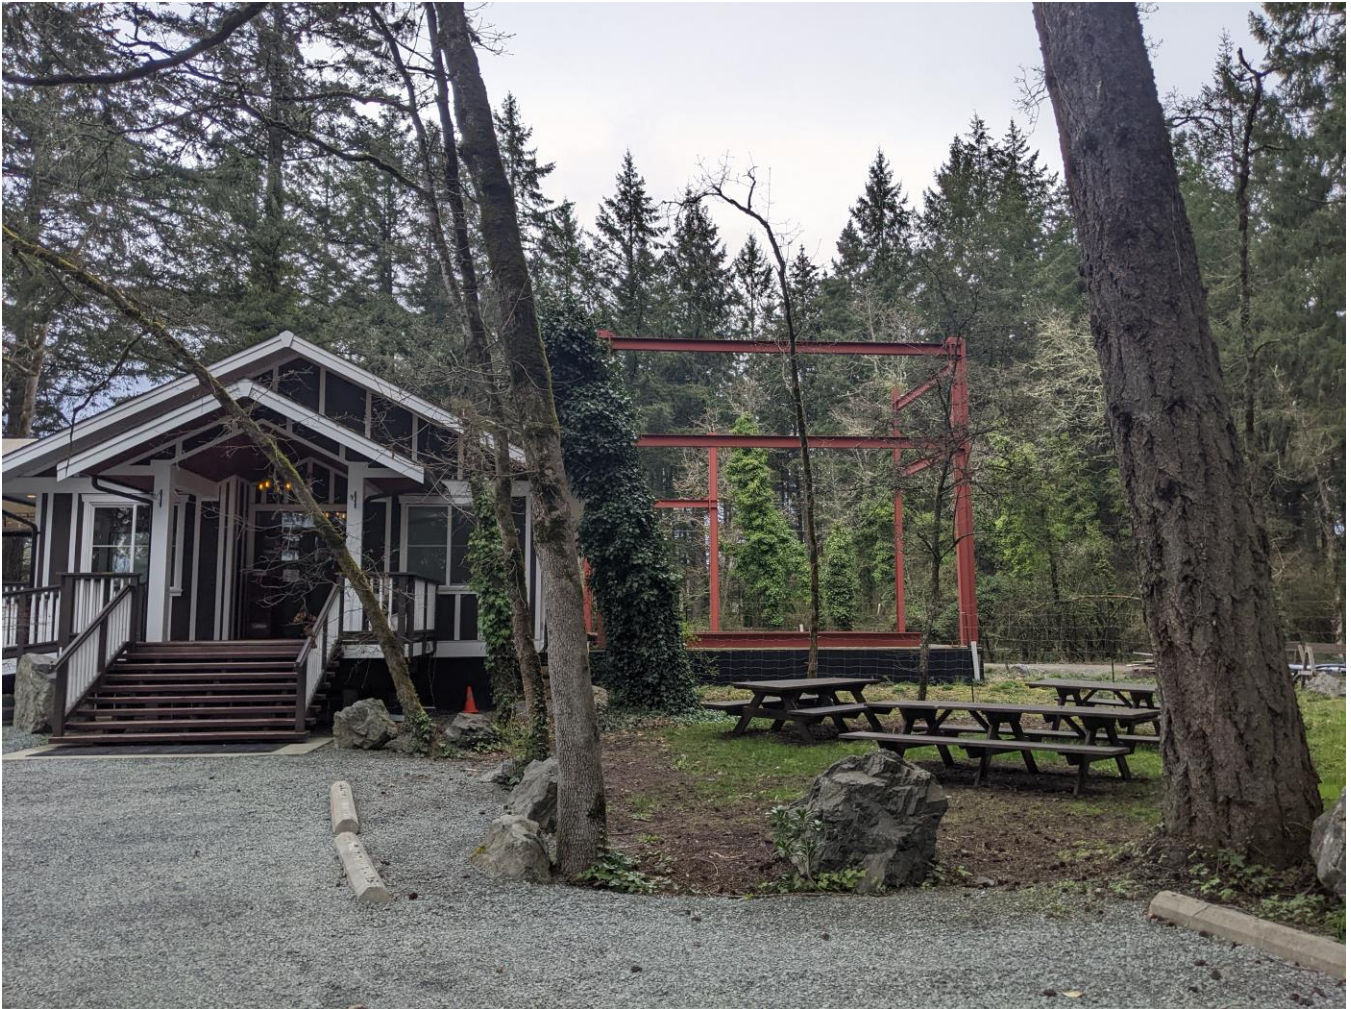
Photo 6 & 7 – Rear and side view of the partially constructed cold storage building addition.
