ENVIRONMENTAL ASSESSMENT FOR 2850 HERD RD & 6833/6823 BELL MCKINNON TEMPORARY USE PERMIT

MUNICIPALITY OF NORTH COWICHAN
7030 TRANS-CANADA HIGHWAY
DUNCAN, BC V9L 6A1

CORVIDAE PROJECT #2023-051
JULY 2023

CORVIDAE
ENVIRONMENTAL CONSULTING INC

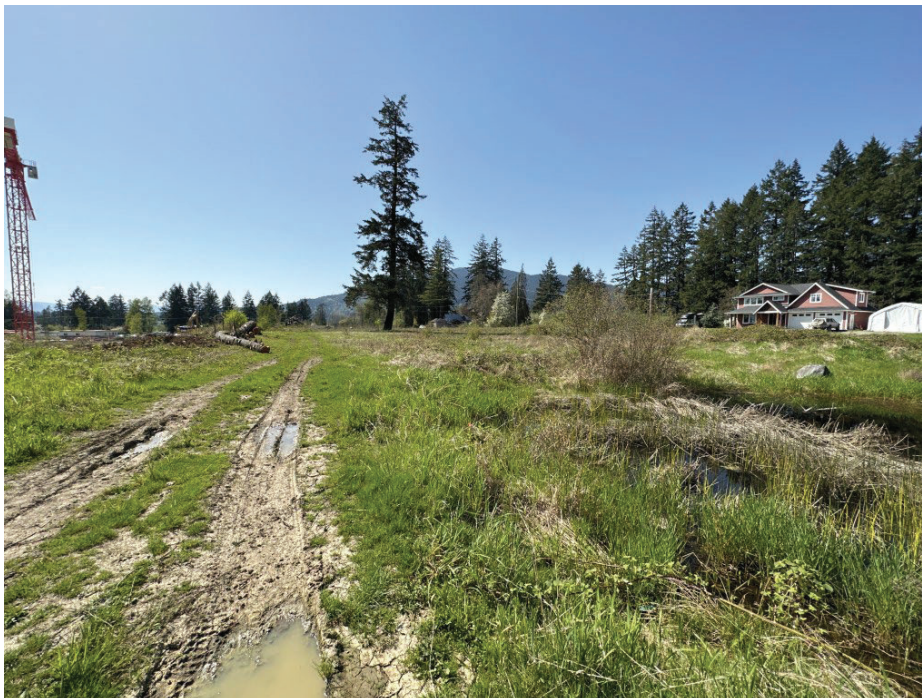
Photo 2. West view of southern parcel extent and proposed parking area in background. May 3, 2023.

Stormwater resulting from development should be returned to natural hydrologic pathways or managed to avoid excessive overland flow that could cause erosion of soils. The parking lot is permeable and water infiltration will go through the gravel cap to the soils below and into the vegetated area prior to entering any watercourse areas.

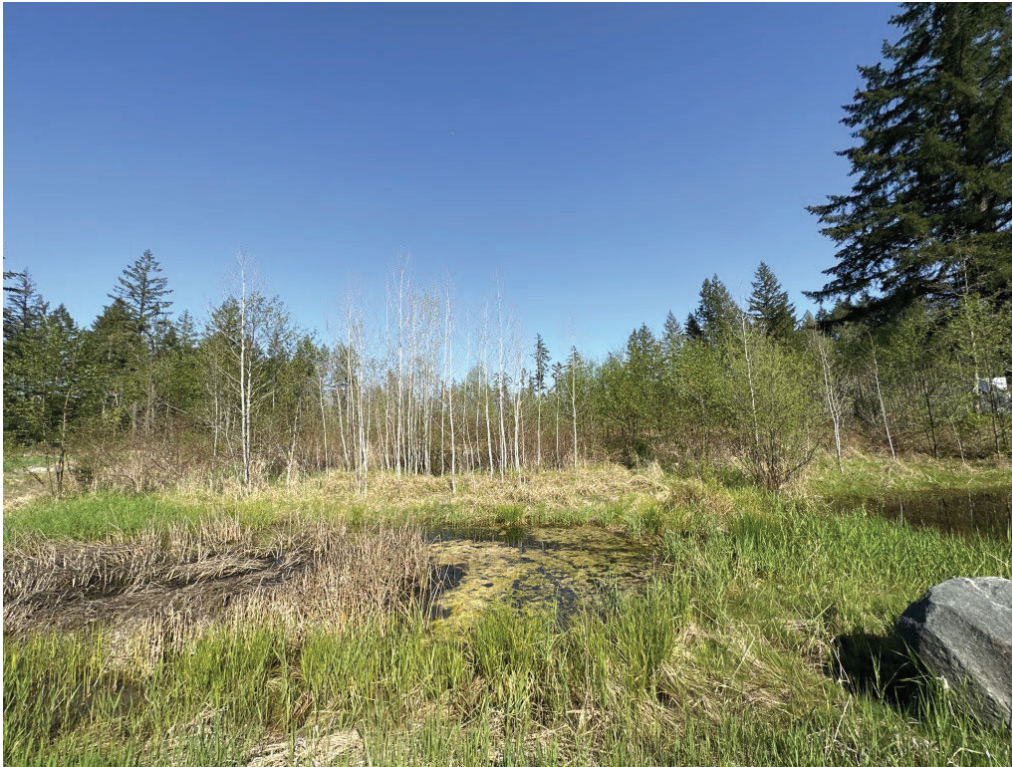
An ephemeral watercourse was observed to the east of the main residence within 6833 Bell McKinnon Road. Flows originate within the property to the north (2796 Herd Road) and are conveyed within a narrow channel in a southeast direction for entry into a small wetland near the southern property line of 6823 Bell McKinnon Road. The wetland currently drains through a culvert underneath an onsite road to a ditch located to the south within the new hospital site at 6775 Bell McKinnon Road. The upper extent of the ephemeral watercourse was dry at the time of the assessment. Standing water was observed within the southern sections of the watercourse and within the wetland.

The wetland and watercourse are excluded from the definition of stream under the RAPR because they do not support fish and do not drain into a watercourse that supports fish. Extensive modifications to the environment within the property to the south to accommodate the new hospital has included enclosure of a watercourse immediately downstream of the onsite wetland and wetland modification for the purpose of stormwater management and detention.

Photo 3. Existing wetland, looking north. May 3, 2023.

- Install a sediment fence barrier outside of the wetland SPEA, protecting this ecosystem.
- Seed the topsoil storage area with an agronomic mix immediately after placing, this includes a fall rye, clover and grass mix.
- Heed weather advisories and schedule work to avoid wet and rainy periods that may result in high surface water flow volumes and/or increase erosion and sedimentation.
- Regularly monitor the aquatic environment for signs of sedimentation during all phases of the development activities and take corrective action if required.
- Store materials and soils in dry, flat areas at least 15 m outside the edge of the identified wetland area.

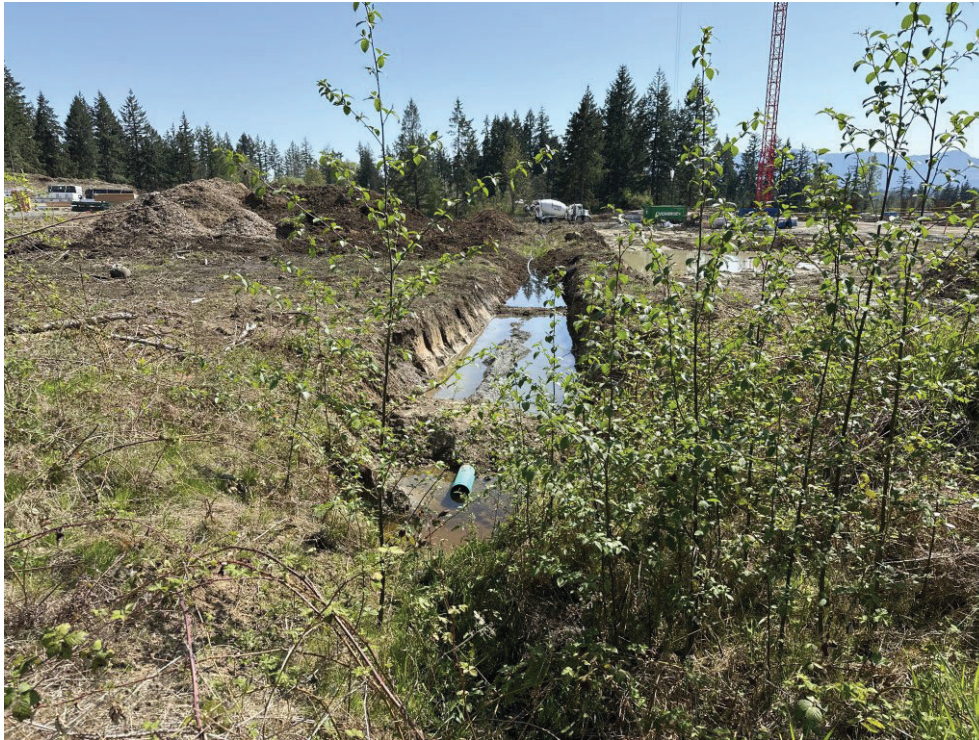
Photo 5. South view into new hospital site and outflow location for onsite wetland. May 3, 2023.

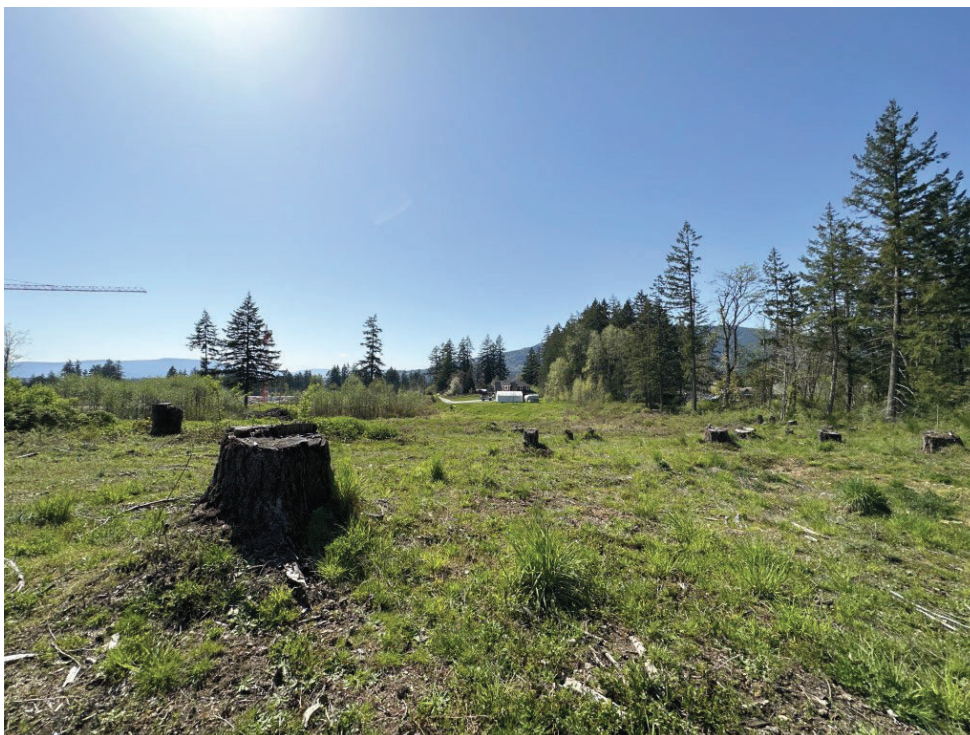
- The polygon mapped as Mature Forest no longer applies to this project as clearing of mature trees occurred on the property between February and July 2022 according to available imagery (Google Earth Pro).

The eastern portions of the project are largely void of vegetation due to previous clearing of mature forest. Vegetation remaining in this area is comprised of shrubs, reed canarygrass (*Phalaris arundinacea*), and pockets of red alder (*alnus rubra*) where soils are moist. The western aspects of the property contain large, grassed areas, shrubs, fruit trees, alder thickets, and intermittent mature trees. Riparian vegetation associated with the roadside ditch, wetland, and northern drainage include reed canary grass, red alder, hardhack (*Spiraea douglasii*), Himalayan blackberry (*Rubus armeniacus*), and slough sedge (*Carex obnupta*). Areas surrounding the project to the north and east are forested and are characterized by a canopy of Douglas-fir (*Pseudotsuga menziesii*), grand fir (*Abies grandis*), western hemlock (*Tsuga heterophylla*), and western redcedar (*Thuja plicata*).

Photo 6. Northwest view of historically cleared areas mapped as mature forest. May 3, 2023.

The 15 m wide area along the eastern boundary of the property is adjacent to agricultural land. As per North Cowichan's regulations, this buffer area must be vegetated. As the area would be developed in the future, we have proposed an interim remediation plan. The interim plan is an application of an aggressive seed mix to remediate the area. We are proposing to use a Premier Quick Grow Reclamation Seed Mix specs are provided in Table 1. Seeding Rate is 112-168 kg per hectare.

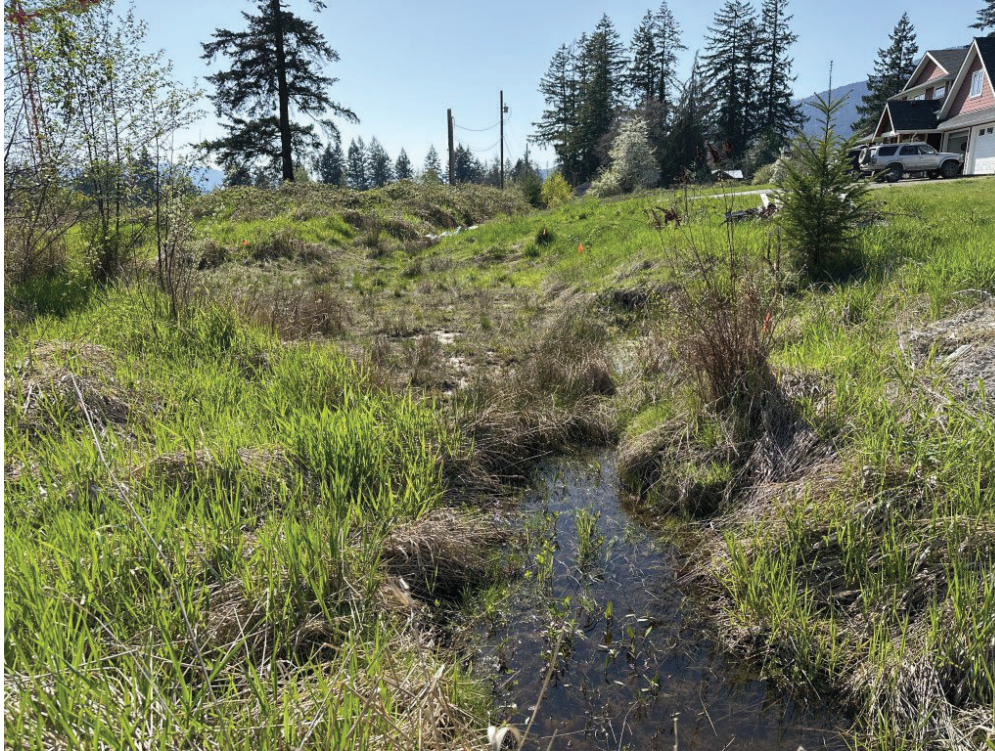
Photo 7. Watercourse leading into onsite wetland, looking southwest. May 3, 2023.

The onsite surface water features will be protected during the proposed soil storage and parking area construction with the implementation of the measures described in Section 6 of this report.

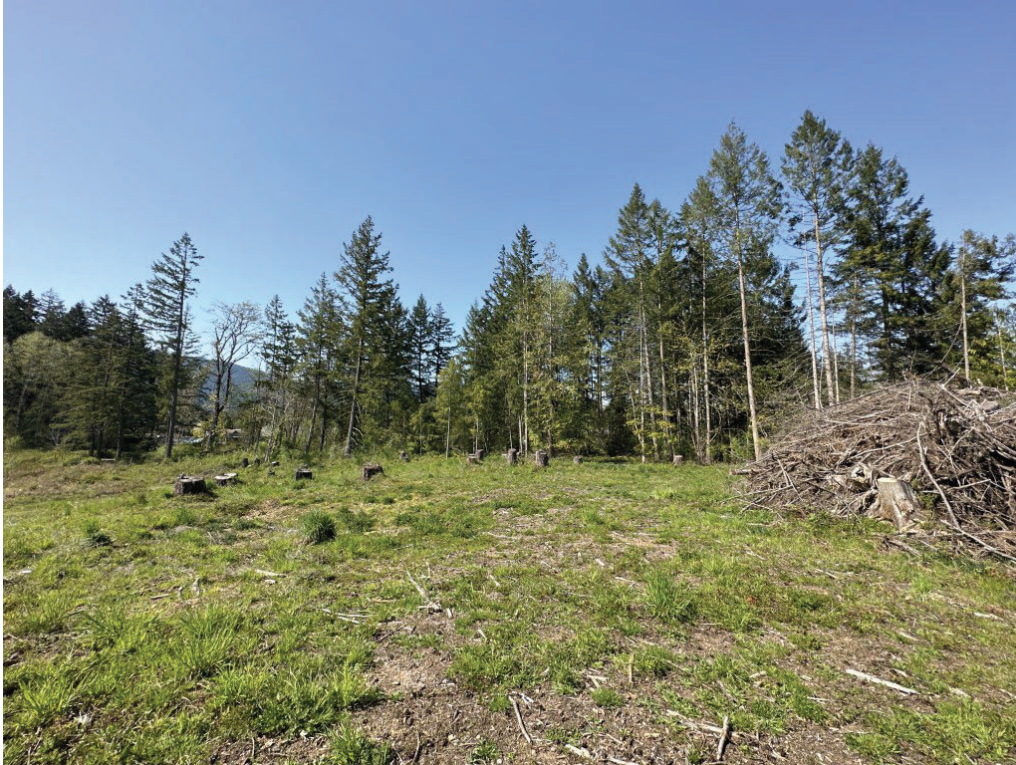
Photo 9. North view of proposed soil storage location. May 3, 2023.

For topsoil storage location, seed immediately after placement with a combination of agronomic species (fall rye, clover, and grasses). and/or seeded with native seed mix (Table 2). Seeding rate is 56-112 kg per hectare.

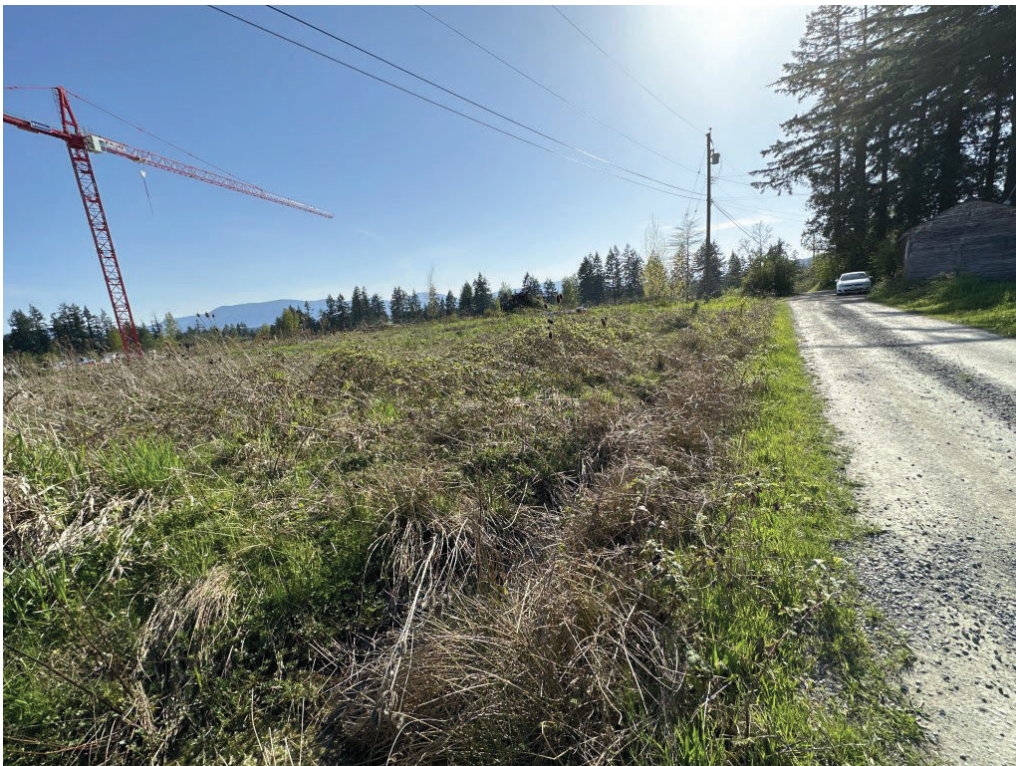
A constructed roadside ditch occurs to the south of the main driveway into the site and discharges to the wetland further east. It is anticipated that these surface water features described above are dry during the summer months when precipitation is reduced or absent. The ditch, watercourse, and wetland are also not expected to be fish-bearing, although detailed sampling has not occurred. These surface water features are not mapped within the BC HabitatWizard database (Province of BC 2023b) or on North Cowichan's OCP Map 4 (Environmentally Sensitive Areas).

Photo 10. Southwest view of roadside drainage ditch. May 3, 2023.
