Prepared By Gina Hoar, R.P.Bio.,  
and Phaedra Douglass, BA.

MUNICIPALITY OF NORTH COWICHAN SERVICE  
AGREEMENT WITH THE SOMENOS MARSH  
WILDLIFE SOCIETY  
ANNUAL REPORT 2023

Prepared for: Municipality of North Cowichan

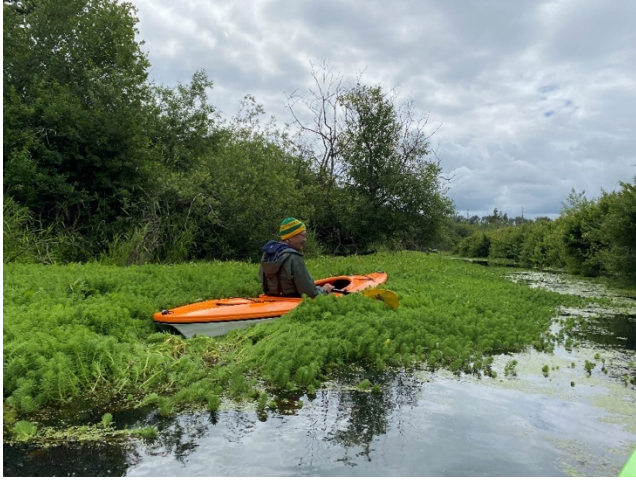
Photo 1: Typical parrot's feather growth in Reach 1 covers most of the channel. June 2023

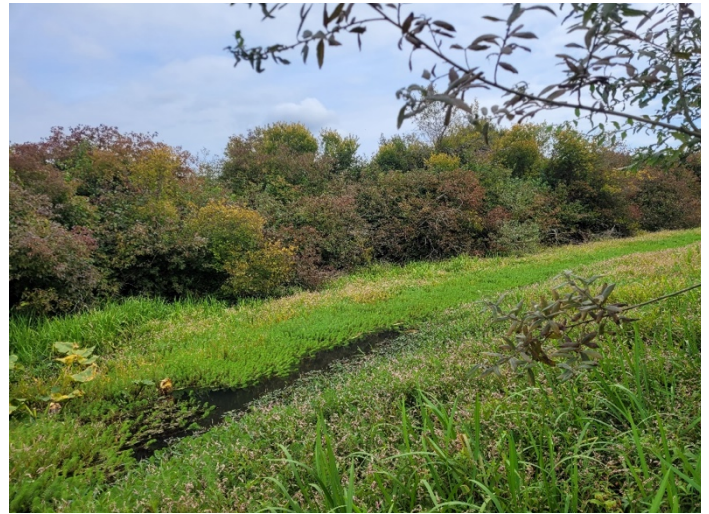
Photo 2: Typical parrot's feather growth in Reach 2 spans entire channel in multiple sections. September 2023

- Reach 2 is adjacent to active farmland on the western shoreline and exposed to full sun. One idea is the sun exposure creates perfect conditions for growth. SMWS's long term plan is to add a treed riparian zone on the west side, to shade parrot's feather and reduce its growth, planting begun in this area this year.
- Reach 3 heavy buildup of parrot's feather is likely to be caused by a slow section downstream of the pipeline crossing. At the end of the green highlighted area in Reach 3, there is a wide, backwater which slows the creek down provides perfect conditions for parrot's feather to grow and creates a 100% covered area.

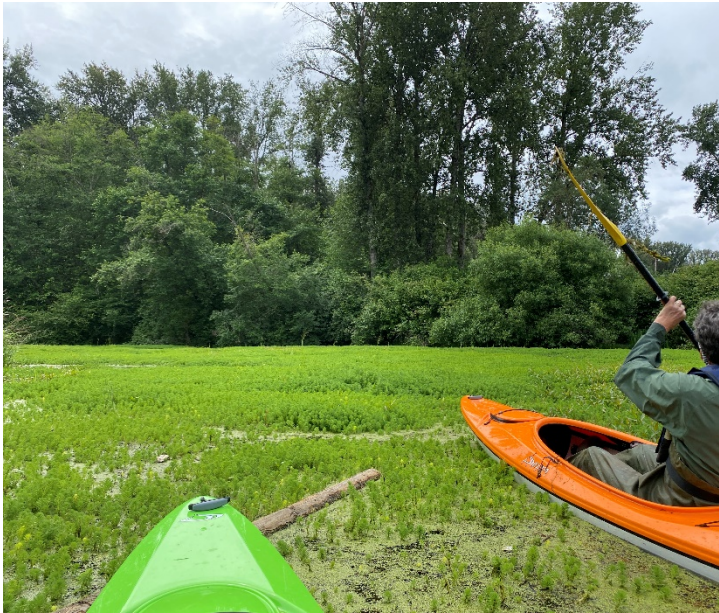
Photo 3: downstream view of typical parrot's feather coverage in Reach 3 that spans the entire channel within Cowichan Tribes land. June 2023

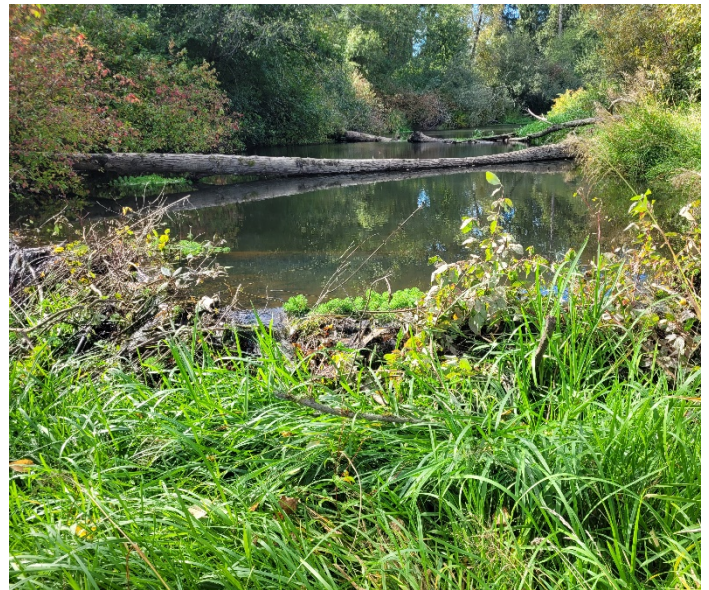
Photo 4: Upstream view from Beaver dam at the end of Reach 3 shows water levels are still low in October, 2023

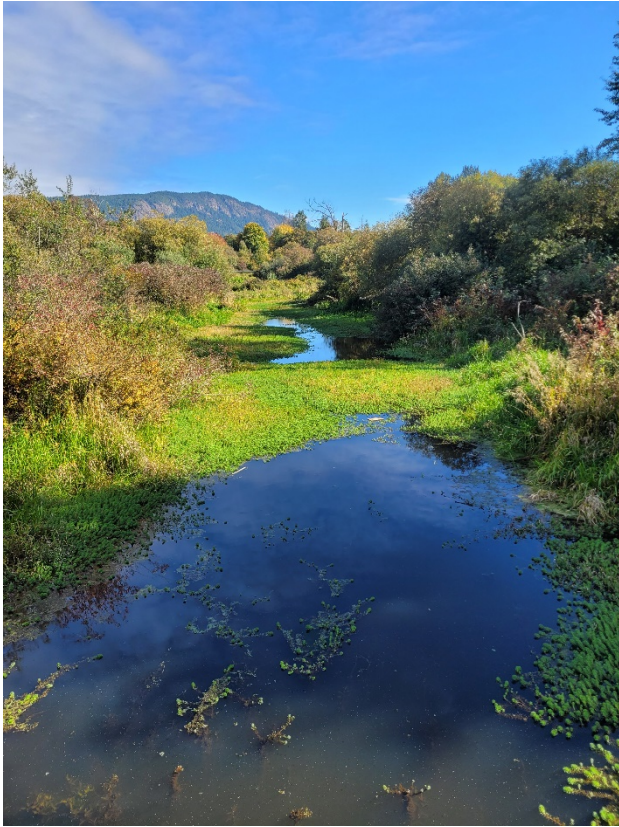
Photo 5: Upstream view from Tzouhalem Bridge, Reach 3, shows growth in June, 2023.

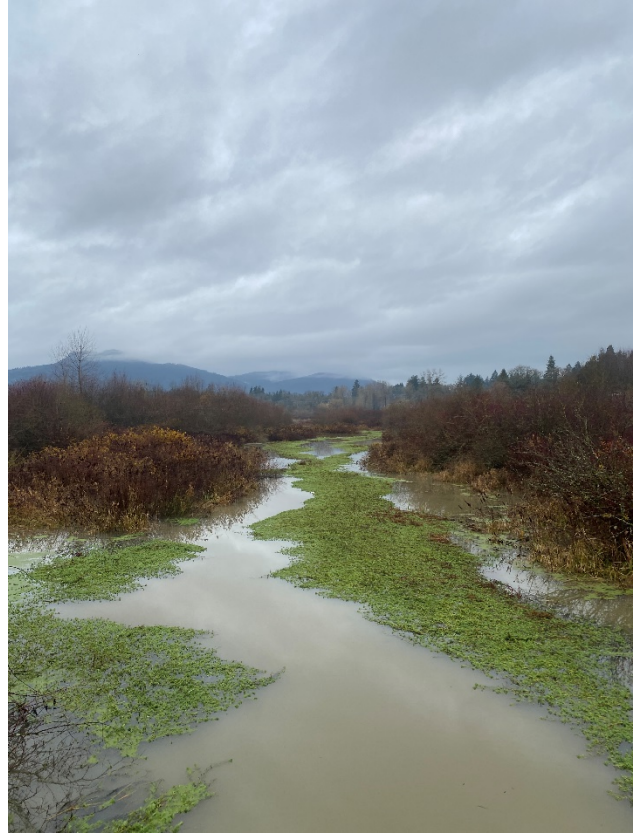
Photo 6: Upstream view from Tzouhalem Bridge, Reach 3, shows dying parrot's feather being pushed downstream in higher flows in December, 2023

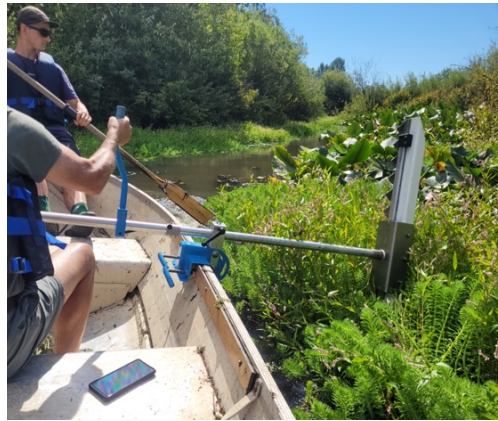
Photo 7: The aquatic mower in action on Somenos Creek.

The aquatic mower was mounted on the right side of the boat onto the reinforced gunwale (photo 7) which meant that the NE side of the Creek was cut while moving upstream and the SW side while moving downstream. Originally the proposal was to limit the cutting to the leading edge of the *M. aquaticum*; however, as the PFC did not begin until late June, there were sections where larger clumps had to be cut off in order to create and maintain a channel.

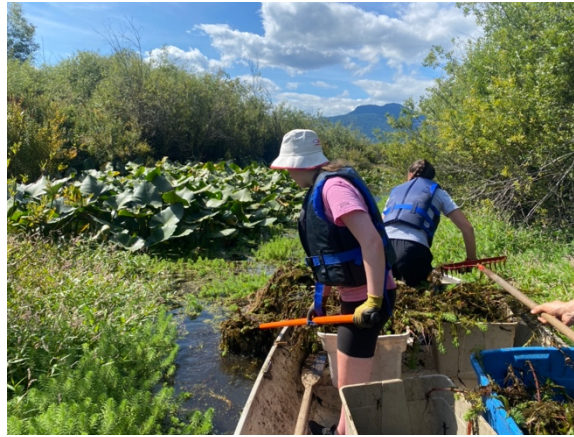
Photo 8: Parrot's feather collection in Somenos Creek.

The team would work their way upstream in the boat, stopping to collect the cut *M. aquaticum* which floated freely in the Creek. It was collected in the boat in 5 large totes, (photo 8) which, once full of *M. aquaticum* would then be hauled out of the creek and dumped out on the greenway to dry. Most of the *M. aquaticum* was spread out about 20cm thick while some was left in a pile to determine which method was most effective at killing the plant over the summer and winter months.

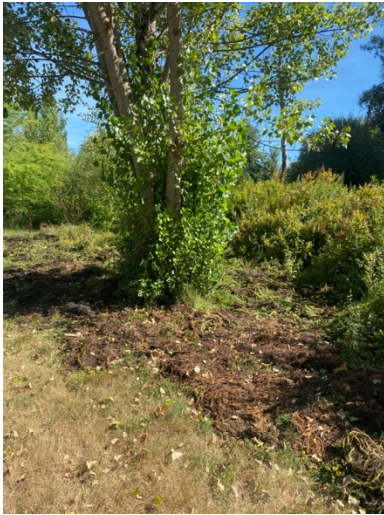
Photo 9: Parrot's feather pile at the end of August, 2023.

The Society removed, in total, 15.191m<sup>3</sup> of *M. aquaticum* from Somenos Creek over the duration of the PFC, as measured by 194 mid-sized storage totes. This material was dumped and spread out on the park greenway near the boat launch site (Photo 9), and some was piled in another area to compare results. The *M. aquaticum* dried well over 2 months in the summer heat having a crispy consistency that fell apart when crushed; however, it was observed that some of the *M. aquaticum* began sprouting as soon as the wet season began in September (Photo 10). It is surmised that even though the layer of *M. aquaticum* was laid out to dry in a thin layer of 20cm, not all of it dried and would have needed more time to fully desiccate. Half of the *M. aquaticum* that was laid out to dry was turned over in September to discern if flipping it may make any difference in the drying process, no discernable difference was observed and *M. aquaticum* continued to produce new growth after being flipped. After observing the *M. aquaticum* piles until December, it was noted that most of the plant had turned black/brown and appeared to be dead, with only one observable still green plant (Photo 11). The society found that both the spread-out *M. aquaticum* and the pile had significantly decomposed by mid-December, which demonstrates that both methods were effective at killing the plant. The *M. aquaticum* will continue to be observed through the winter.

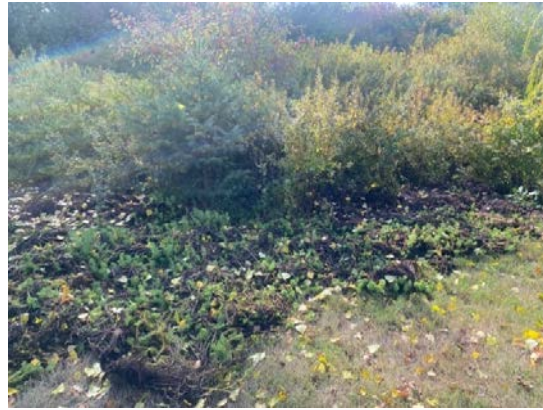
Photo 10: Parrot's feather pile, on September 29<sup>th</sup> 2023.

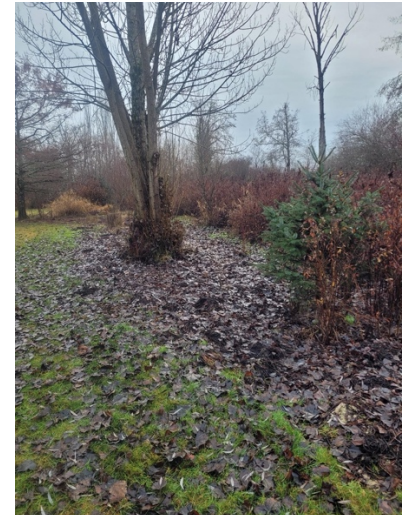
Photo 11: Parrot's feather pile December 18<sup>th</sup> 2023.

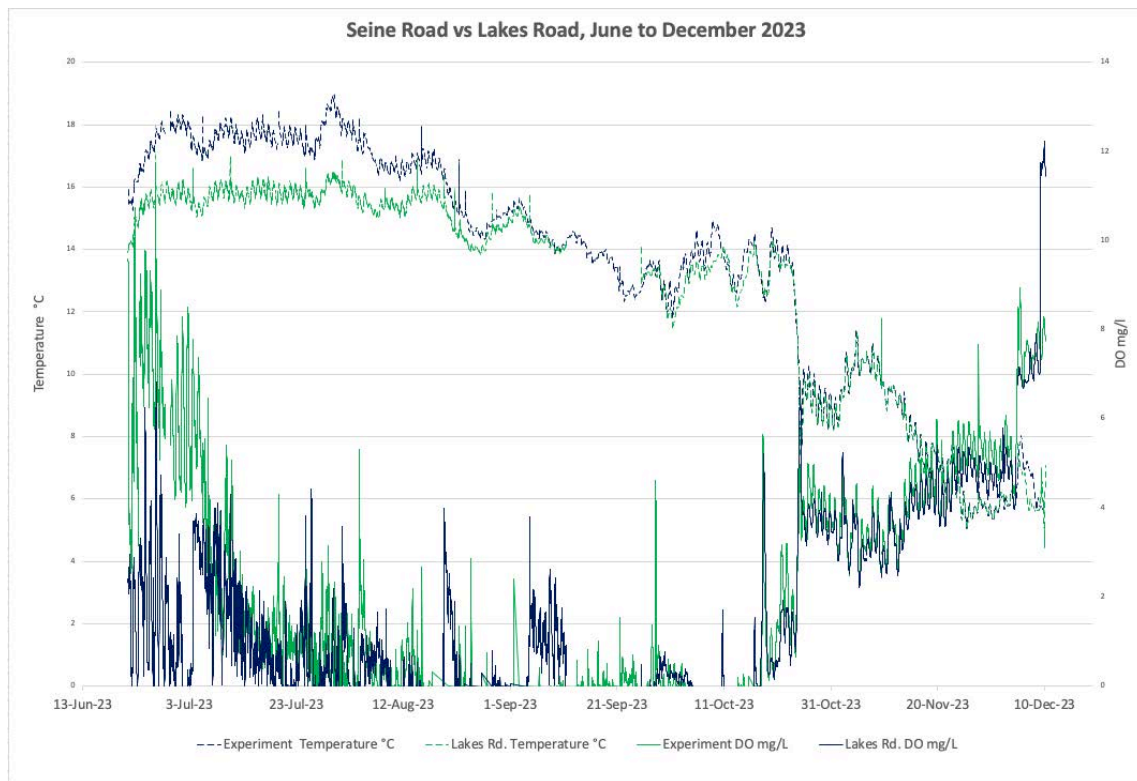
**CHART 2: PROJECT VS CONTROL DISSOLVED OXYGEN AND TEMPERATURE FROM BEGINNING OF PROJECT TILL MID-DECEMBER.**

Due to the uncertainty of the water quality results and the limitations of the first phase of the PFC, the Society concludes that the PFC, at this scale, had no observable effect on the water quality in Somenos Creek. Detailed water quality data is available at Somenos Marsh Wildlife Society upon request.

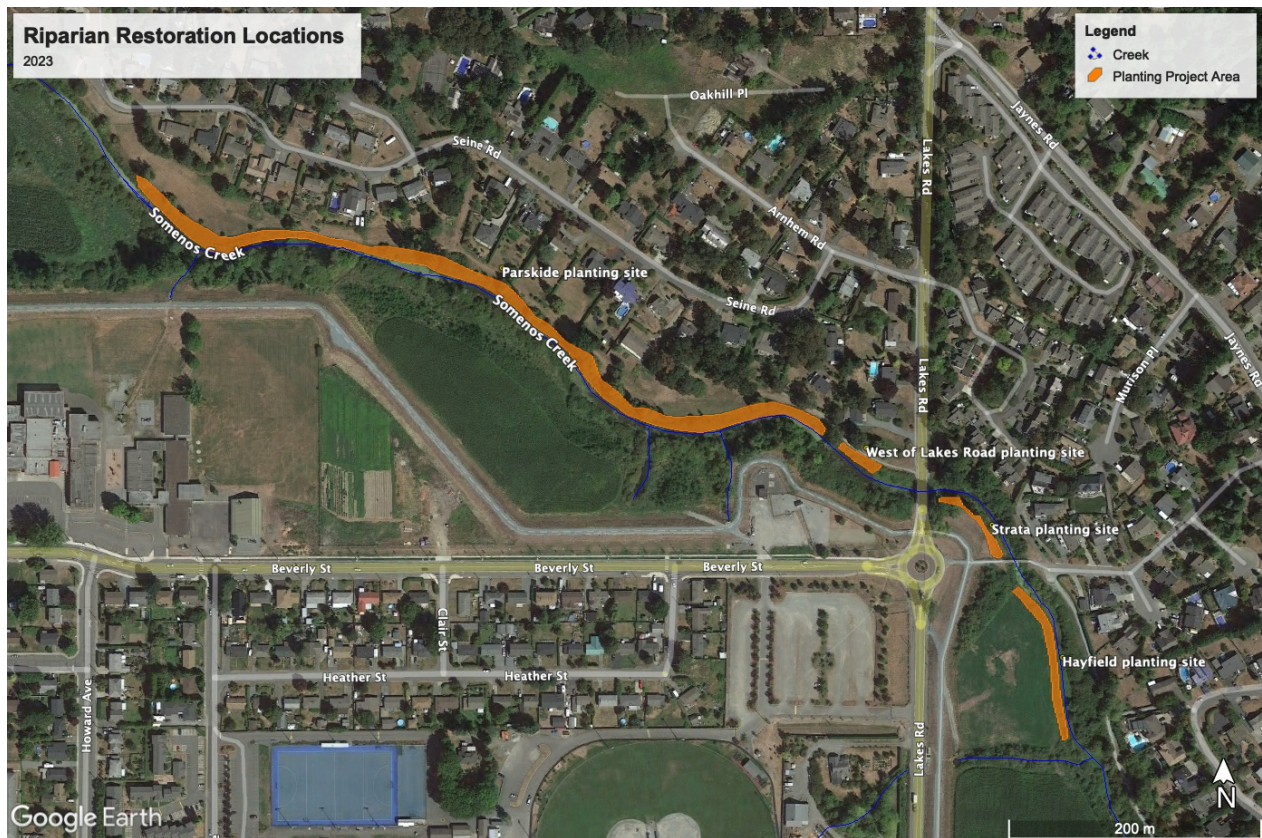
**FIGURE 5: MAP OF FOUR LOCATIONS WHERE RIPARIAN PLANTING WAS DONE IN 2023.**

Four locations were chosen and maintained in 2023 to provide riparian shading (Figure 5). They include:

1. The hayfield south of the Lakes Road footbridge (hayfield).
2. The open section on the north side of Somenos Creek, just west of Lakes Road (west of Lakes Road)
3. The southwest side of the Haycroft Chase Strata Property and MNC Right of Way (strata)
4. The north side of Somenos Creek along the municipal park between Lakes Road and Seine Road (parkside).

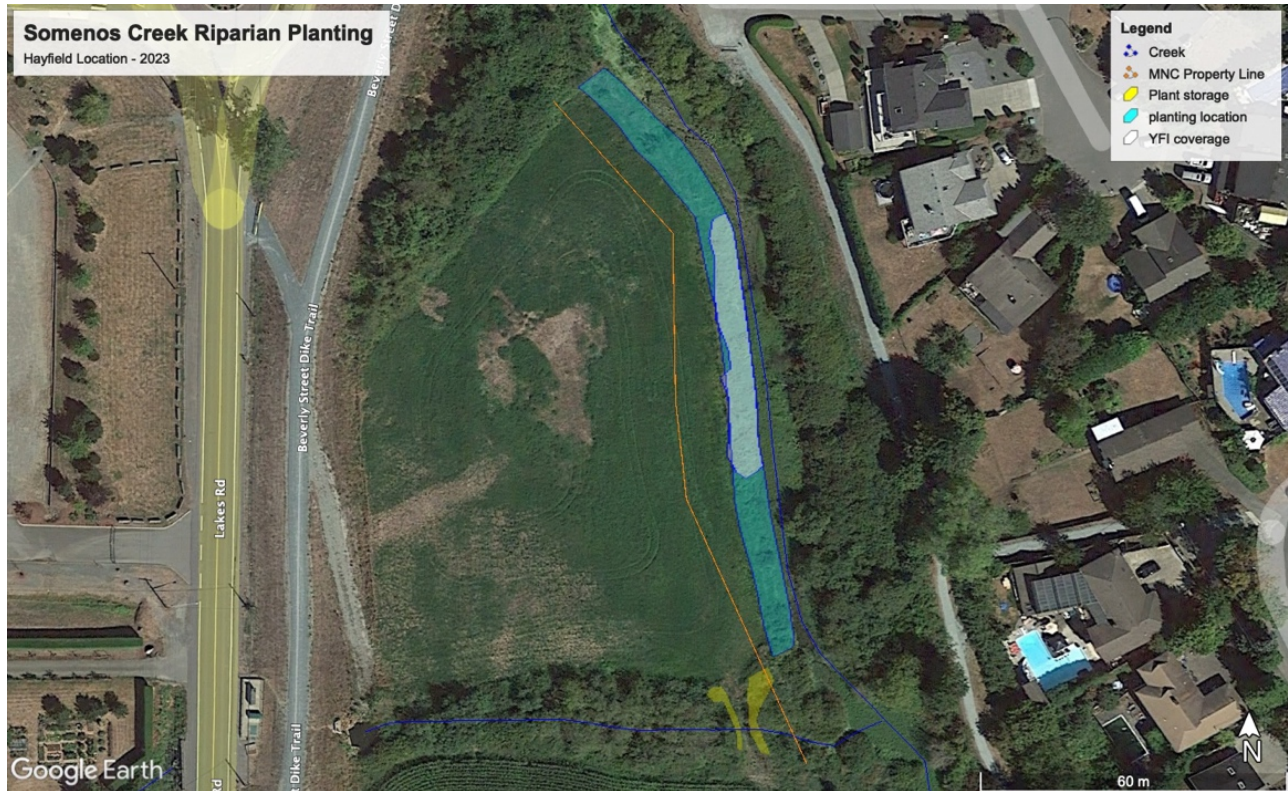
**FIGURE 6: MAP OF HAYFIELD PLANTING LOCATION WITH MNC PROPERTY LINE AND PLANT STORAGE AREA.**

In April three site visits with SMWS, MNC and the Farmer (Aaron Van Boven) were completed to confirm the MNC right of way and the planting area, the area agreed upon is shown in Figure 6 below. Based on the meetings with the MNC, Aaron Van Boven and additional correspondence with Greg Howard (Madrone), the planting plan was updated to consider the change in area.

Site prep began the first week of May 2023 and planting commenced on May 4<sup>th</sup>, large posts delineating the planting area were installed and planting began on the southern section of the Hayfield. Yellow flag iris (*Iris pseudacorus*) was present on site, see figure 6, and some removal was done, however, this proved futile due to the amount that was present, reed canary grass (*Phalaris canariensis*) was also present on site, particularly in the northern section, this was mowed down to allow for easier access. Plants were planted one plant per square meter which follows the riparian restoration rule of thumb (DNV, date unknown), and suggestions from Greg Howard, where vegetation was already established, new plants were planted one meter away. Based on suggestions in the Madrone report and requests from the Farmer, a planting zone system was established: shorter, drought resistant shrubs and trees were planted closest to the hayfield (zone 1), tall trees were planted in the middle (zone 2) and shorter wetland plants were planted along the bank (zone 3), see figure 7.

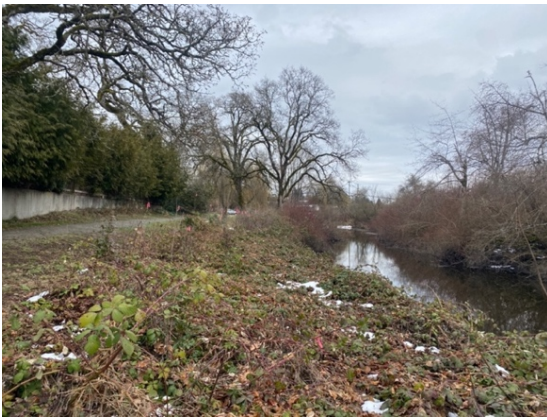
Photo 14: Image of planting area looking east, before invasive removal.

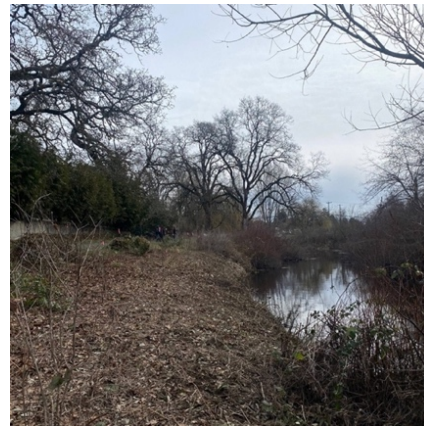
Photo 15: Image of planting area looking east, after invasive removal.

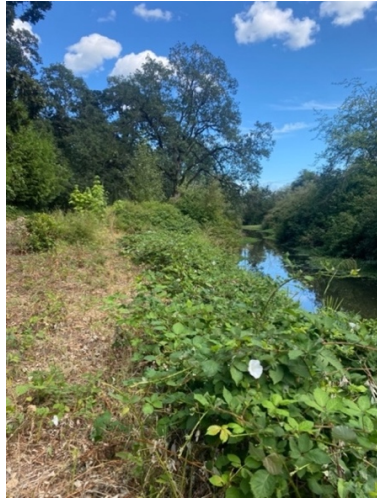
Photo 16: Image of planting area, looking east before summer invasive removal and planting.

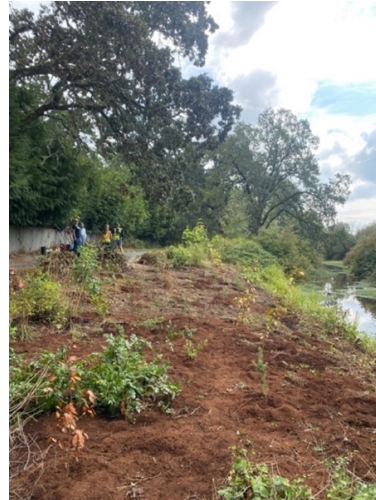
Photo 17: Image of planting area, looking east after summer invasive removal, planting and mulch spreading.

- 374m<sup>2</sup> invasives were removed.
- 89.75 volunteer hours.
- 64 native plants planted.
- 274m<sup>2</sup> restored.

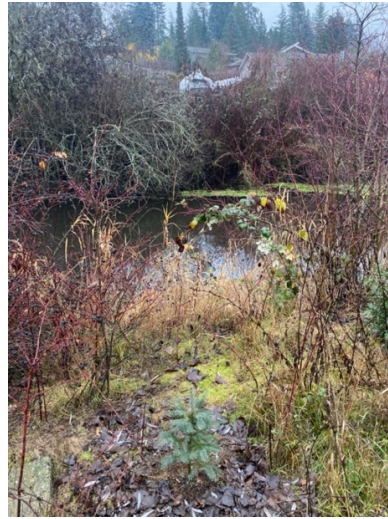
Photo 19: Image of sitka spruce near the edge of Somenos Creek at the strata.

Monitoring of the site in the spring and summer of 2023 indicated that survivability rates were low, most of the willows and red alders planted in the drier, more rocky section of the bank did not survive, however, hardhack, sitka spruce and red osier dogwood were still growing well, it was also noted that the Himalayan blackberries had encroached once again into the planting area. After consulting the MNC, on August 7<sup>th</sup>, 39 plants left over from the hayfield planting were used to replace the dead willows and red alders, (see Appendix G, Table 5). Additionally, on November 30<sup>th</sup> invasive removal was completed, 30m<sup>2</sup> Himalayan blackberries were removed and 10 plants purchased from Streamside were planted to fill in a few gaps. Planting methods followed those used at the hayfield, described in Section 6.3.2, and watering of the site occurred through the dry season, one to three times a week depending on the weather.

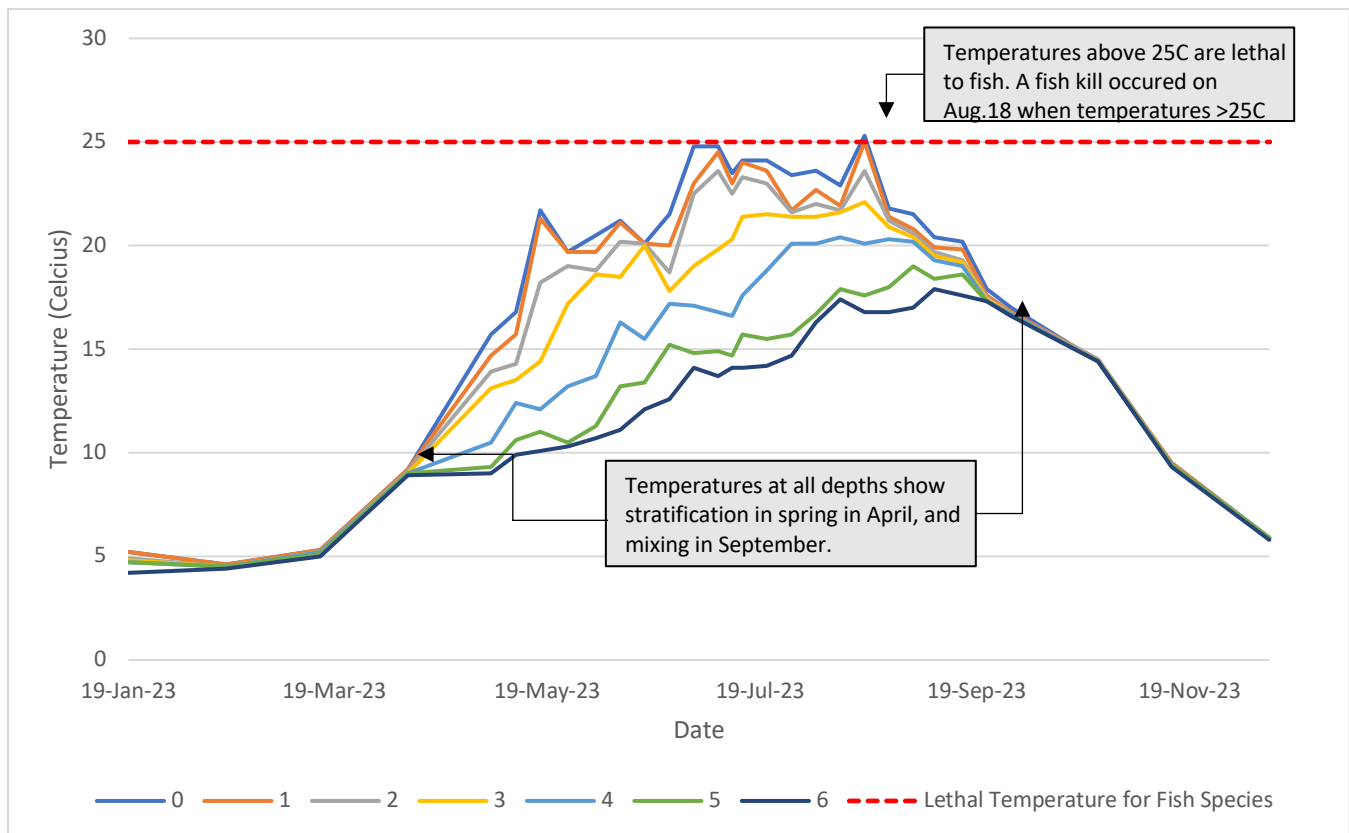
**Chart 1 Somenos Lake Temperature Profile from the surface to 6 m depth, 2023.**

Dissolved oxygen and temperatures indicated that stratification occurred in early April and turned over by late September (Chart 1 and 2). Interestingly, in late September when mixing occurred, dissolved oxygen dropped dramatically throughout the lake. This likely occurred when the anoxic conditions at the bottom of the lake mixed with the top layers, and created low oxygen environment throughout. This low oxygen event didn't last long and by October the lake oxygen levels normalized as fall rains and cool temperatures began.

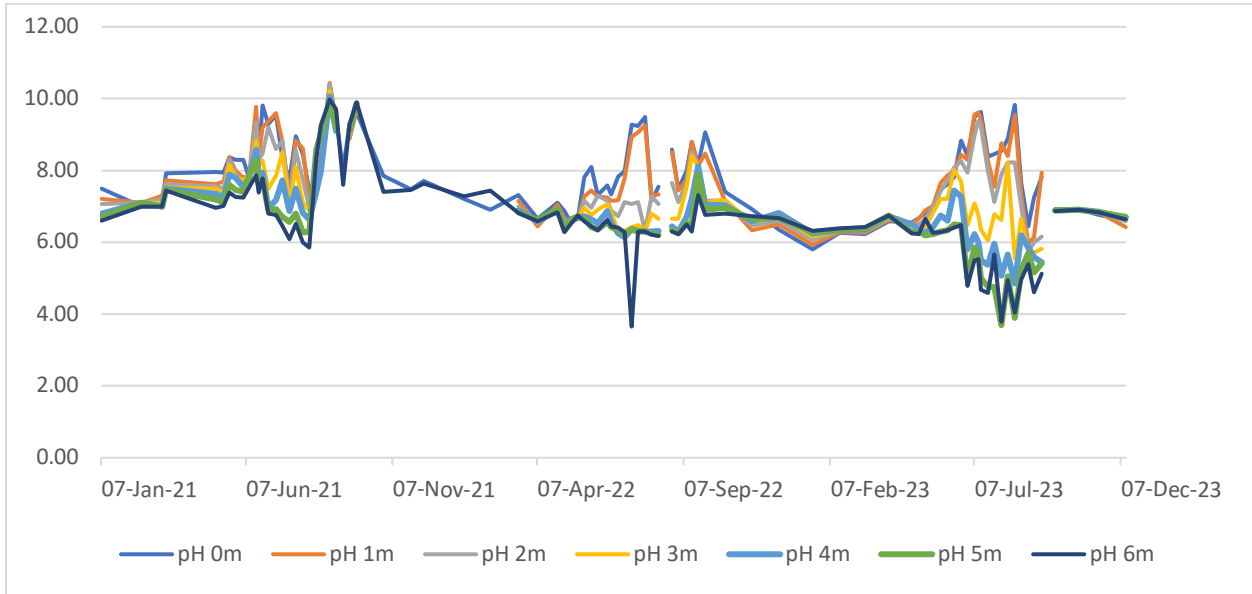
**Chart 9: Somenos Lake pH YSI Profile Levels, 2021-2023**

Similar pH results are observed in 2021 to 2023 showing an increase in acidification at the deepest depths, and high alkalinity at the surface in summer (Chart 9).

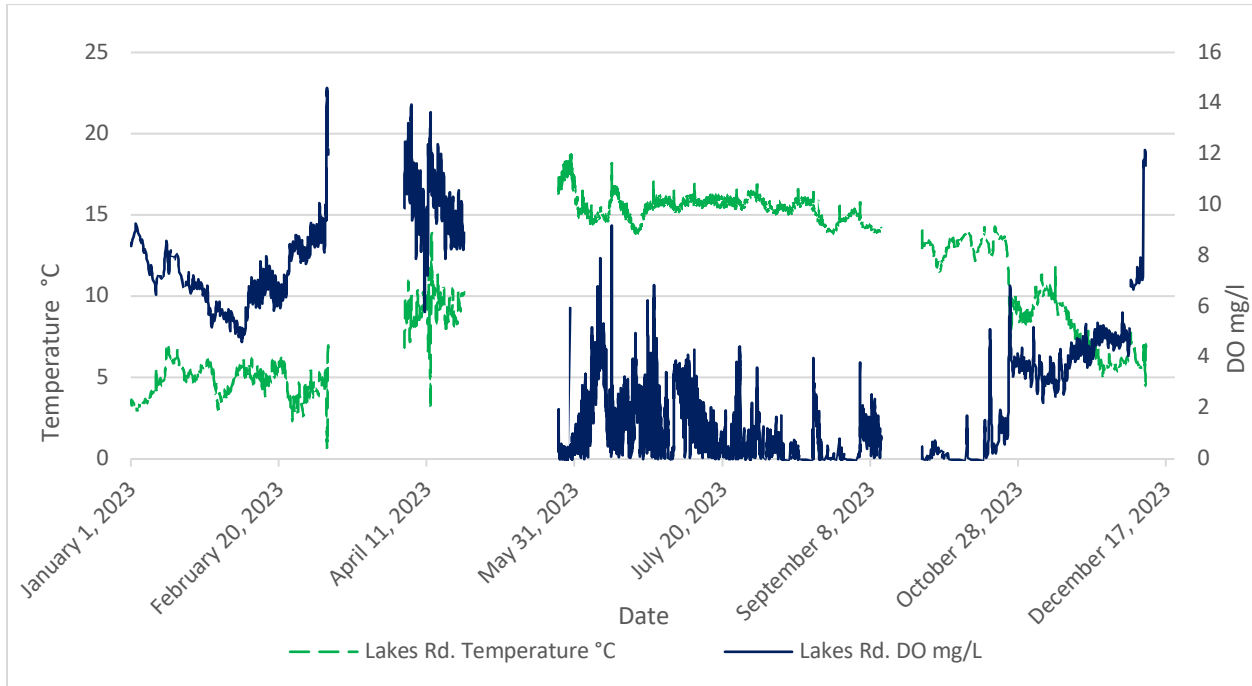
**Chart 21: Somenos Creek Annual Temperature and Dissolved Oxygen Data Logger, 2023**
