1935 Maple Bay Road Unnamed Tributaries to Quamichan Lake

Riparian Areas Protection Regulation Assessment Report

December 15, 2022

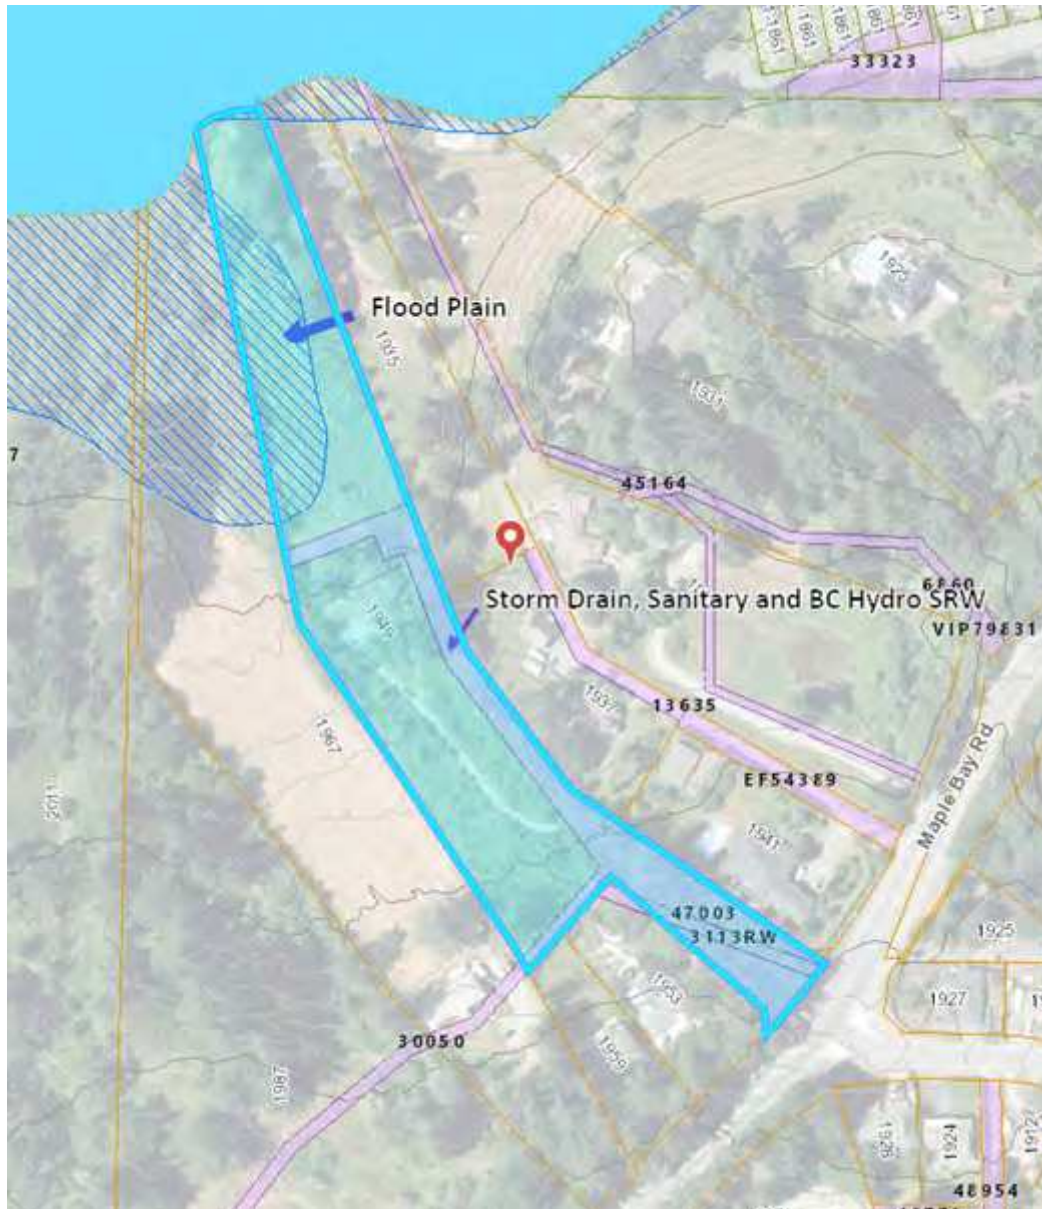
Figure 6. Municipal map of area showing the SRW (shaded blue) within which are contained the municipal storm drain, sanitary sewer, and BC Hydro power pole alignment. The floodplain limit for Quamichan Lake is also shown. 1935 Maple Bay Rd is marked with a red dot on the south property line. Map from Municipality of North Cowichan files.

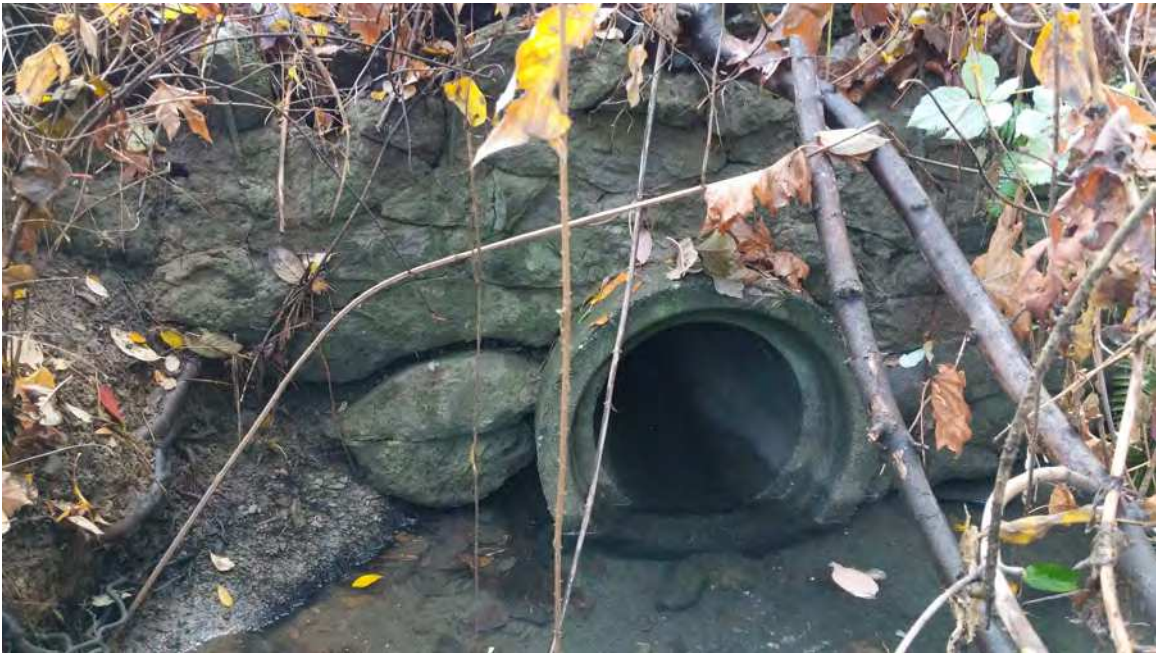
Figure 27. The outlet of the culvert under Maple Bay Road and its shallow plunge pool; the shallow plunge pool indicates there are typically insufficient stormwater volumes to scour a deep plunge pool at the outlet.

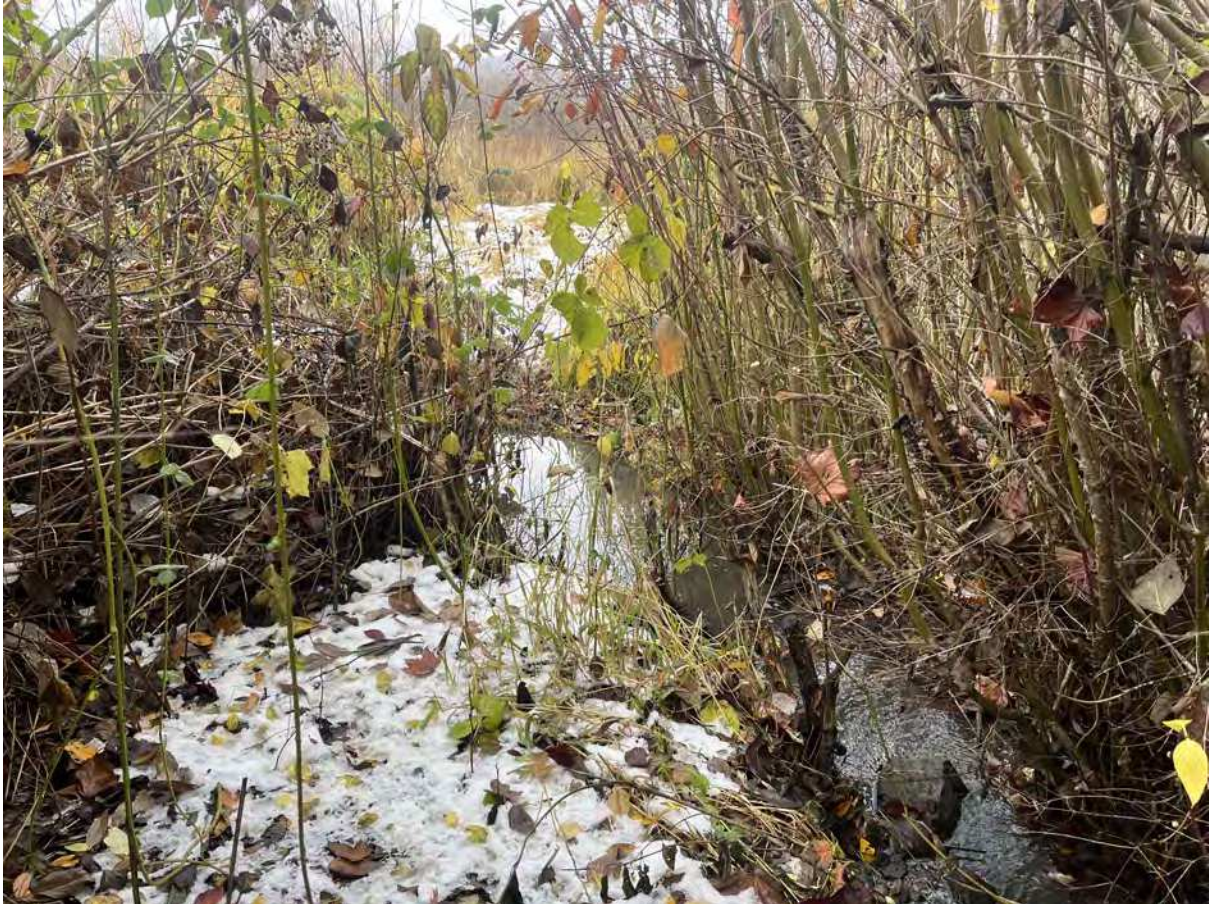
Figure 28. Looking downslope at the discharge end of the drainage ditch (Ditch 1) as it discharges into Wetland 1. This section of the channel has a wider channel width than the channel upslope of this section, with the banks being stabilized by a mixed agronomic grass and shrub plant community. The reed canarygrass field can be seen in the background.

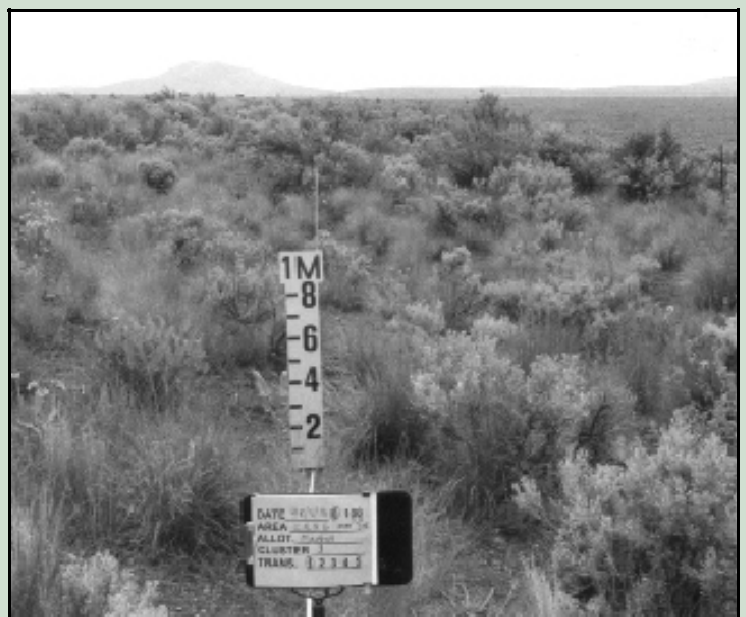
Figure 3—Photo point monitoring site showing a photo identification card and a meter board. (Adapted from Hall 2002.)

For topic photography, it may be desirable to place a meter board or other size control object at the photo point or near the subject of interest. A meter board provides a consistent point for camera orientation, a point on which to focus the camera, and a size reference that can be used to quantify change. Directions for constructing a meter board are provided in *A Weed Manager's Guide to Remote Sensing and GIS*. Meter boards are typically not used in general photography of scenes.
