Development Permit with Variance

Permit No:	DP000302	
Applicant:	Total Concept Developments Ltd.	
Registered Owners:	Somenos Views Residences Inc., Somenos Views Holdings 2 Inc. and Somenos Views Holdings 3 Inc.	
Subject Property:	2591 Beverly Street	Folio: 01242-003
Description of Lands:		
Parcel Identifier	030-594-715	
Legal Description	Lot 3, Section 19, Range 6, Quamichan District, Plan EPP85394	
Proposal:	Development Permit with Variance (DPA-1, DPA-2, DPA-3, DPA-4, DPA-6) for the construction of a Mixed-Use Building with Ground Floor Commercial Use and 210 Residential Apartment Units

RESIDENCES
2591 BEVERLY STREET, DUNCAN
(BUILDING B)
SITE LIGHTING

TECHNICAL MEMORANDUM

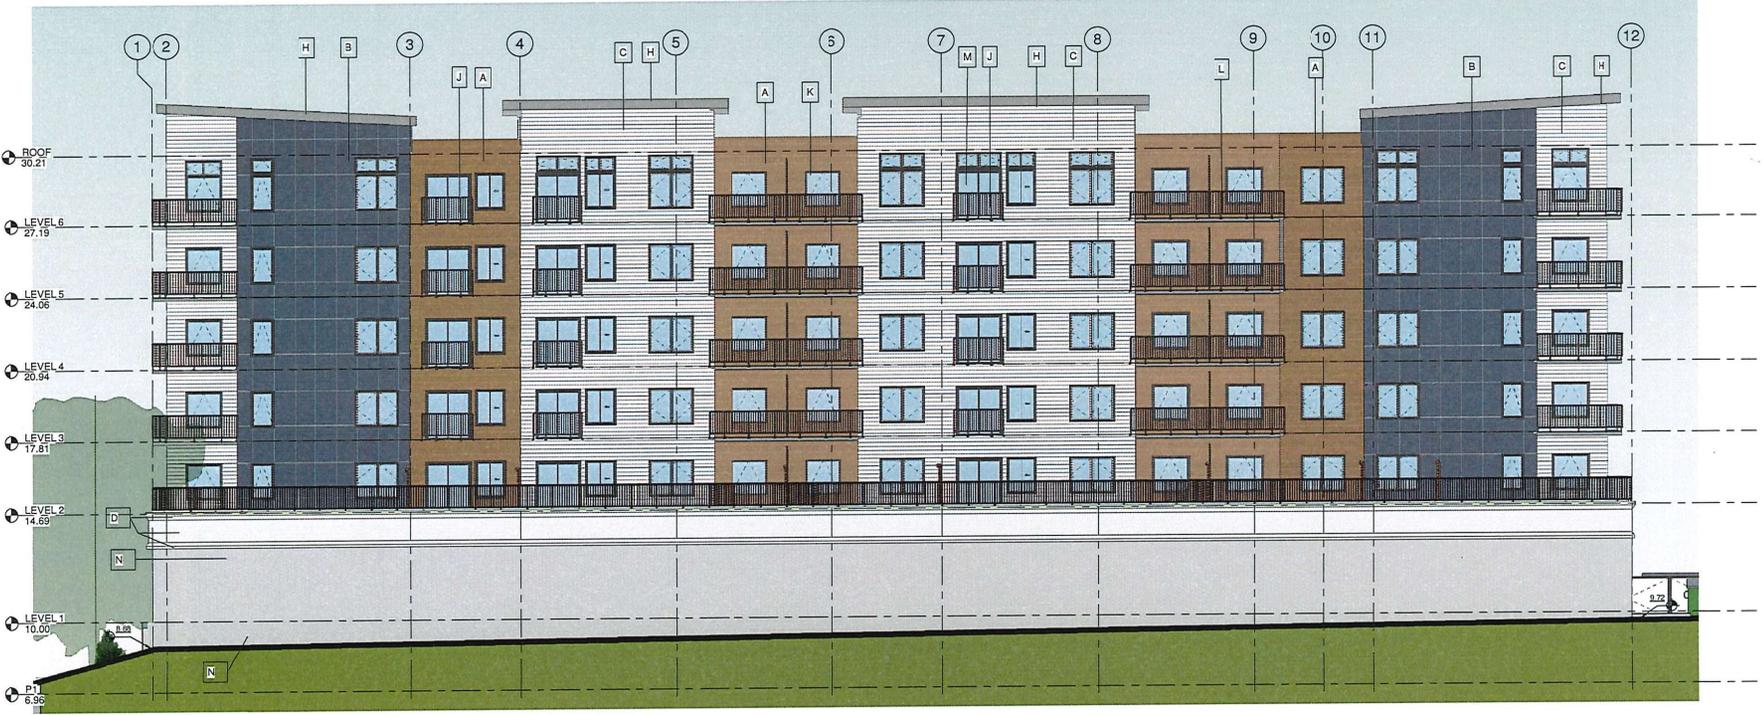
NORTH ELEVATION

KEYNOTES:	
A	Hardie Lap Sliding - Wood tone Cedar
B	Hardie Panels - Deep Ocean w/ Black Easy Trim
C	Hardie Lap Sliding - Arctic White
D	Stucco Grey
E	Cedar Wooden Pergola
F	Veneer Stone Tile
H	Cap Flashing - Iron Gray or Artic White
I	Anodized Aluminum Handrail - Black
J	42" High Anodized Aluminum Picket Railing - Black
K	72" Anodized Aluminum Privacy Panel with Frosted Glass
L	Glulam Beam
M	Sliding Door - Black
N	Exposed Concrete - Sealed
O	72" High Wood Fence

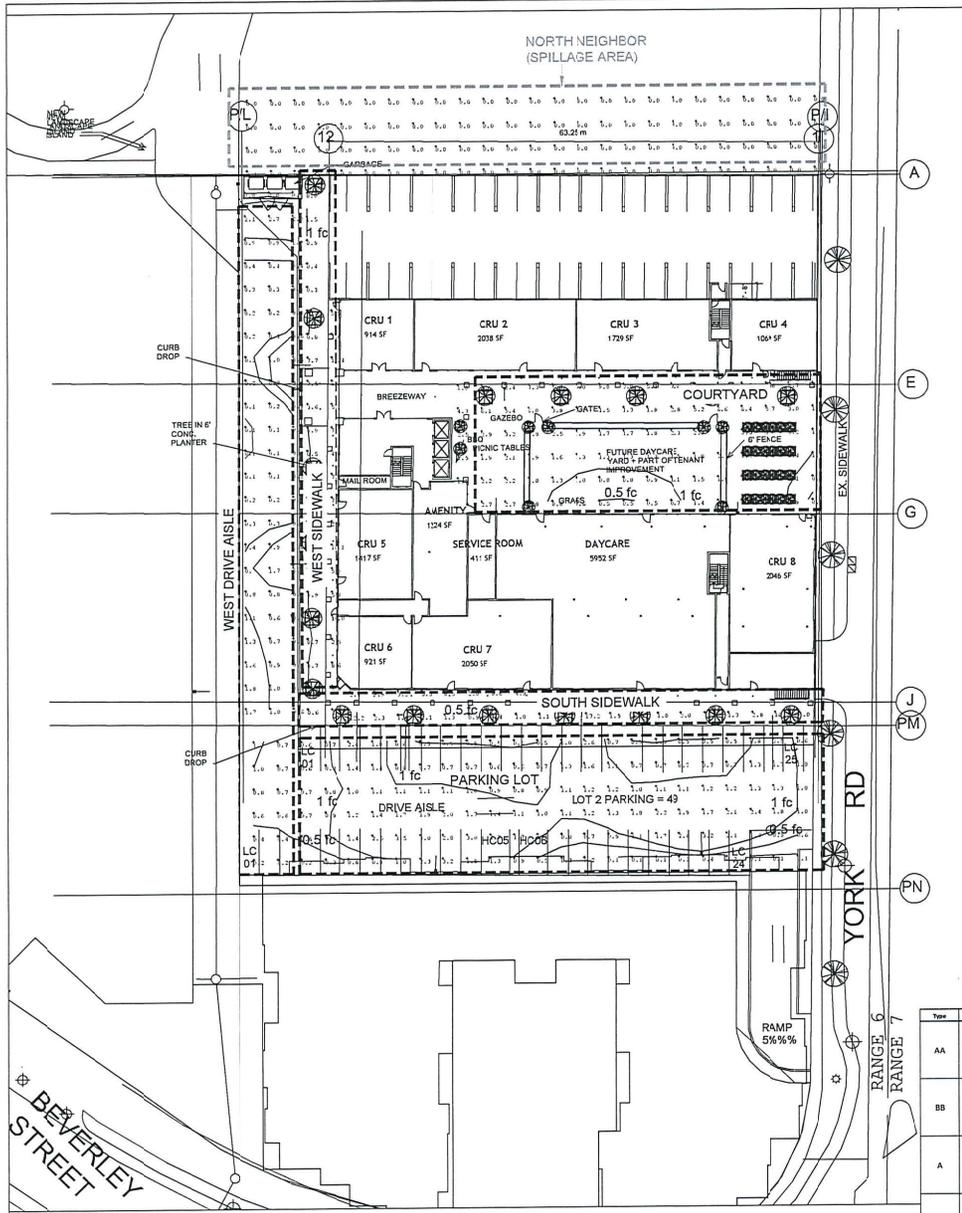
1 SITE PHOTOMETRICS
SCALE: NTS

Location	Average	Max
Parking Lot	1.3	-
West Sidewalk	4	-
South Sidewalk	4.3	-
West Drive Aisle	0.8	-
Courtyard	2.7	-
North Neighbour	0	-

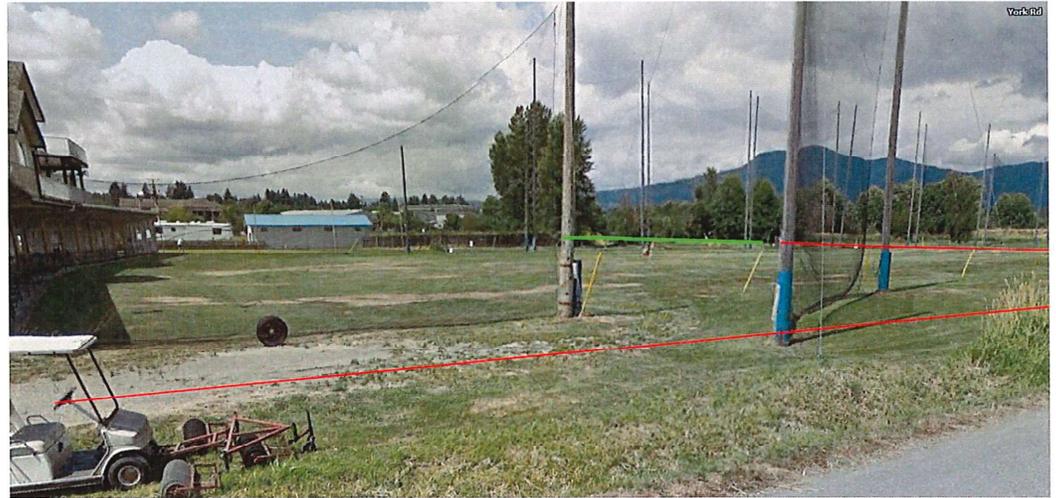
Figure 0.1:View from York Road looking west.

Adjacent properties records indicate upgrades to York Road, along the east side of the subject property, were designed by Cowichan Engineering Services Ltd. The upgrades generally consist of a paved 7.5m driving surface, with a cul-de-sac at the north end, a 2m sidewalk and barrier type curb along the west side of York Road, and a realigned ditch and new CMP culverts along the east side. All surface runoff from York Road is conveyed via an overland flow path to the new ditch at the northeast end of York Road. The surface runoff from York Road is not anticipated to impact the subject property.

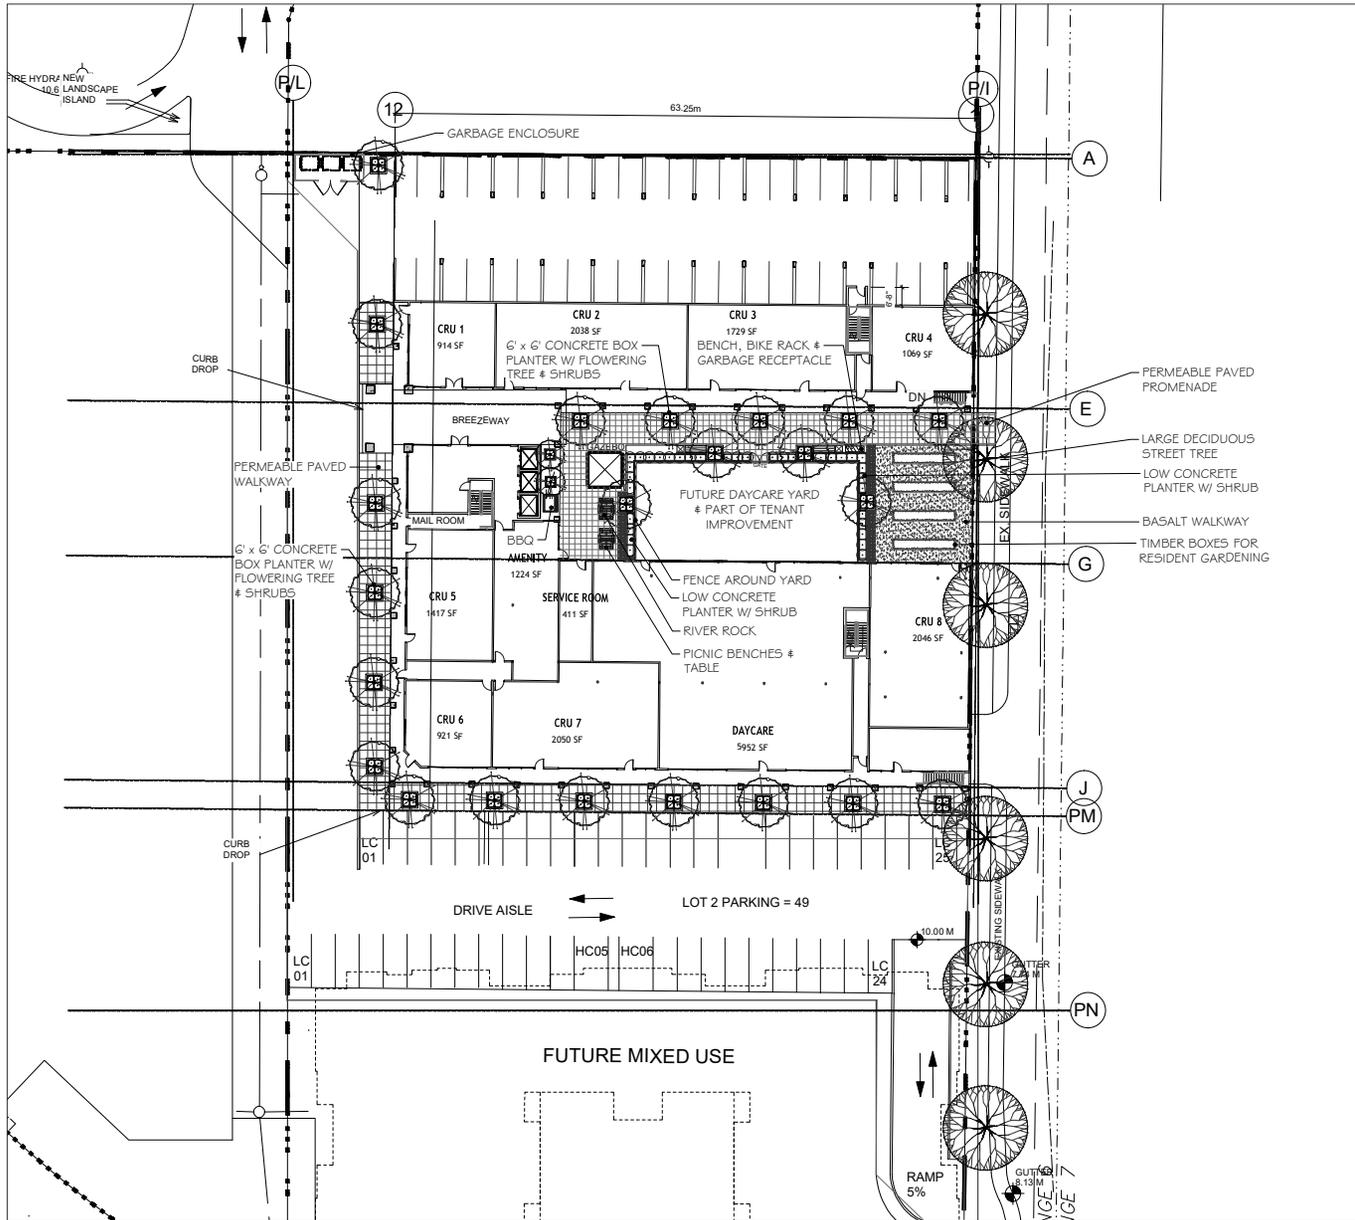
SUGGESTED PLANT LIST

Key	Common Name	Latin Name	Size
Trees	VMAP	Vine Maple	Acer circinatum	6cm Cal.
	JMAP	Japanese Maple	Acer palmatum var. 'Bloodgood'	6cm Cal.
	GINK	Maidenhair Tree	Ginkgo biloba var. 'Princeton Sentry'	7cm Cal.
	FAGU	Columnar Purple Beech	Fagus sylvatica var. 'Dawick's Purple'	6cm Cal.
Medium Shrubs	BCX	Bowwood	Buxus sempervirens var. 'Wintergreen'	#5 Pot
Small Shrubs	AZAW	Evergreen Azalea	Azalea var. 'Gumpo White'	#2 Pot
	EUOP	Creeeping Euonymus	Euonymus fortunei var. 'Emerald Gaiety'	#1 Pot
	DWPL	Dwarf Lily of the Valley Shrub	Lilium japonicum var. 'Debutante'	#1 Pot
Ground Covers	BEAR	Bearberry	Arctostaphylos uva-ursi var. 'Vancouver Jewel'	SP4
	BERG	Heartleaf Bergenia	Bergenia cordifolia var. 'Blossingham Ruby'	SP5
	CCTO	Creeeping Cotoneaster	Cotoneaster dameri	SP4
Vines	ARVI	Evergreen Clematis	Clematis amandii	#5 Pot
Perennials & Grasses	SOZ	Saffir Lily	Scilla sibirica var. 'Oregon Sunset'	SP5
	HEJC	Coral Bells	Heuchera var. 'Palace Purple'	SP5

Notes: - All landscape work to conform with B.C.S.L.A. / B.C.N.T.A. standard specification.
- All areas to be irrigated with an automatic underground system.

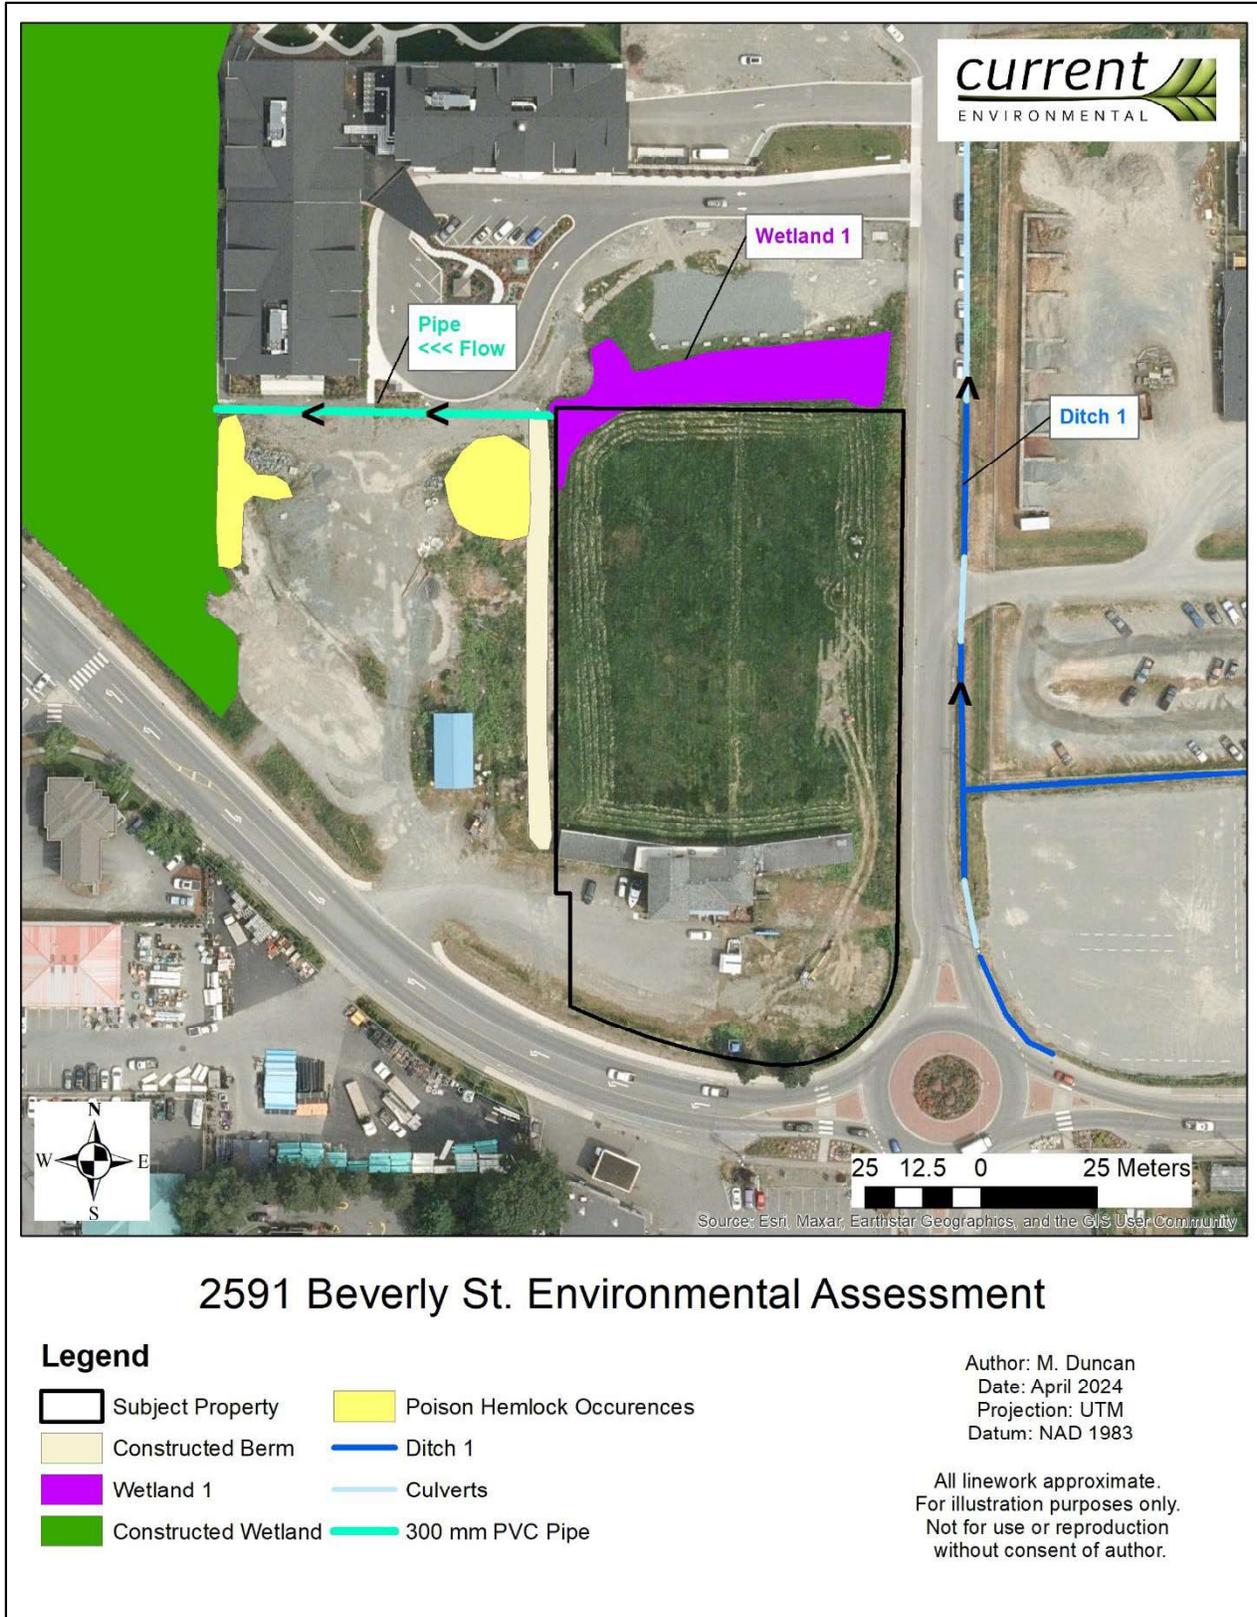
Figure 3. Identified ESAs on and near the subject property at Lot 3, 2591 Beverly St. (black outline).

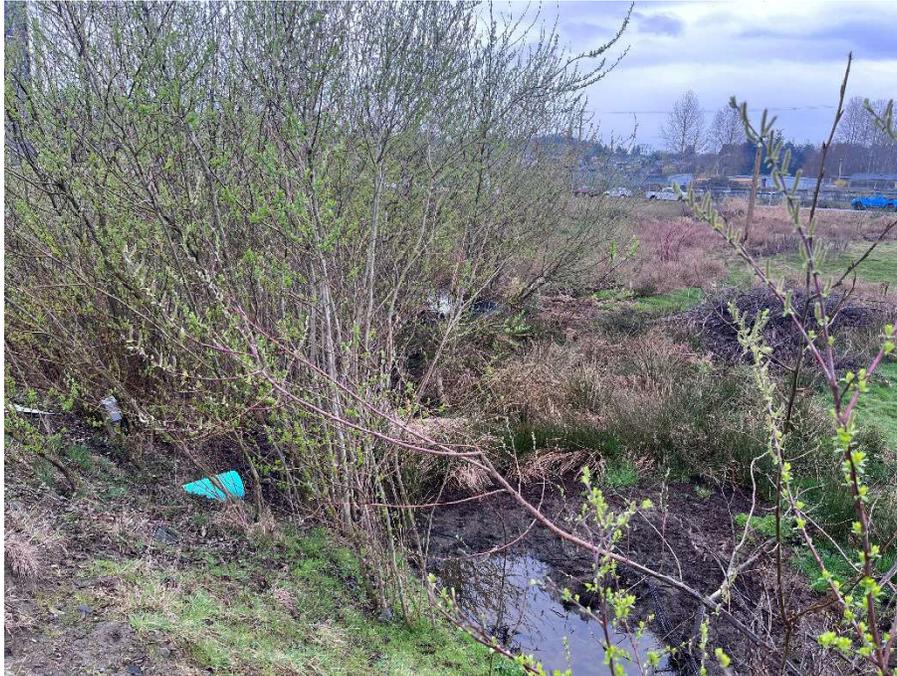
Photo 1. View looking east from the adjacent berm of Wetland 1 and the 300 mm PVC pipe on the subject property that connects to the constructed wetlands to the west.

Along the northern property boundary, a wetland (Wetland 1) was observed on 5950 York Road with a small intersection into the northwest corner of Lot 3, 2591 Beverly St. It is believed that Wetland 1 receives inputs from runoff of the neighbouring property to the north and the shallow water table onsite. Wetland 1 is approximately the length of the northern property boundary and drains into a 300 mm PVC pipe located in the northwest corner of the property (Photo 1). Flow remains piped underneath the adjacent property to the west and outlets into the Municipality of North Cowichan constructed wetlands approximately 75 m from the subject property (Photo 2).

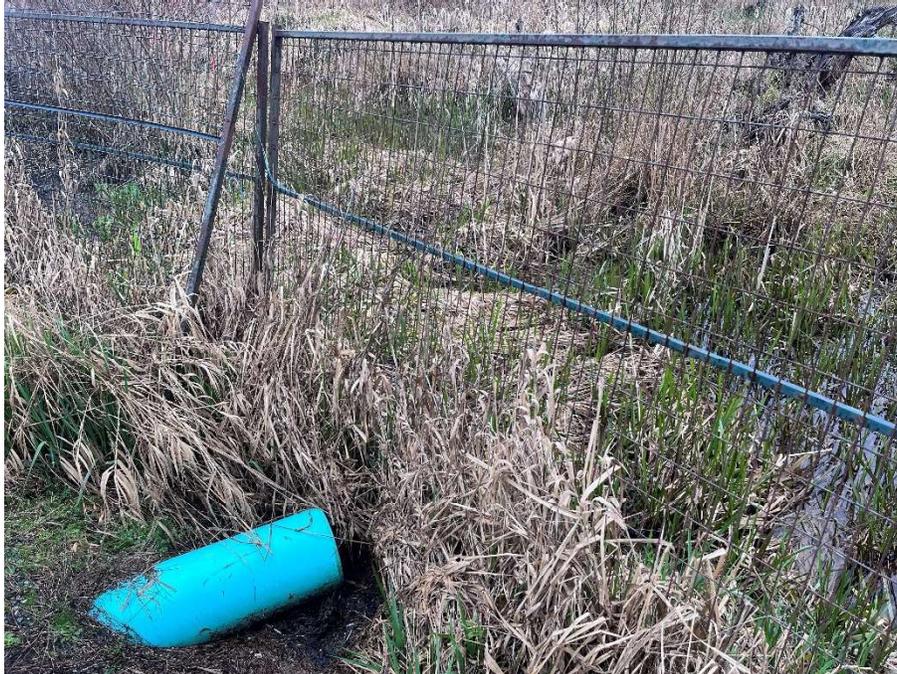
Photo 2. View of the outlet of the pipe into the constructed wetlands approximately 75 m west of the subject property.

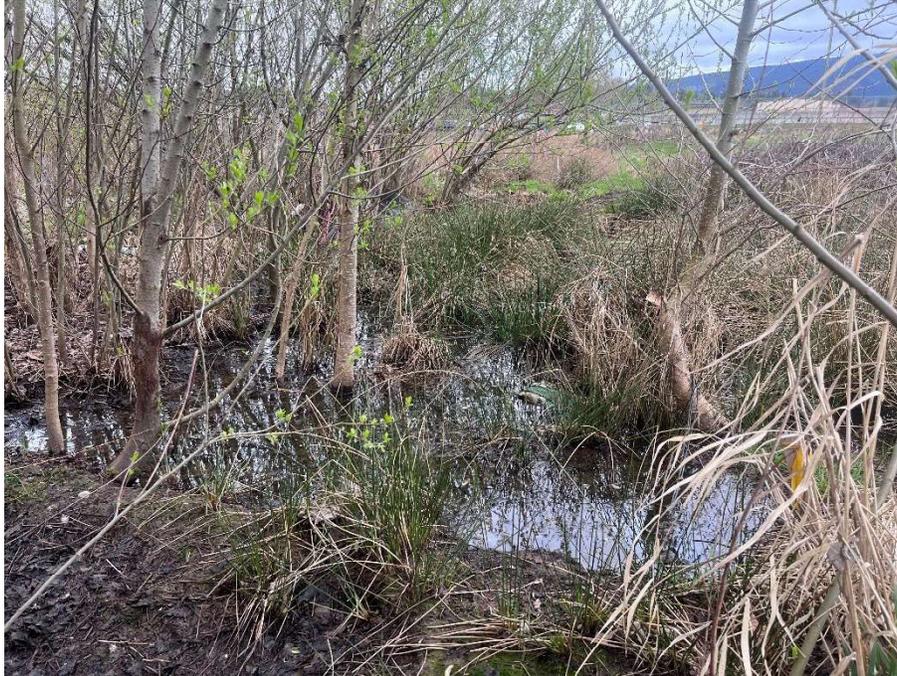
Photo 3. View of wetland vegetation in Wetland 1 near the inlet of the pipe.

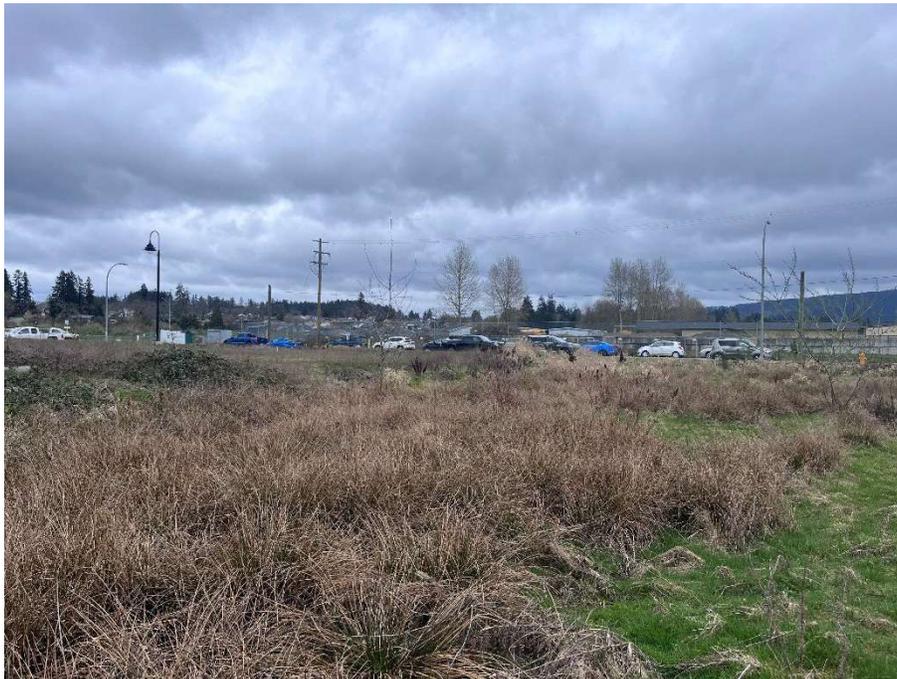
Photo 4. View of Wetland 1 on the neighbouring property to the north at 5950 York Road.

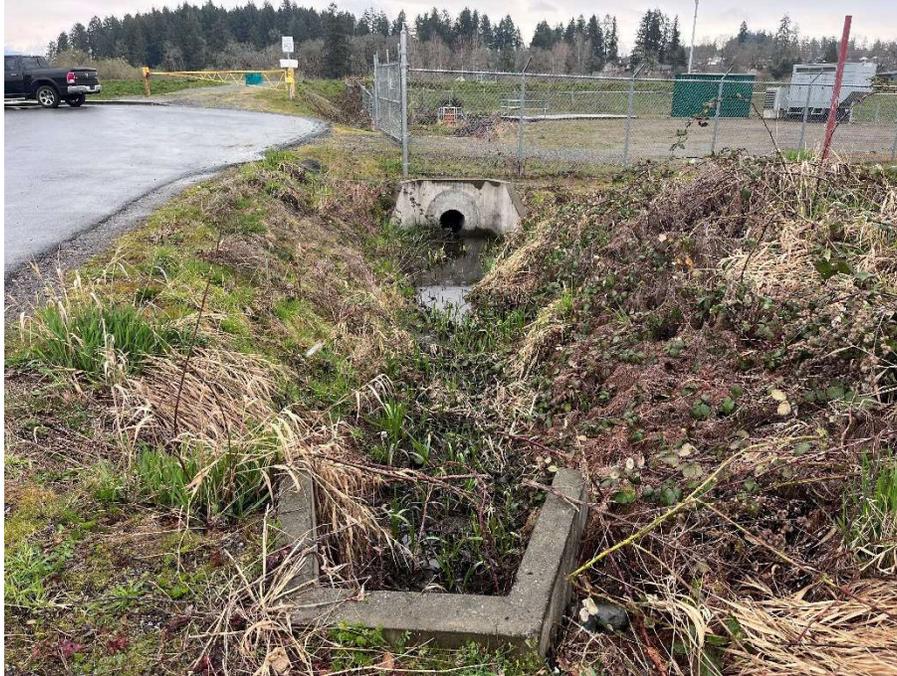
Photo 5. View of riparian vegetation in Ditch 1 and the York Rd. flood station in the background.

Since Ditch 1 is located on the opposite side of York Road and lacks any surface water connection to the subject property, there will be no interaction between development on the subject property and the ditch. **Ditch 1 is recommended to be excluded from the RAPR assessment process for proposed development on Lot 3.**

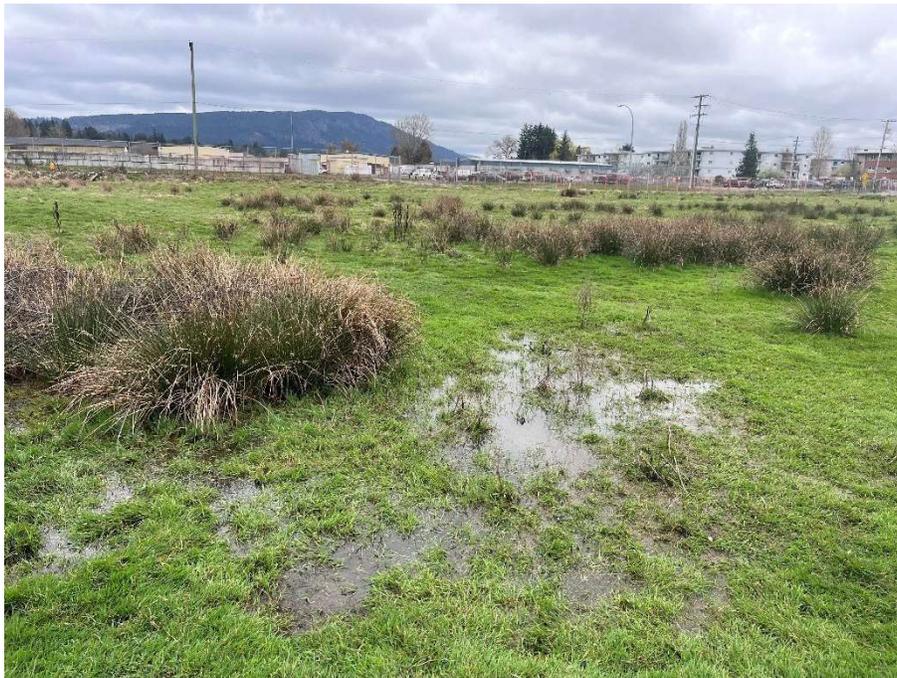
Photo 6. View of the northern portion of the subject property showing vegetation and the shallow water table.

The majority of the subject property has been cleared of native vegetation and mostly consists of common rush, grass species, trailing blackberry, and invasive species (Photos 6 & 7). Tree cover on the subject property is limited to two lodgepole pine trees along the southern property boundary, and red alder saplings along the constructed berm (Photo 8). Throughout the property, Himalayan blackberry, reed canary grass, Scotch broom, wild carrot, and thistle species were observed. As outlined in DPA-1 guidelines Section 1.5.2 h) and DPA-2 guidelines Section 2.3.4 e), invasive plants and noxious weeds must be removed and replaced with native plant species as part of the landscape plan. During the development phase of the subject property, it is recommended that all invasive species be removed and properly disposed of.

During the site visit, it was determined that the subject property has a very shallow water table as pockets of standing water and saturated soils were observed throughout the site (Photo 6). Pursuant to DPA-3 guidelines Section 2.4.5 Aquifer Protection Areas, an assessment of the characteristics of the aquifer and its ability to accommodate the additional groundwater demand proposed by development must be included where the possibility of a development impacting an aquifer exists. An assessment of the aquifer and recommendations to ensure the aquifer is protected are not included in this memorandum but will be addressed by a suitable qualified professional in a separate report.

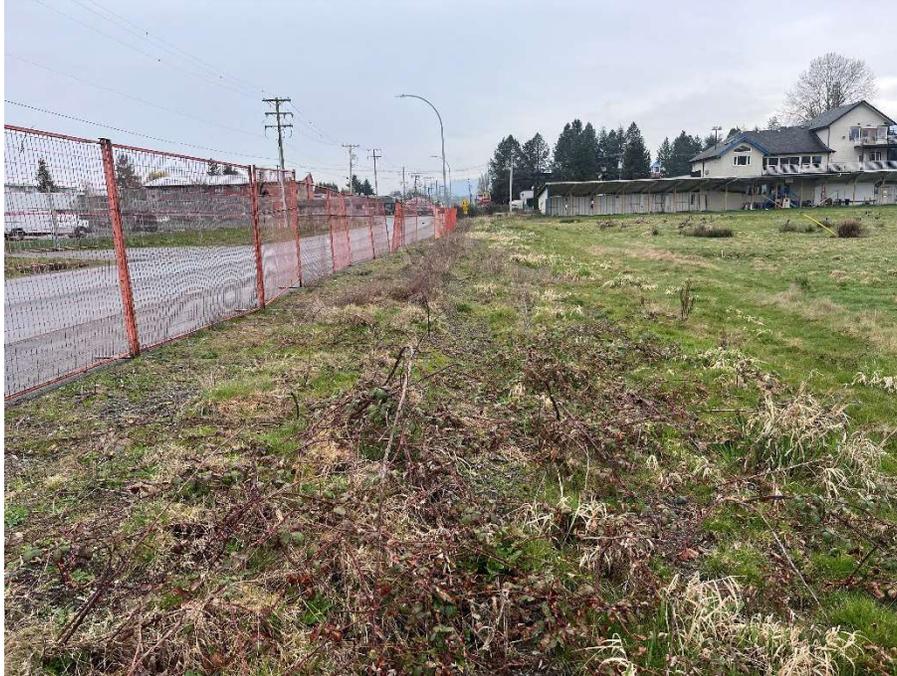
Photo 7. View of the eastern property boundary where invasive species including Himalayan blackberry, reed canary grass, wild carrot, and Scotch broom are present.

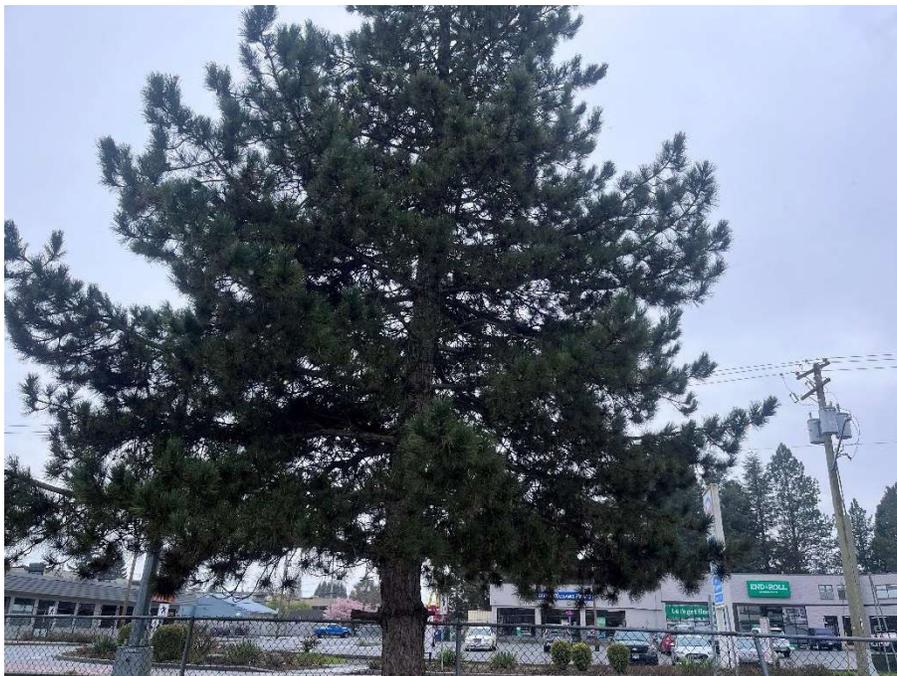
Photo 8. View of one lodgepole pine tree located along the southern property boundary.

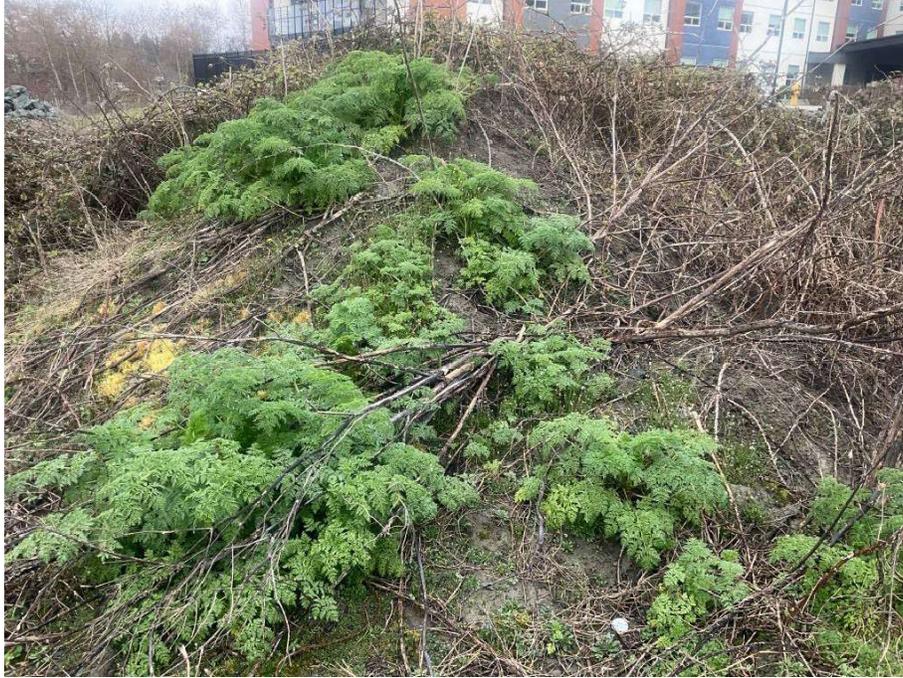
Photo 9. View of poison hemlock and Himalayan blackberry that has colonized a historic soil stockpile approximately 7 m west of the subject property. Enhanced mitigation measures are recommended during construction to limit accidental seed dispersal onto the subject property.

Approximately 7 m to the west of the northwest corner of the subject property, Himalayan blackberry and poison hemlock have colonized two historic soil and material stockpiles on the adjacent property Lot 1 (Photo 9). Neither species is listed as a 'Noxious Weed' under the *Weed Control Regulation* of the *BC Weed Control Act*, and management is voluntary and are not currently present on the subject Lot 3 so are not of immediate concern to this project. **It is recommended that no movement of soils between the adjacent property (Lot 1) and the subject property (Lot 3) occur, and all soil stockpiles generated on Lot 3 be located at least 30 m from the western property boundary to limit any potential cross-contamination. If at any time poison hemlock is identified on the subject property, a management plan is to be created.**

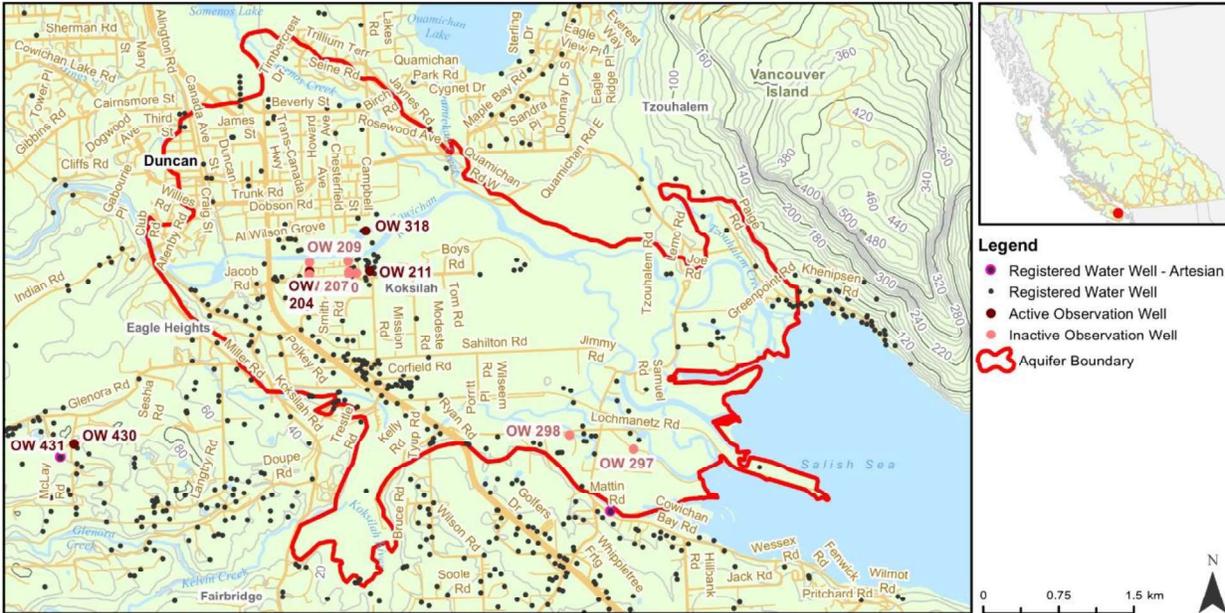
Aquifer #186
 Lower Cowichan River A

Aquifer Description (Mapping Report - 2020):
 Predominantly unconfined fluvial or glacio-fluvial sand and gravel Aquifers found along rivers of moderate stream order with the potential to be hydraulically influenced by the river (subtype = 1b).

Aquifer Details	
Region	West Coast
Water District	Victoria
Aquifer Area	17.4 km ²
No. Wells Correlated	168
Vulnerability to Contamination	High
Productivity	High
Aquifer Classification	IA
Hydraulic Conductivity *	3.2x10 ⁻³ - 2.2x10 ⁻¹ m/s (n=4)
Transmissivity *	3.9x10 ⁻³ - 1.2e+00 m ² /s (n=4)
Storativity *	3x10 ⁻⁴ - 3.8e+00 (n=2)
No. Water Licences Issued to Wells	3
Observation Wells (Active, Inactive)	204, 211, 318, 205, 208, 298

Aquifer 186 covers an area of 17.4 Km² extending BV from the subject property to the mouth of the Cowichan River. Overall, the aquifer is classified as having high productivity and vulnerability to contamination. However, as is normal for large aquifers, conditions may vary from one location to another.

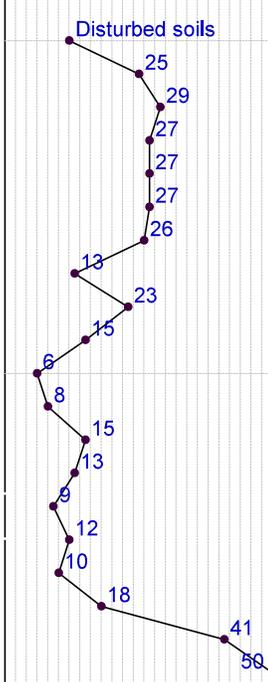
Datum: Surface
Figure Number: A2
Page: 1 of 1

INFERRED PROFILE				Moisture Content (%)	DCPT (blows per foot)	Groundwater / Well	Remarks
Depth	Symbol	SOIL DESCRIPTION	Depth (m)/Elev (m)				
0		Ground Surface	0.0				
1		FILL Compact to very dense silty SAND and GRAVEL. Trace roots. Moist. Black.	0.5				
2		CLAYEY SILT Soft to firm organic clayey silty. Intermixed fibrous wood. Some moisture. Brown.	1.5				
3		SANDY SILT Soft to very stiff sandy SILT. Some wood debris. Grey. Moist.	2.7				
4		SILTY GRAVEL Compact to very dense silty GRAVEL. Some intermixed wood debris. Wet. Grey.	4.9				
5		ORGANIC SILT Stiff to very stiff interbedded organic SILT with trace sand and sandy silts. Intermixed and interbedded PEAT of fibrous wood. Wet. Grey.	8.2				
6		SILTY SAND AND GRAVEL Dense to very dense silty sandy GRAVEL. Coarse grained. Angular. Wet. Grey.	9.1				
7		End of Borehole

Logged: RD
Method: Solid Stem Auger
Date: Feb 14, 2023

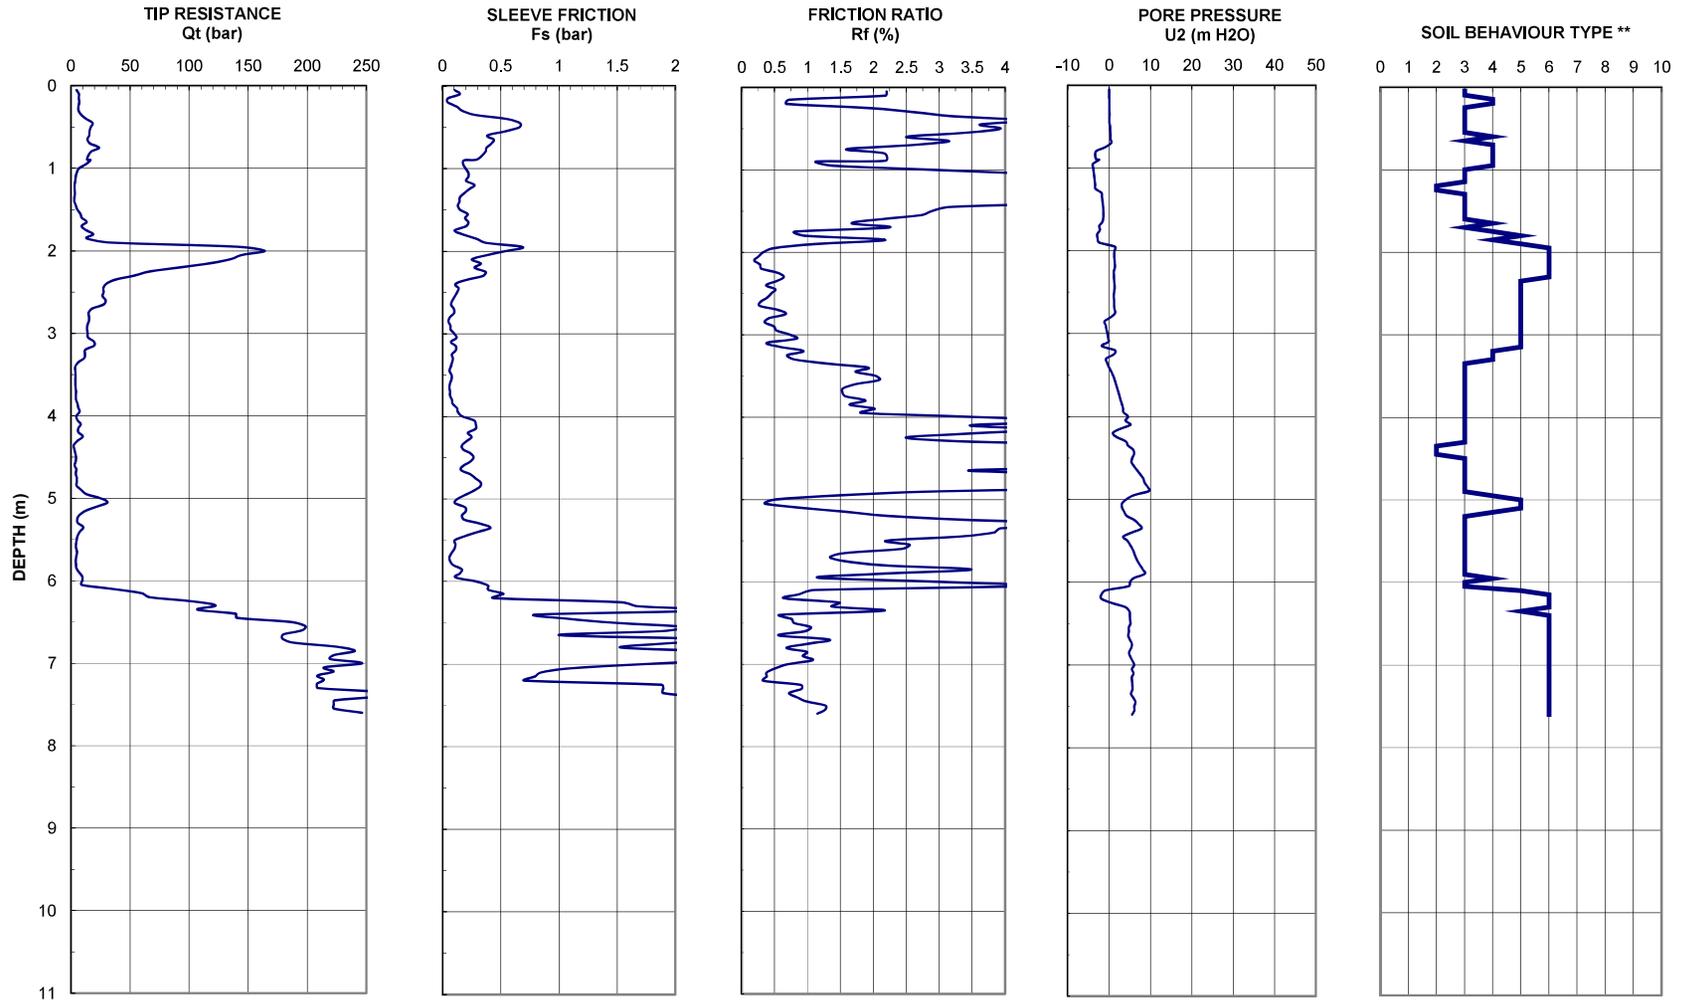
Figure: B.01

◆ = estimated water table depth

** Based on Robertson et. al 1990

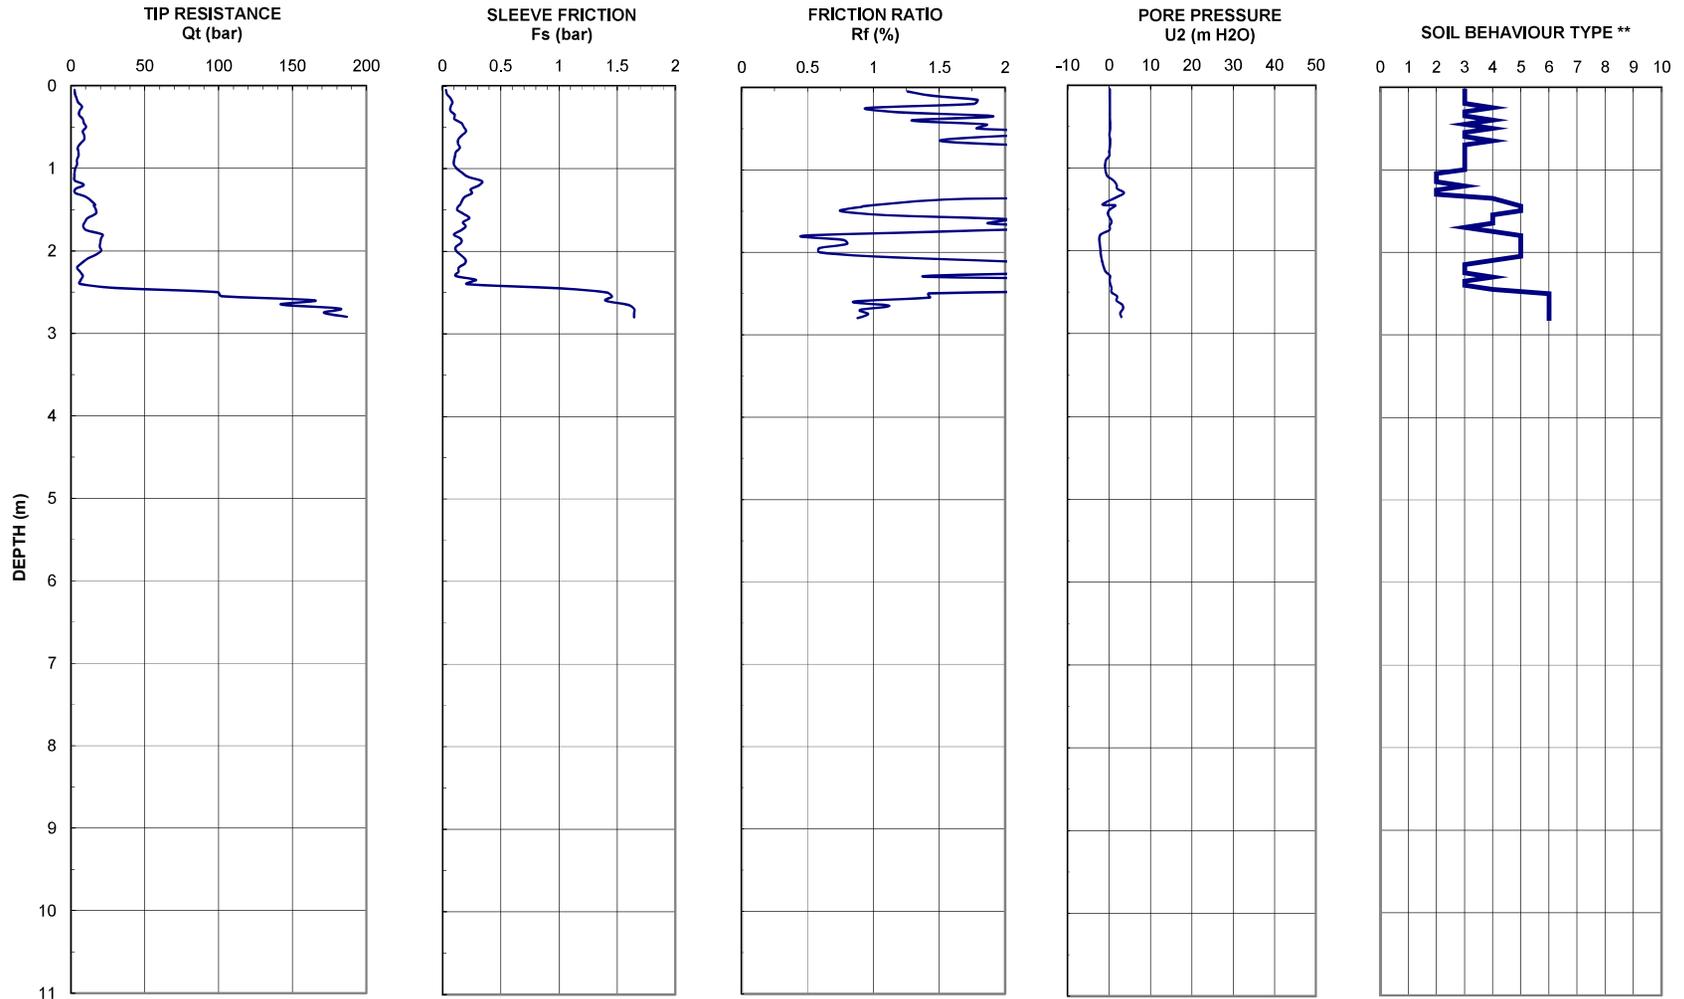
Figure: B.02

◆ = estimated water table depth

** Based on Robertson et. al 1990

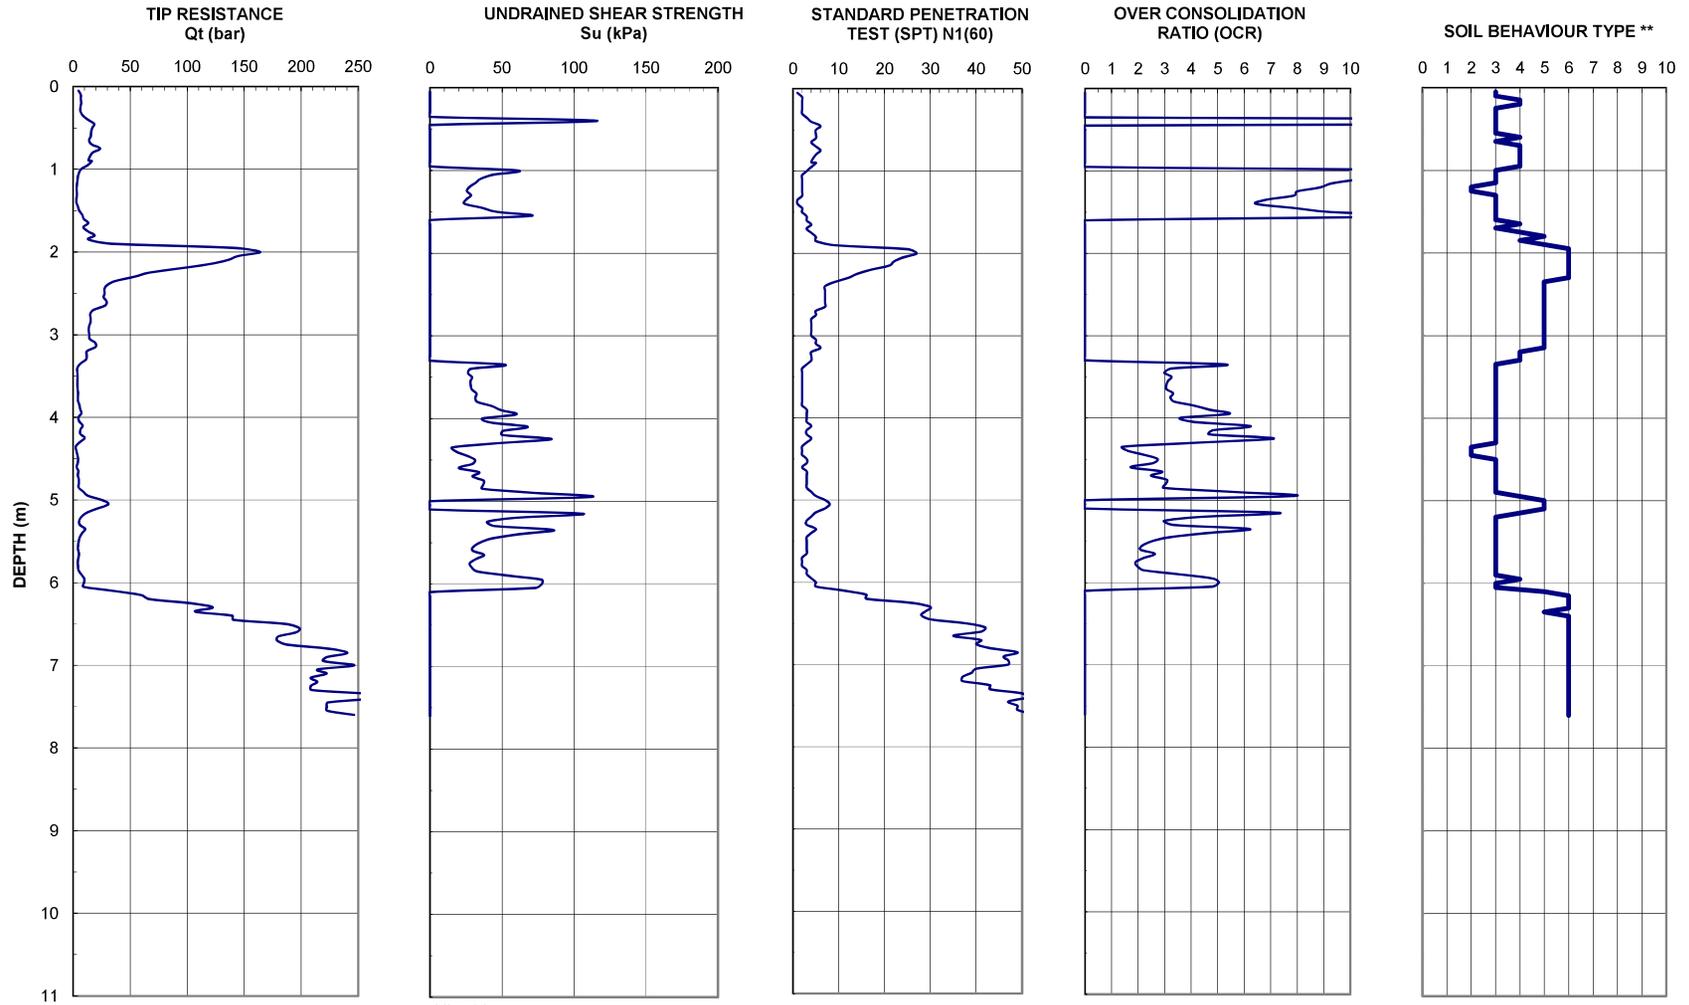
Figure: C.01

** Based on Robertson et. al 1990

- 1 Sensitive Fine Grained
- 2 Organic Material
- 3 Clay to Silty Clay

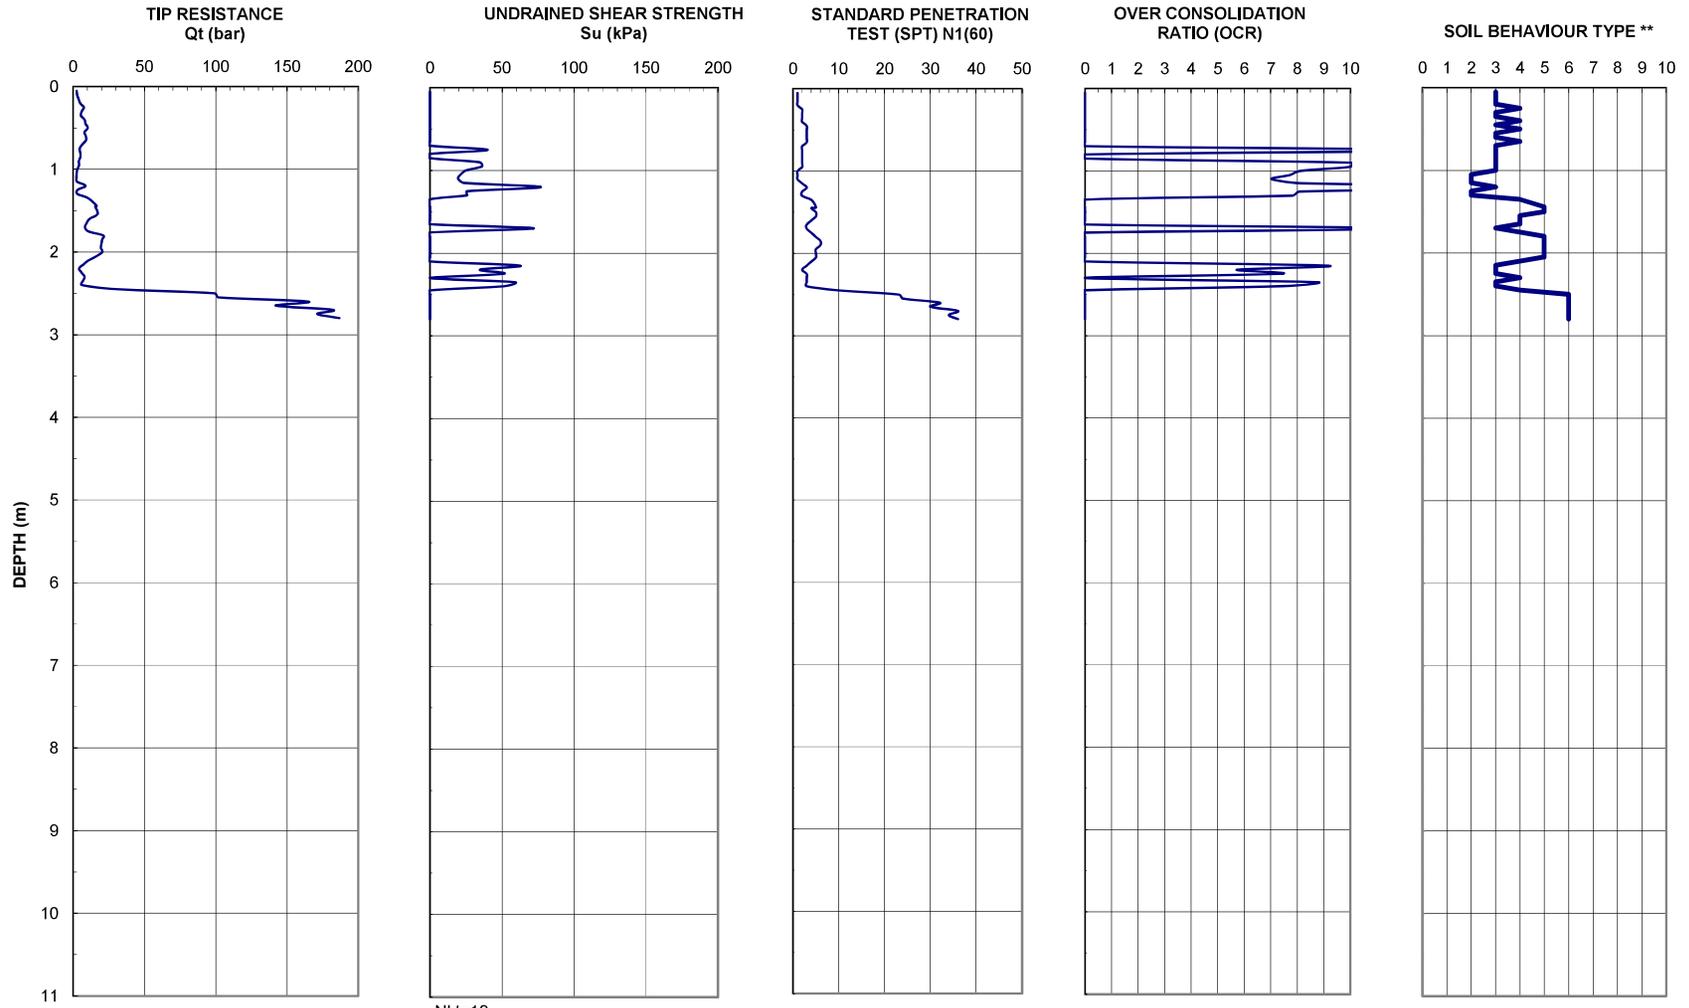
Figure: C.02

Nkt=12

** Based on Robertson et. al 1990
