Development Permit with Variance

Permit No:	DP000302	
Applicant:	Total Concept Developments Ltd.	
Registered Owners:	Somenos Views Residences Inc., Somenos Views Holdings 2 Inc. and Somenos Views Holdings 3 Inc.	
Subject Property:	2591 Beverly Street	Folio: 01242-003
Description of Lands:		
Parcel Identifier	030-594-715	
Legal Description	Lot 3, Section 19, Range 6, Quamichan District, Plan EPP85394	
Proposal:	Development Permit with Variance (DPA-1, DPA-2, DPA-3, DPA-4, DPA-6) for the construction of a Mixed-Use Building with Ground Floor Commercial Use and 210 Residential Apartment Units

RESIDENCES
2591 BEVERLY STREET, DUNCAN
(BUILDING B)
SITE LIGHTING

TECHNICAL MEMORANDUM

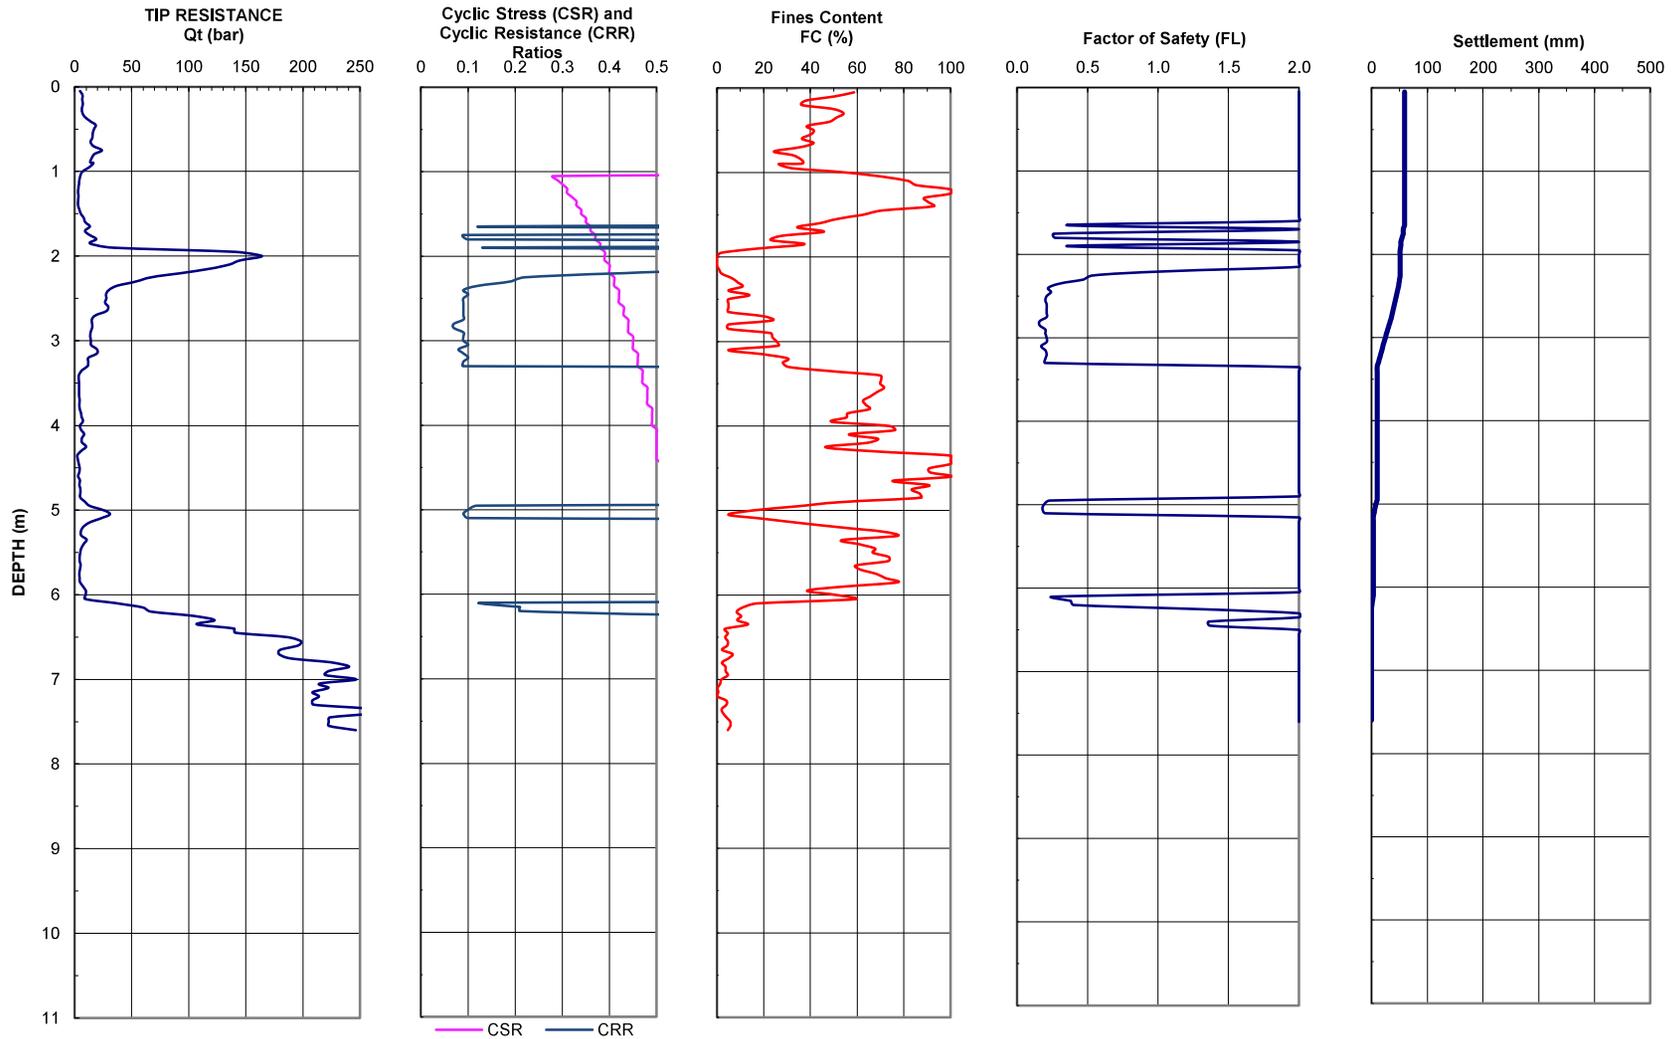
Figure: D.01

Liquefaction interpretation: PGA = 0.51
magnitude = 7.0
settlement accumulation max depth = 15m

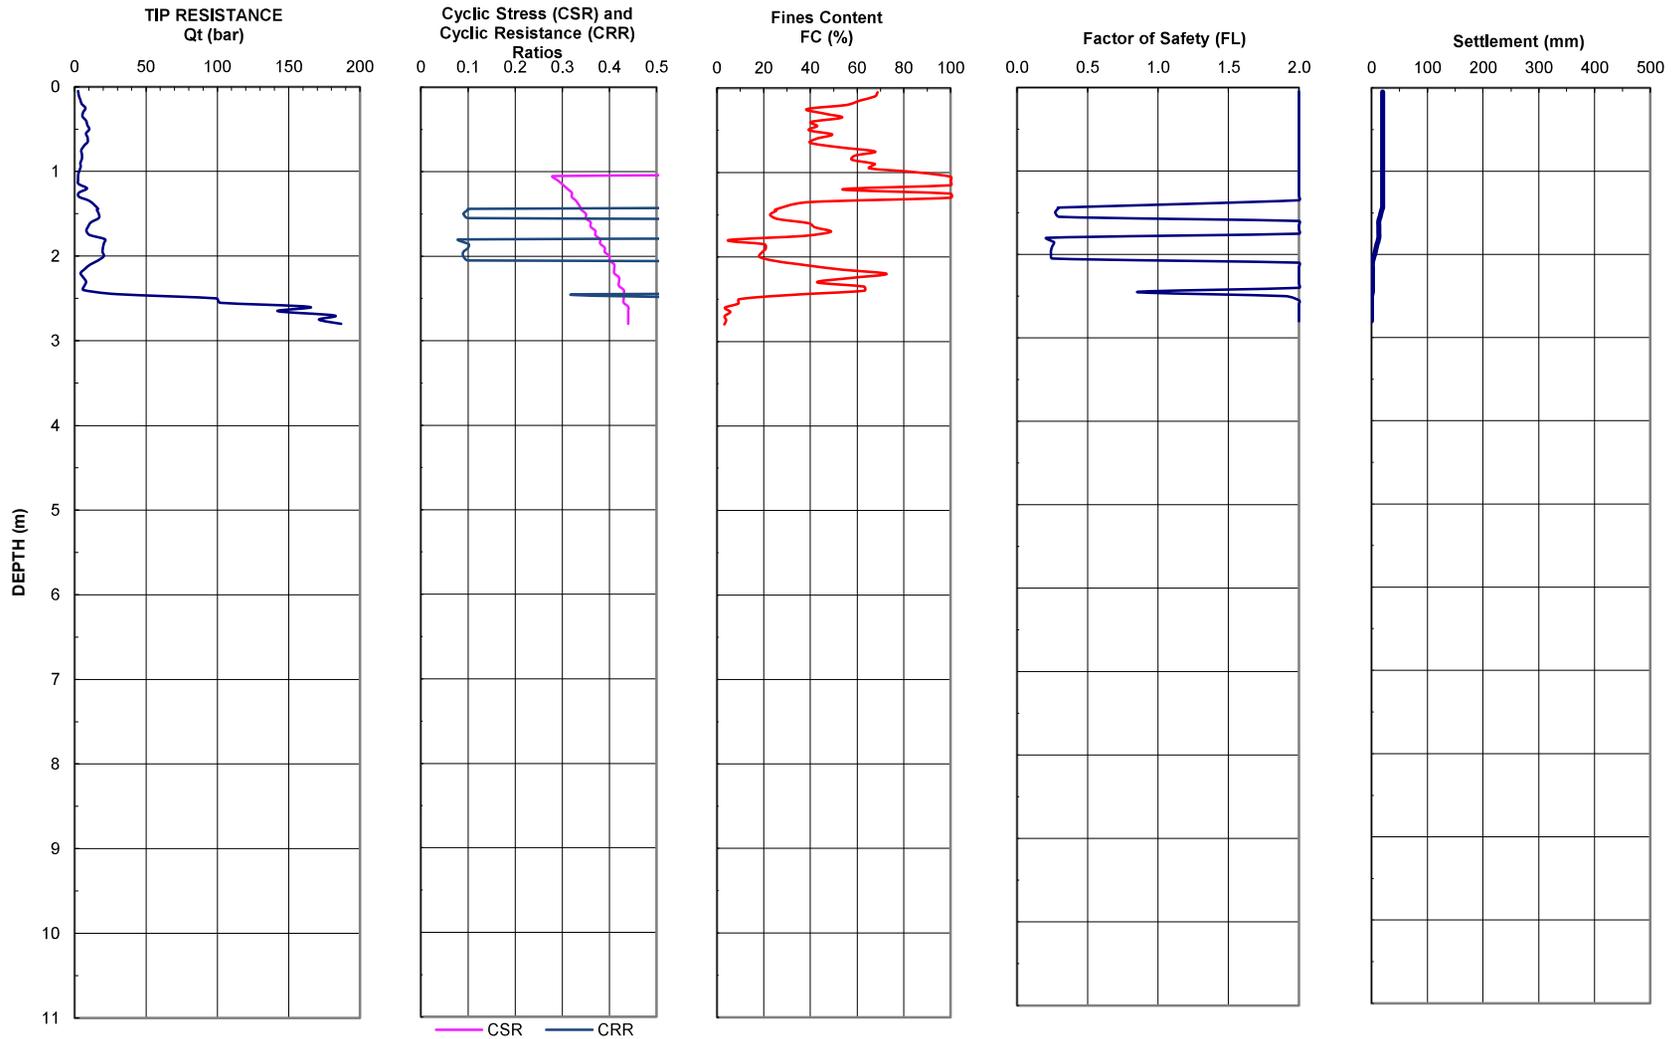
Figure: D.02

Liquefaction interpretation: PGA = 0.51
magnitude = 7.0
settlement accumulation max depth = 15m

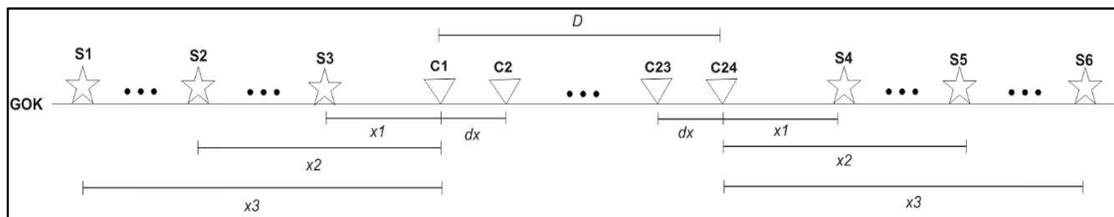
The typical 1D field procedure comprises placing an array of equally spaced geophones in a line and generating a surface wave source at varying distances from each end of the line, as shown in Figure 1. The spacing of geophones has a strong influence on resolution, the total length of the geophone array and the distance of the source have a strong influence on the depth of investigation.

Figure 1: Typical MASW configuration.

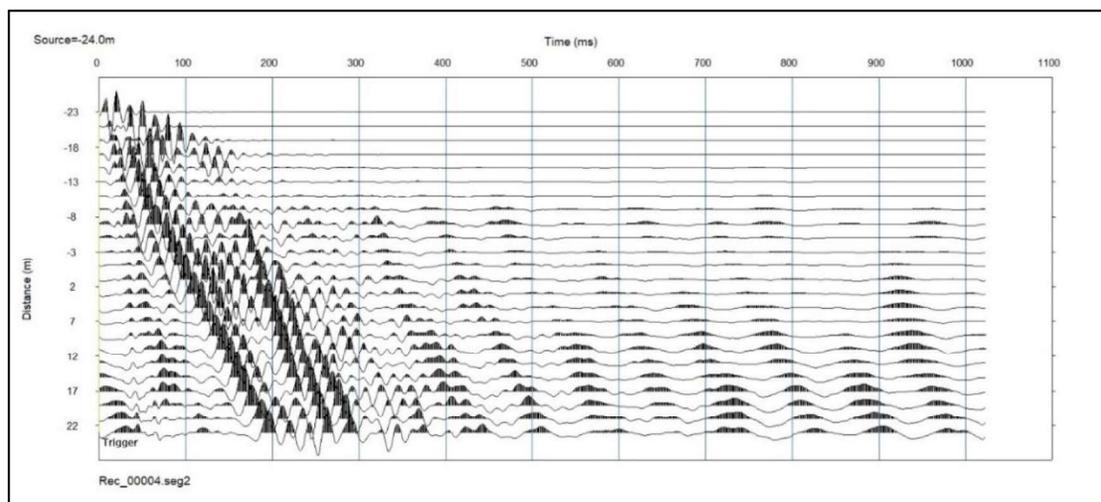
Once a source (shot) has been generated, the geophones are triggered to record. Once the geophones have stopped recording a shot gather is produced which displays the amplitude and time of the recorded subsurface response relating to that source. A typical MASW record is shown in Figure 2. Multiple shots at the same position are usually stacked to increase signal to noise ratio and remove random noise.

Figure 2: Typical MASW shot record.

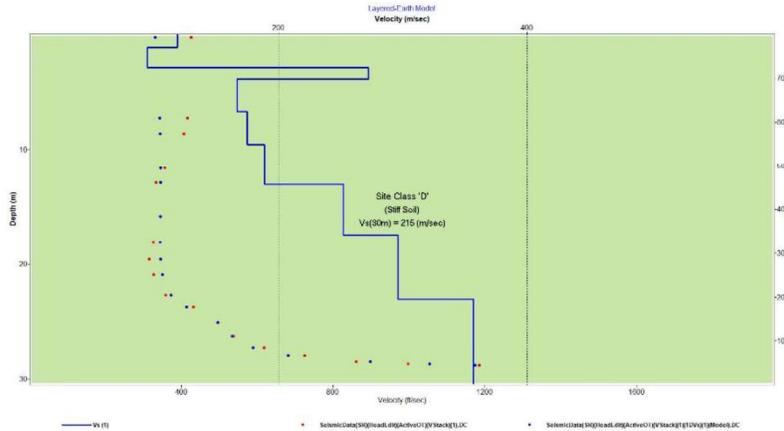
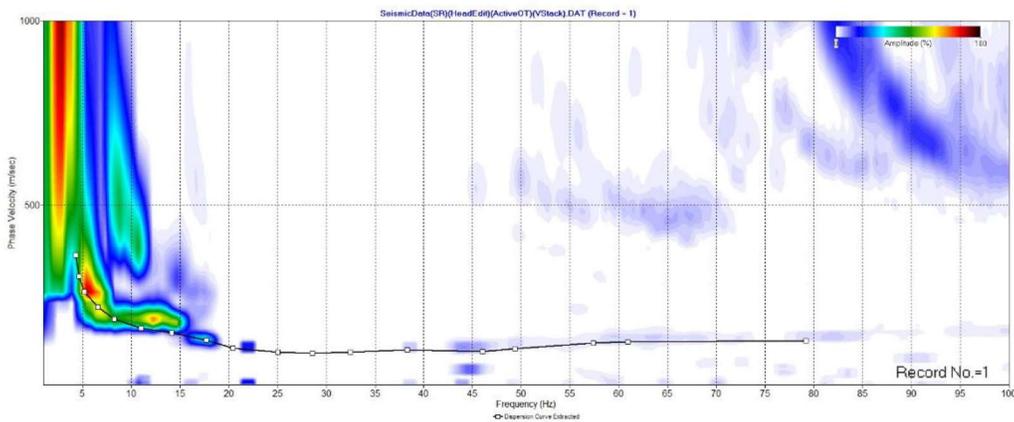
Layer	Depth of Bottom of Layer (m)	Vs (m/s)
1	1.163	118.75
2	2.873	94.56
3	3.896	272.32
4	6.704	166.76
5	9.542	174.83
6	13.09	188.76
7	17.526	252.16
8	23.07	296.07
9	30.5	356.77

MASW23-01 Site Class:
 Site Class 'D' (Stiff Soil)
 $V_s(30m) = 215$ m/s

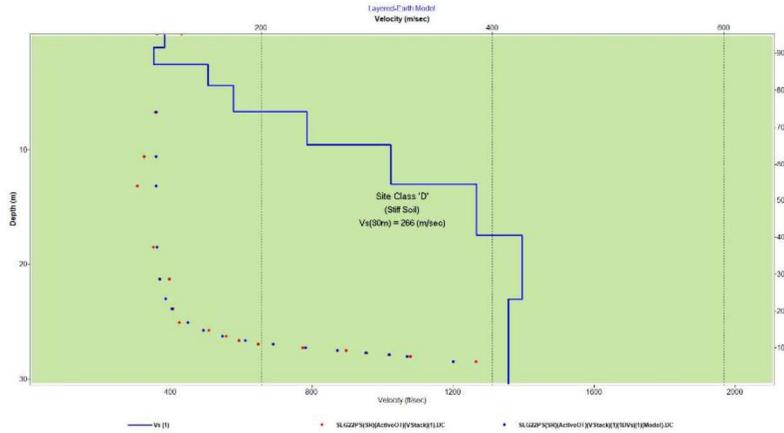
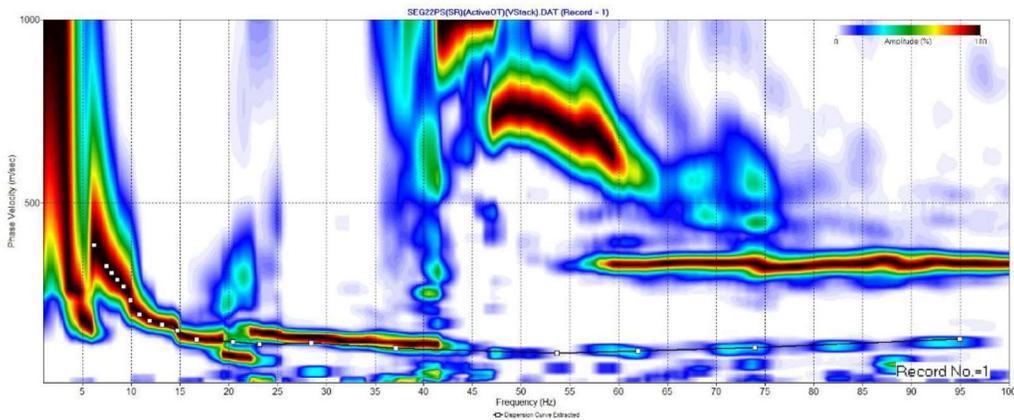
Layer	Depth of Bottom of Layer (m)	Vs (m/s)
1	1.163	116.45
2	2.616	107.28
3	4.433	154.19
4	6.704	176.14
5	9.542	239.6
6	13.09	311.95
7	17.526	386.11
8	23.07	425.67
9	30.5	413.68

MASW23-02 Site Class:
 Site Class 'D' (Stiff Soil)
 Vs (30m) = 266 m/s

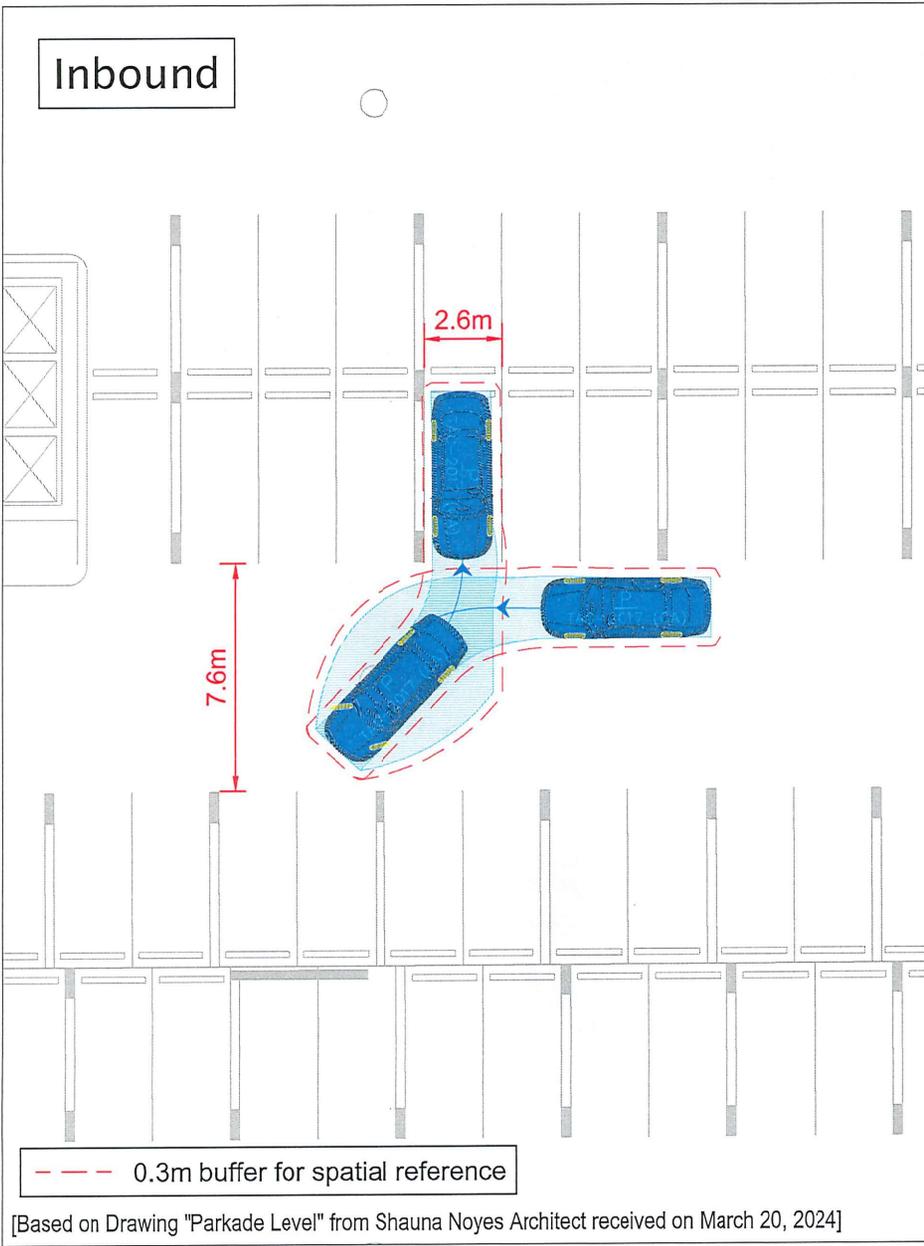
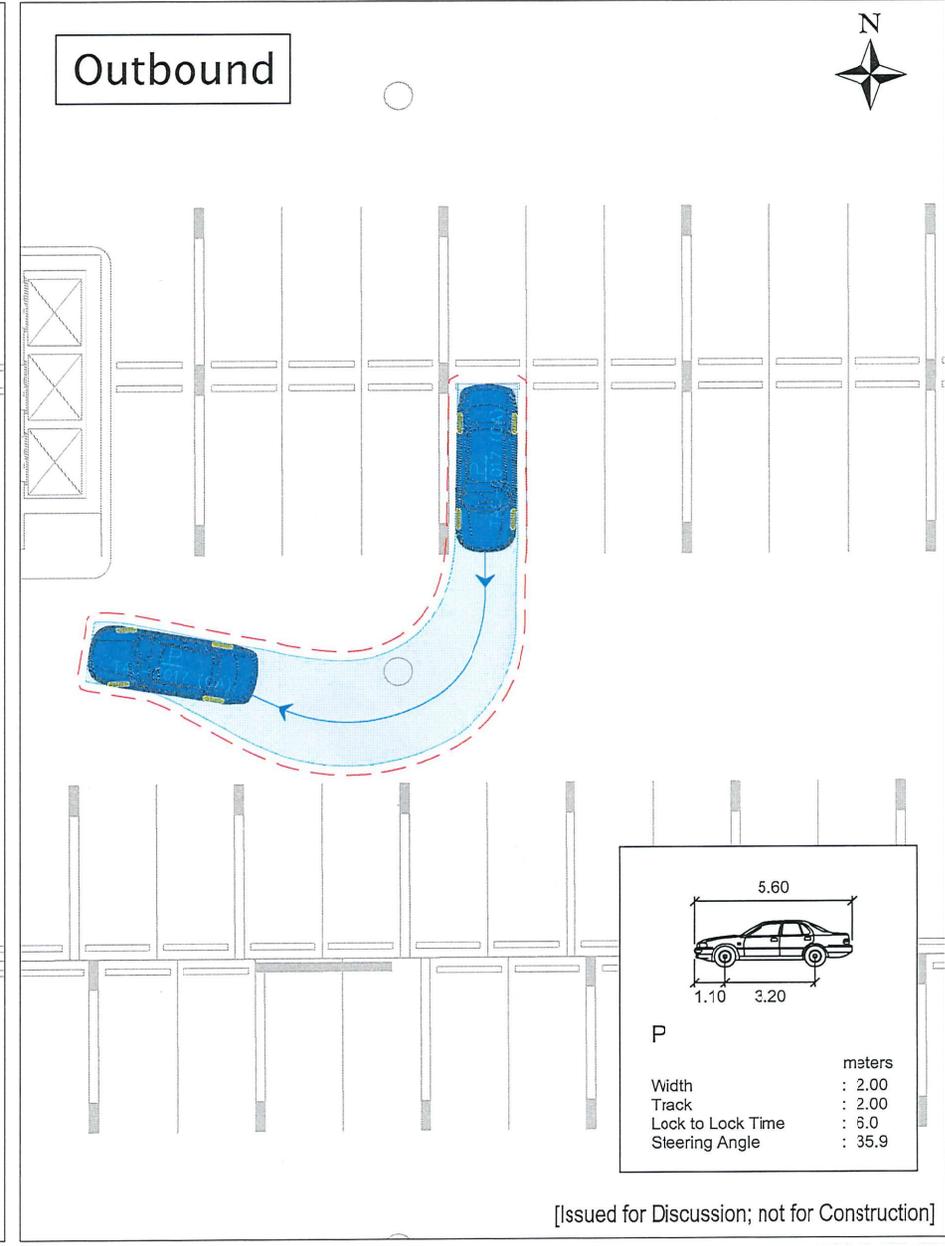
Exhibit 1 Passenger Vehicle Parking - 90-degree Column-Adjacent Stalls

4. Pursuant to Section 490 (1) of the *Local Government Act* this permit varies Section 24 (2)(a) of Zoning Bylaw 1997, No. 2950 by decreasing the minimum width of parking stalls at posts from 3.0 metres to 2.6 metres in the underground parkade.

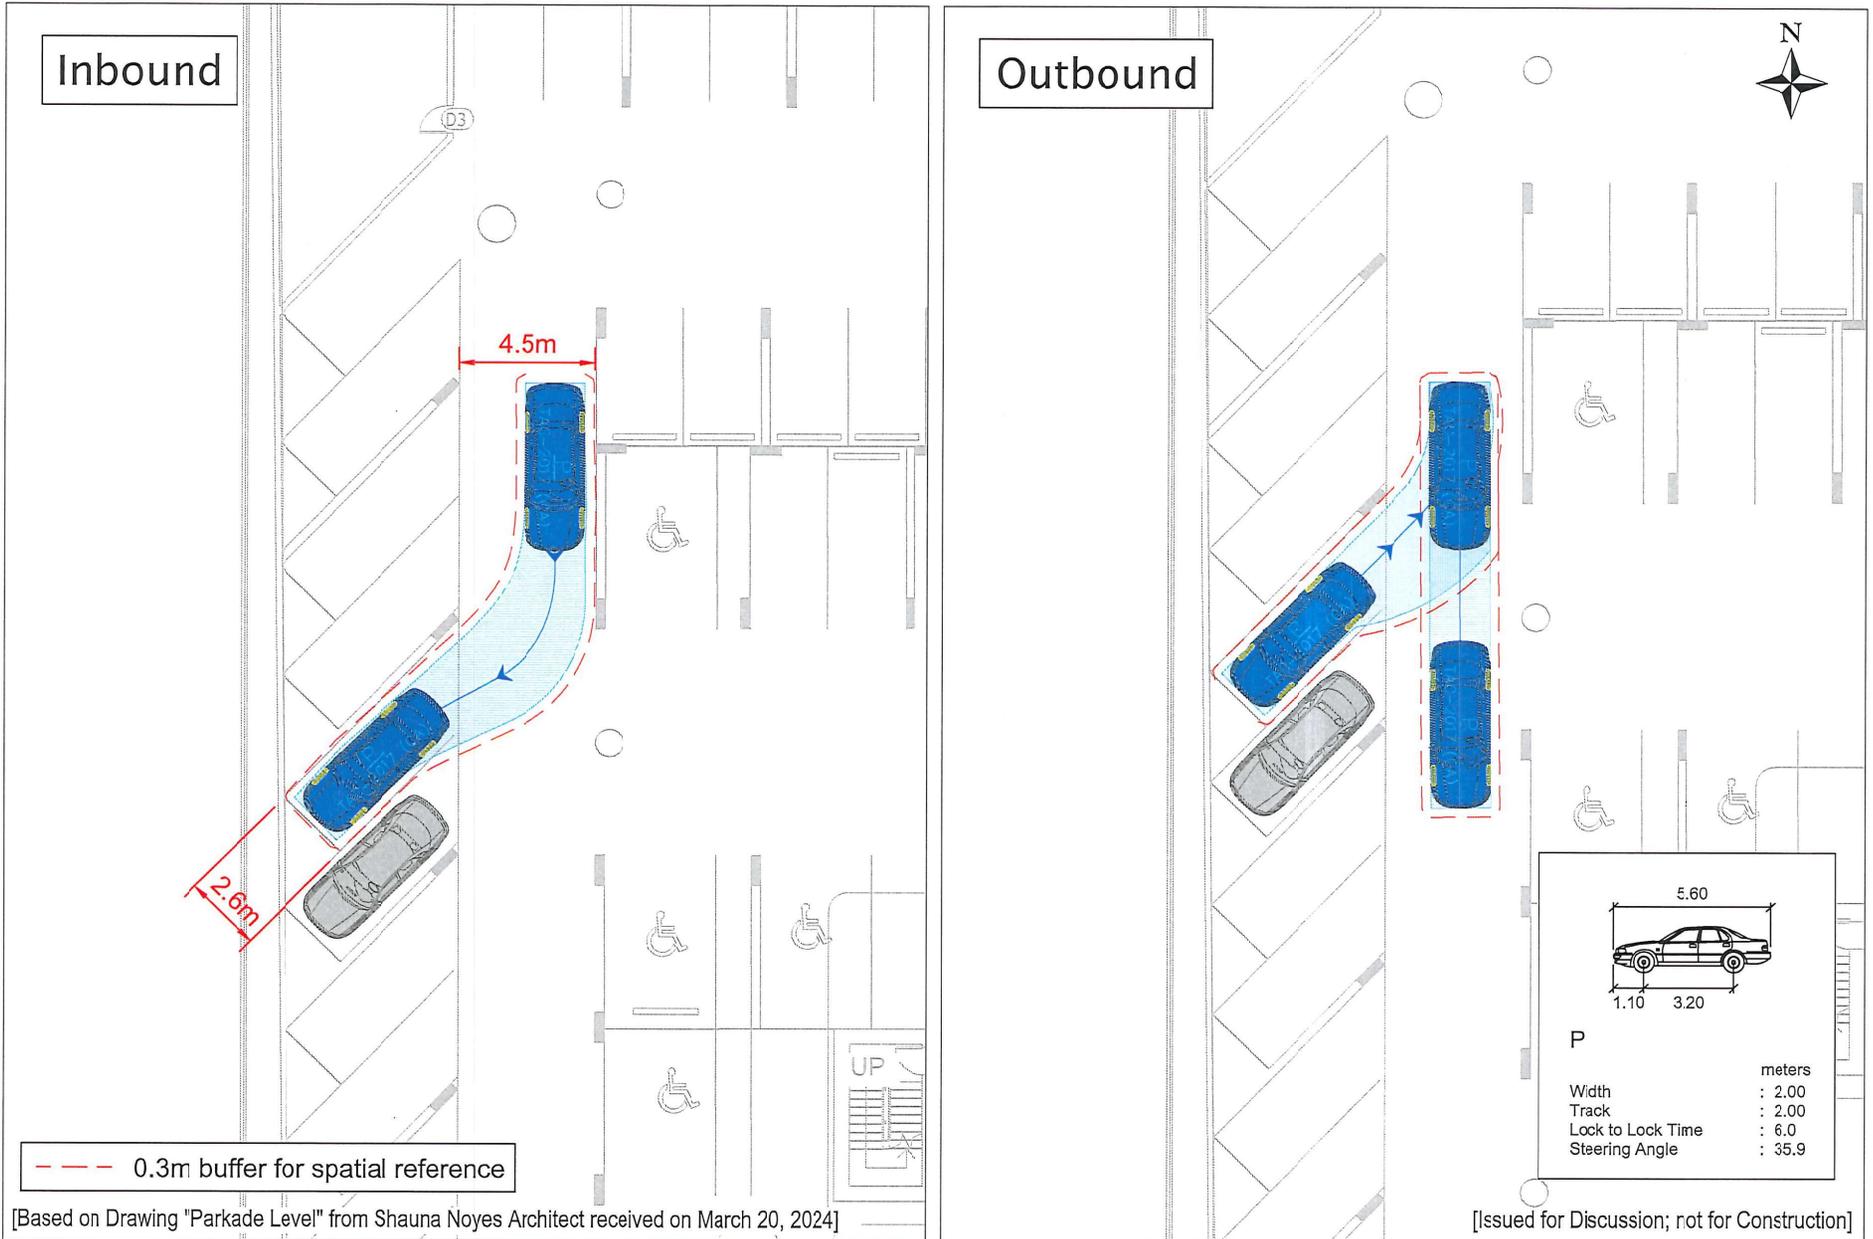
Exhibit 2 Passenger Vehicle Parking - 45-degree One-Way Column-Adjacent Stalls

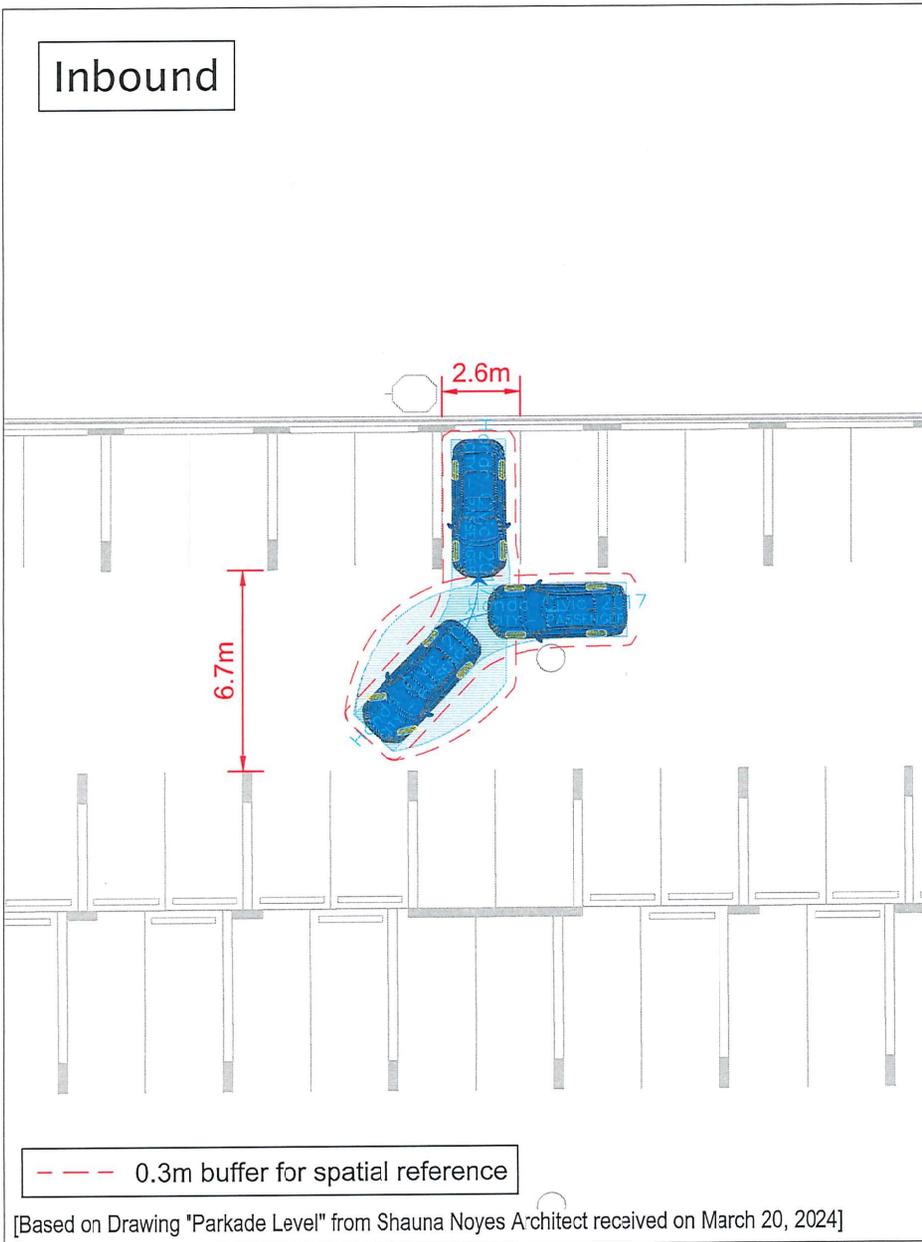
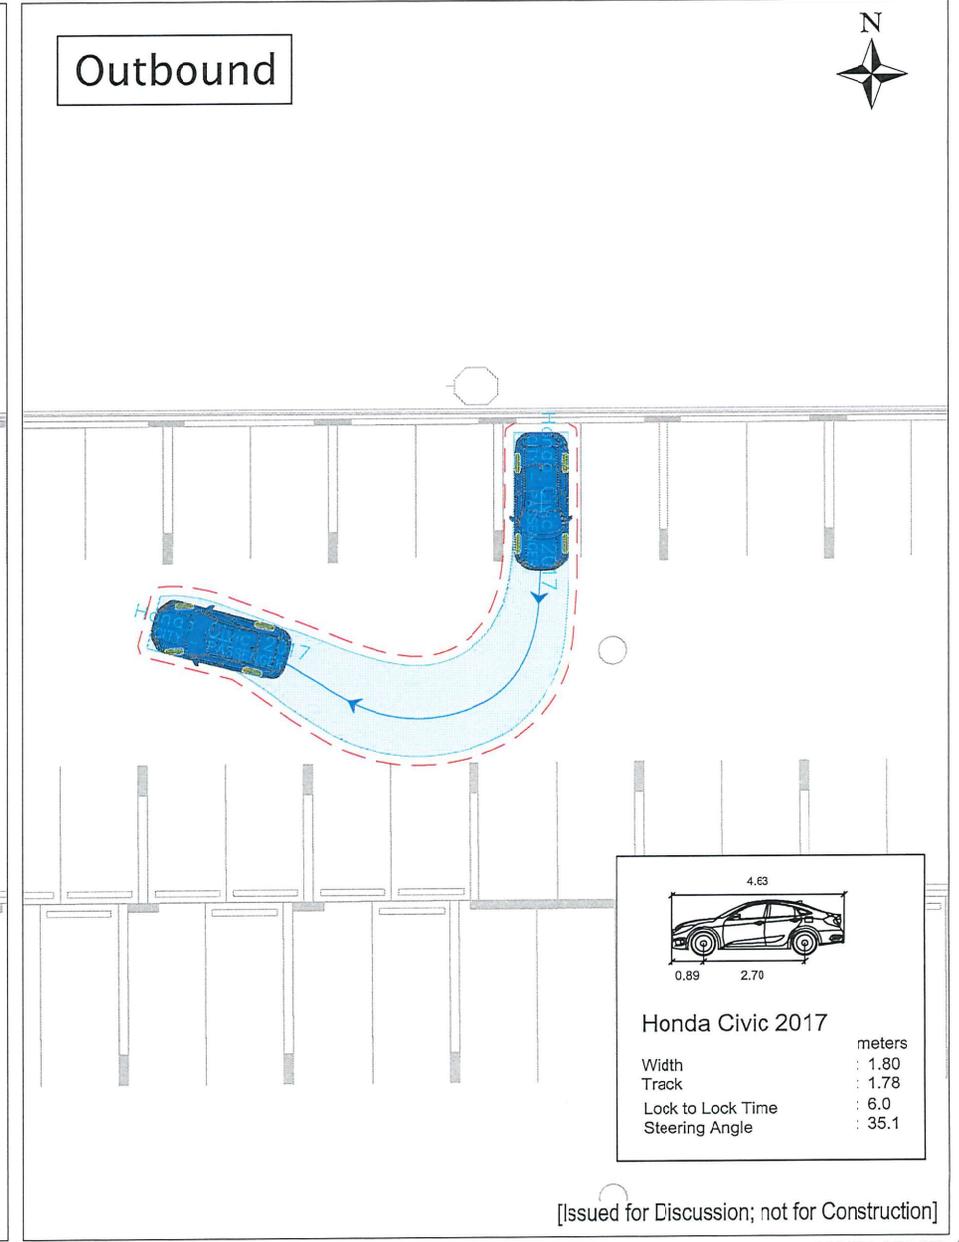
Honda Civic 2017	
Width	: 1.80 meters
Track	: 1.78
Lock to Lock Time	: 6.0
Steering Angle	: 35.1

Exhibit 3 Small Car Parking - 90-degree Column-Adjacent Stalls
