1935 Maple Bay Road Unnamed Tributaries to Quamichan Lake

Riparian Areas Protection Regulation Assessment Report

December 15, 2022

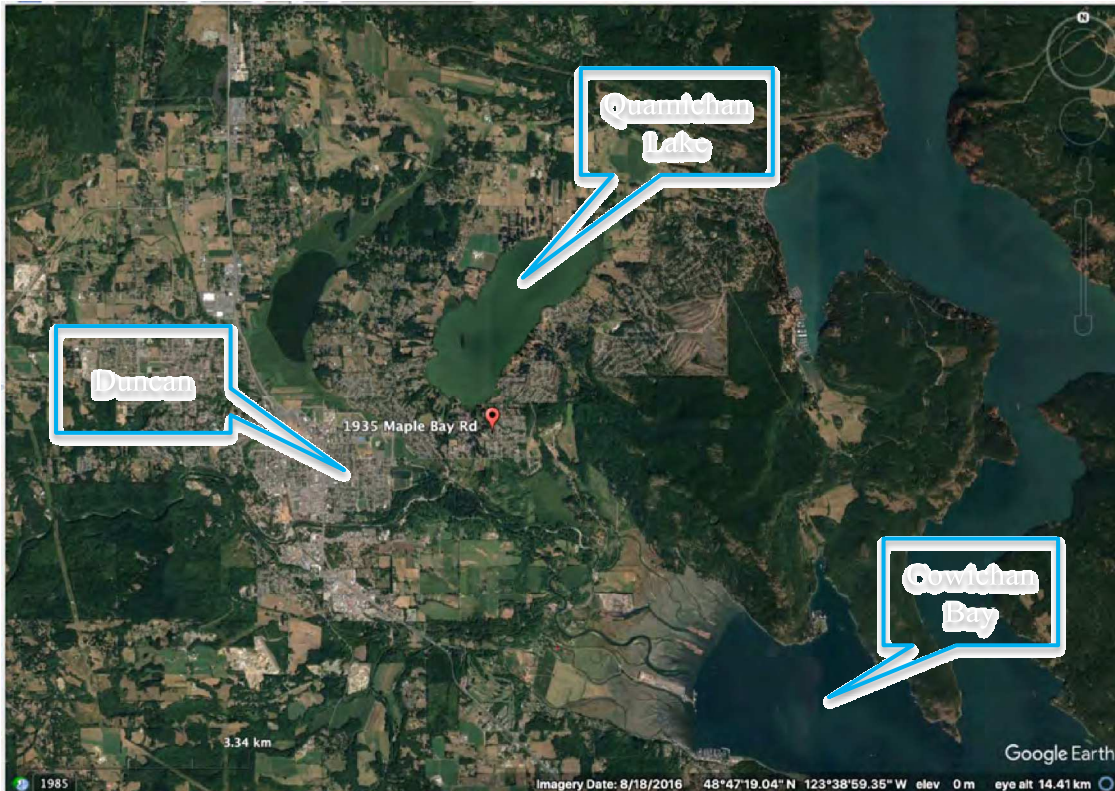
Figure 1. Map of the Southern Vancouver Island with watershed landmarks in relation to the subject property (red dot). Quamichan Lake flows into Cowichan Bay via the Cowichan River.

The subject property is located east of Duncan and southwest of Quamichan Lake (Figure 1 – Figure 3). The property is supplied with municipal drinking water and a new septic treatment system will be constructed on-site, for the ancillary dwelling (carriage house).

The subject property lies within the Quamichan Lake catchment (Figure 1). The Quamichan Lake average water level is 25.4± metres; the lake flood construction level (FCL) is 27.4 metres. Two water features are associated with the subject property – a wetland/pond / manmade outlet channel (classified under the RAPR as a stream) and a municipal drainage ditch; both these features are headwater drainage channels (Figure 3). The wetland/pond appears in historical air

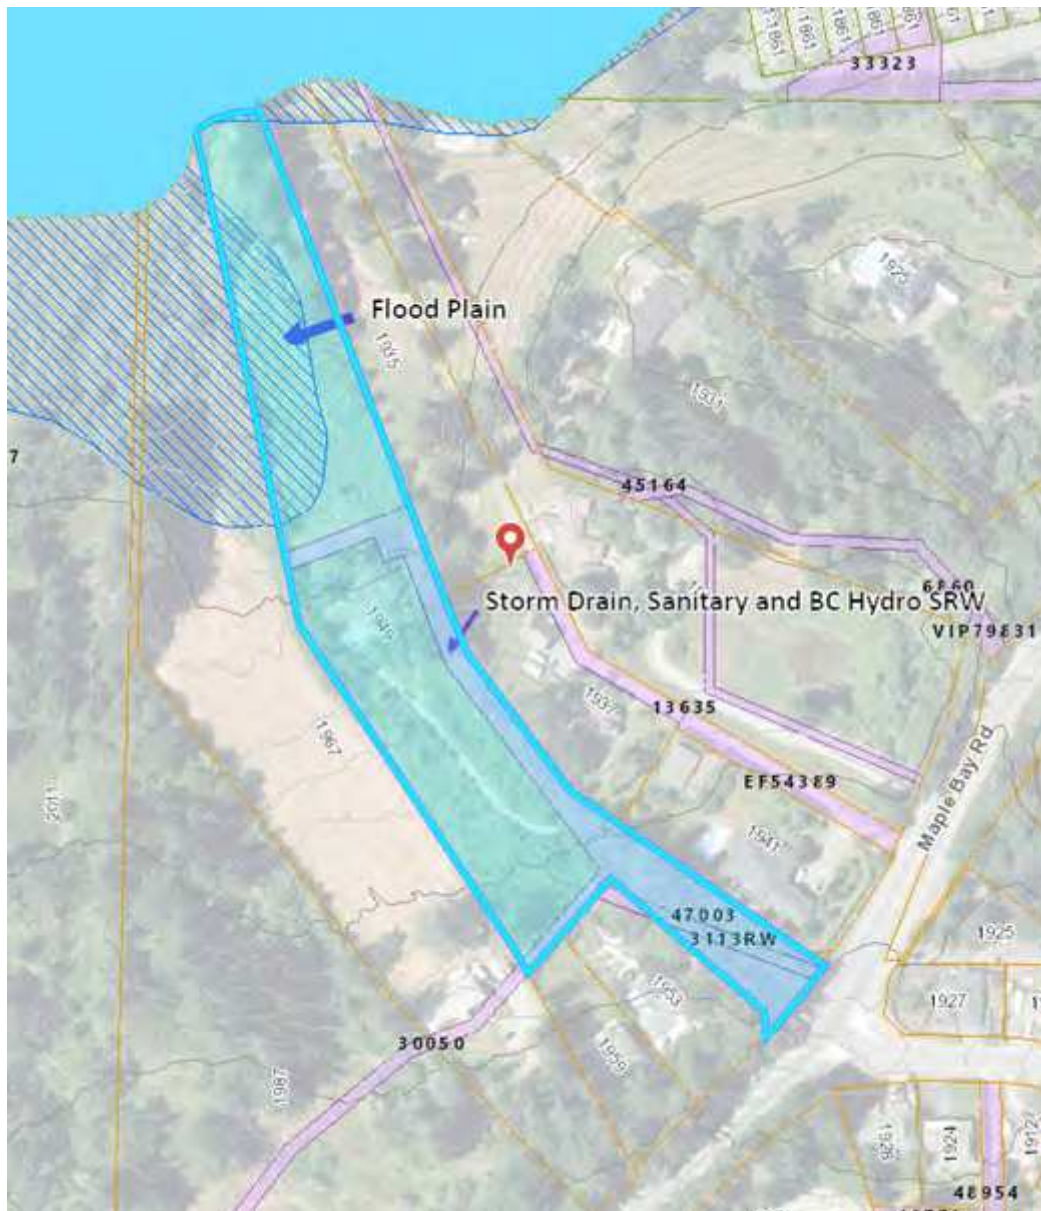
Figure 6. Municipal map of area showing the SRW (shaded blue) within which are contained the municipal storm drain, sanitary sewer, and BC Hydro power pole alignment. The floodplain limit for Quamichan Lake is also shown. 1935 Maple Bay Rd is marked with a red dot on the south property line. Map from Municipality of North Cowichan files.

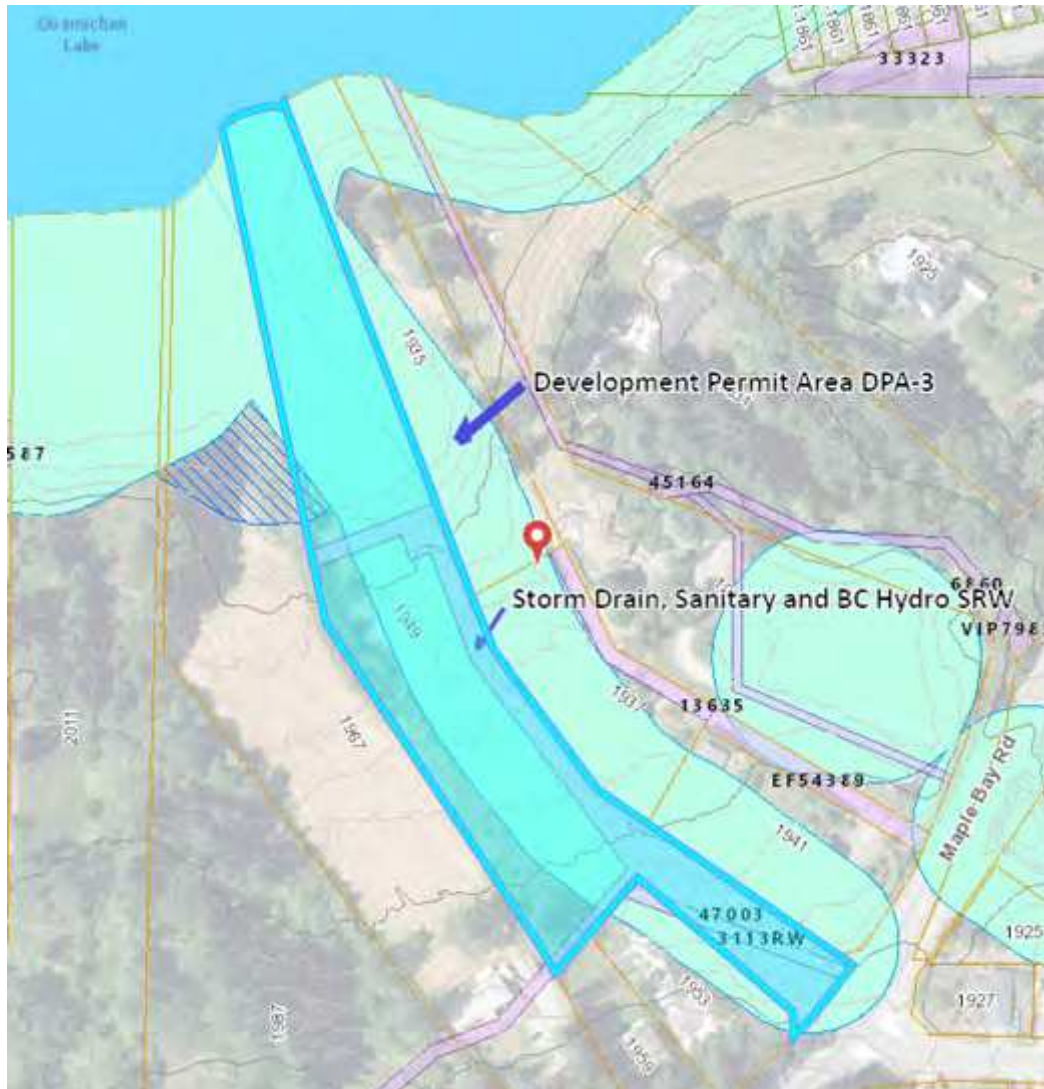
Figure 7. Municipal map of area showing the SRW (shaded blue). The Development Permit Area (DPA-3) associated with the drainage ditch's 30m RAA (light green polygon) is shown. The RAA for the wetland/pond on 1933 Maple Bay Road is marked as a green circle. The connecting culverts and open stream channels are not marked or included in the RAAs. The small RAA zone on the south side of Maple Bay Road is **not** connected by a culvert, under the road, to the wetland RAA on the north side. Maple Bay Road has two catch basins on the south side of the road, in the bottom of the dip in the road, which drain onto the rock ballast of the road, via twin small diameter pipes. The catchment for these twin catch basins is the south side of the road, a distance of ~30m. Map from Municipality of North Cowichan files.

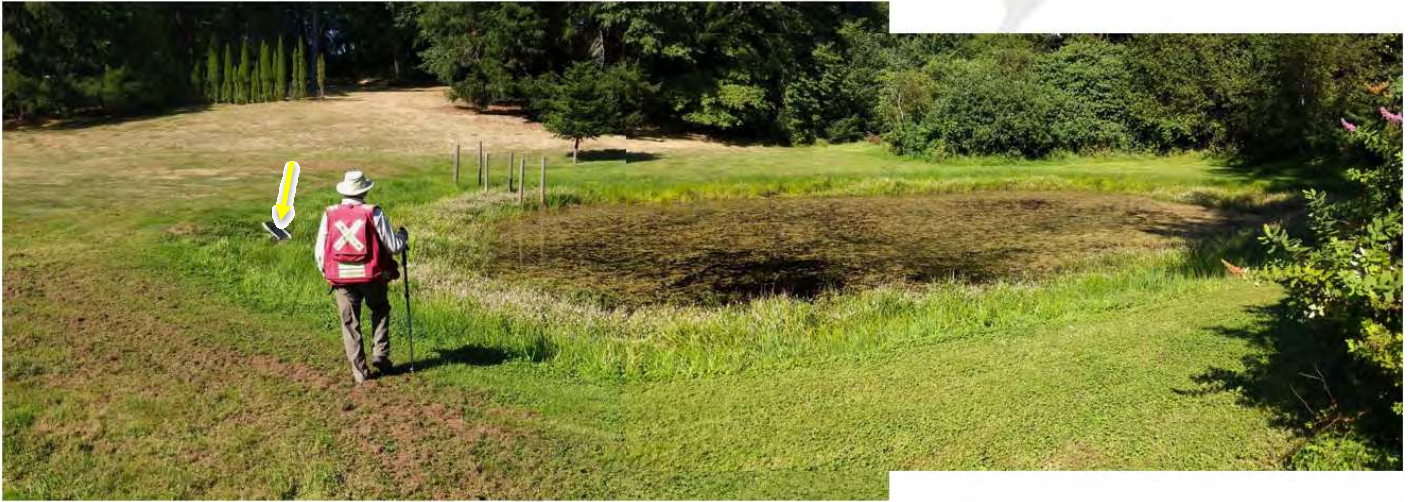
Figure 11. This is the headwater wetland/ pond on 1933 Maple Bay Road that provides the water to Stream 1. Photo taken from 1933 Maple Bay Road looking north across the turf lawn at the pond. Note the depression within which the pond lies. There is a narrow fringe of sedge and agronomic grasses around the pond. The yellow arrow indicates the headwall and inlet of the buried culvert that drains the pond during periods of elevated water level. The area surrounding the wetland/pond is higher than the top of the headwall. This feature is on 1933 Maple Bay Road (Figure 10) and does not affect 1935 Maple Bay Road. Image taken in mid-summer, 2022.

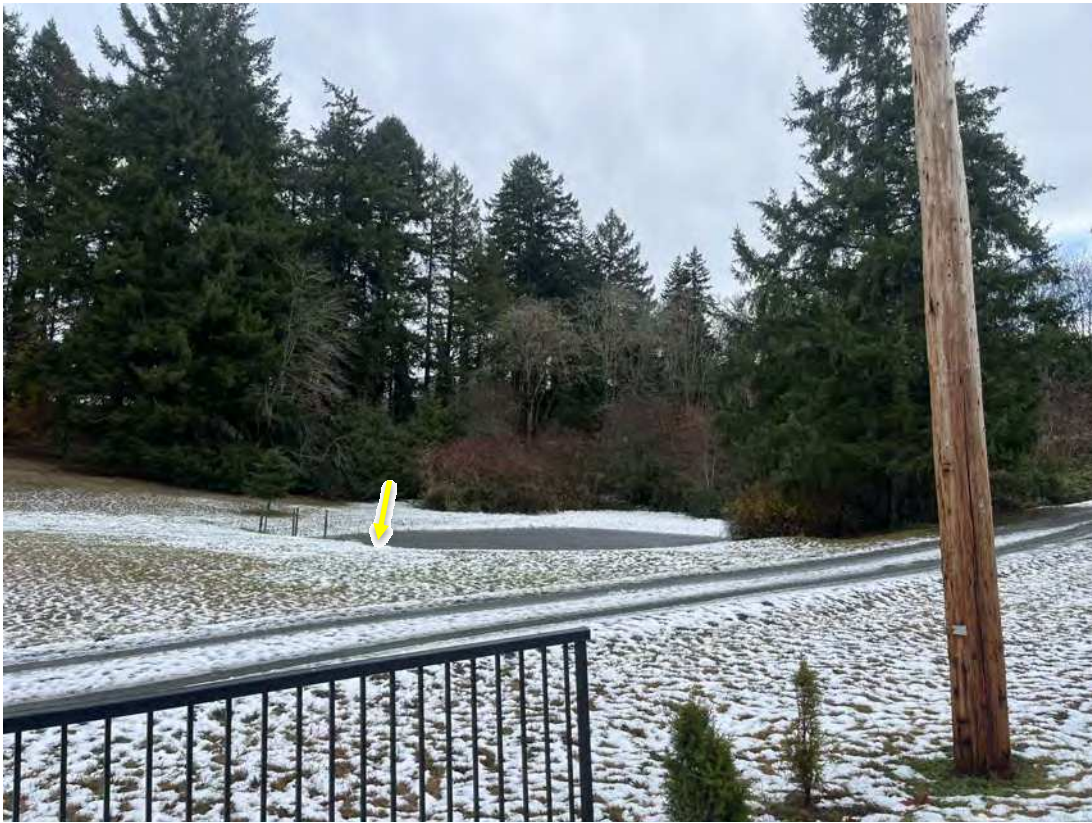
Figure 12. Standing on 1937 Maple Bay Road driveway looking southeast across 1933 Maple Bay Road toward the wetland which provides the headwater for Stream 1. Yellow arrow indicates the headwall. Image taken on November 30, 2022.

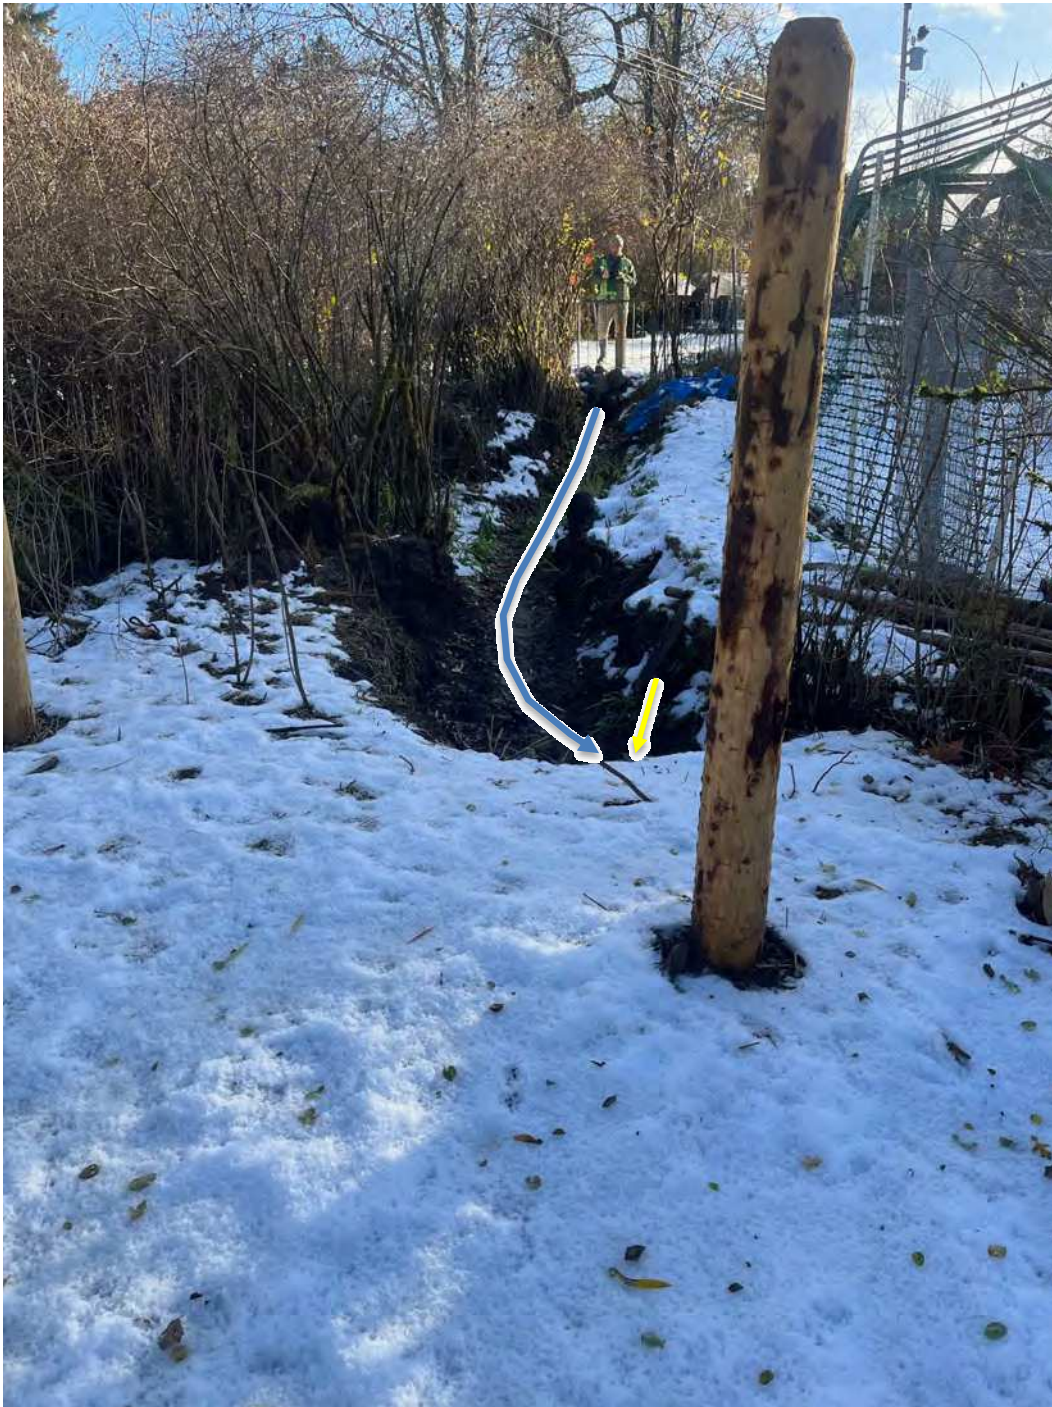
Figure 13. Looking upstream (southeast) at the recently daylighted stream channel on 1937 Maple Bay Road (Figure 10). Yellow arrow indicates the buried culvert inlet.

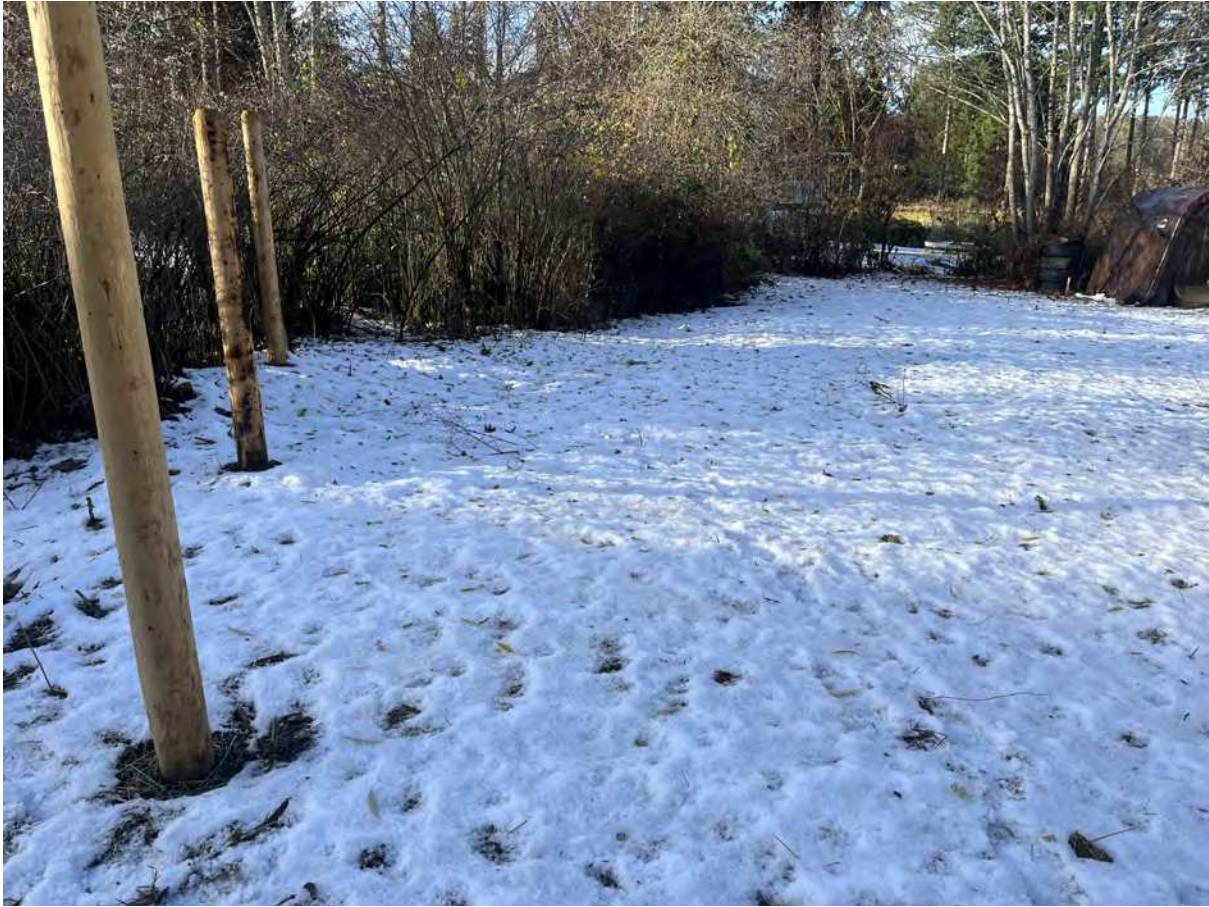
Figure 14. Looking northwest across the subject property along the alignment of the buried culvert on 1935 Maple Bay Road, toward the drainage ditch on 1949 Maple Bay Road (Figure 10).

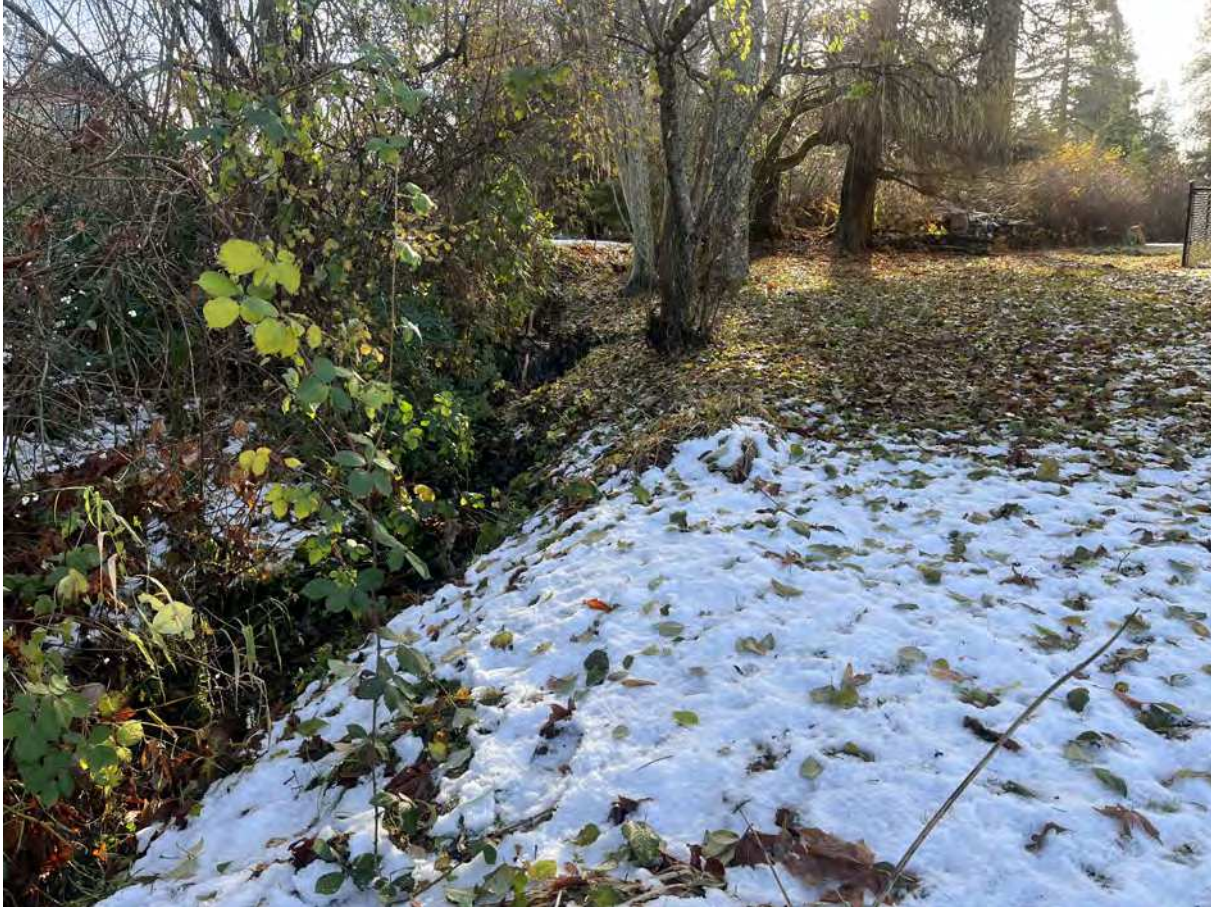
Figure 16. Looking upstream (south) at the moderately entrenched Ditch 1 on 1949 Maple Bay Road. Note the turf lawn and copse of trees on the west side of the channel. The culvert discharge shown in Figure 15 lies to the left of this image.

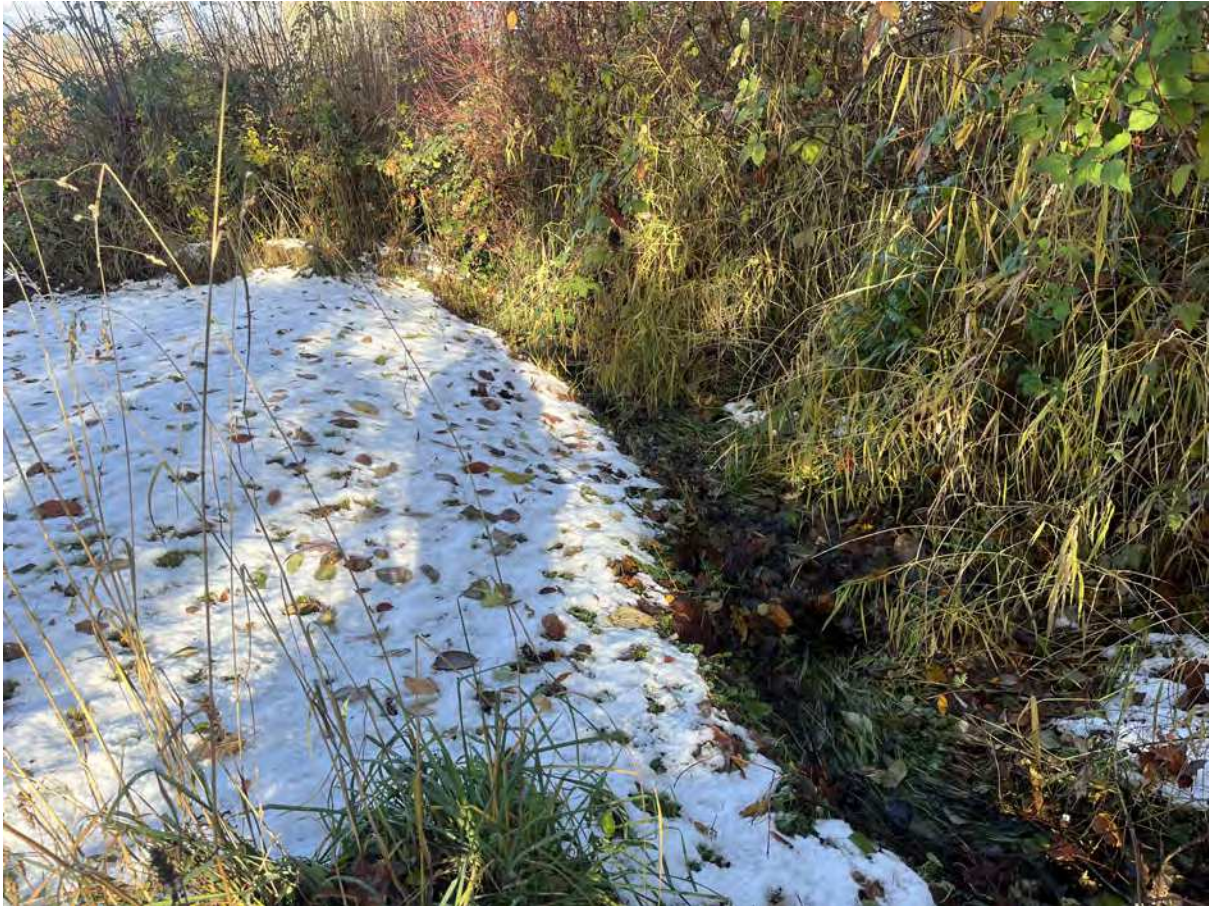
Figure 17. Looking downstream (north) at the moderately entrenched drainage ditch (Ditch 1) on 1949 Maple Bay Road. The culvert discharge shown in Figure 15 lies to the right of this image.

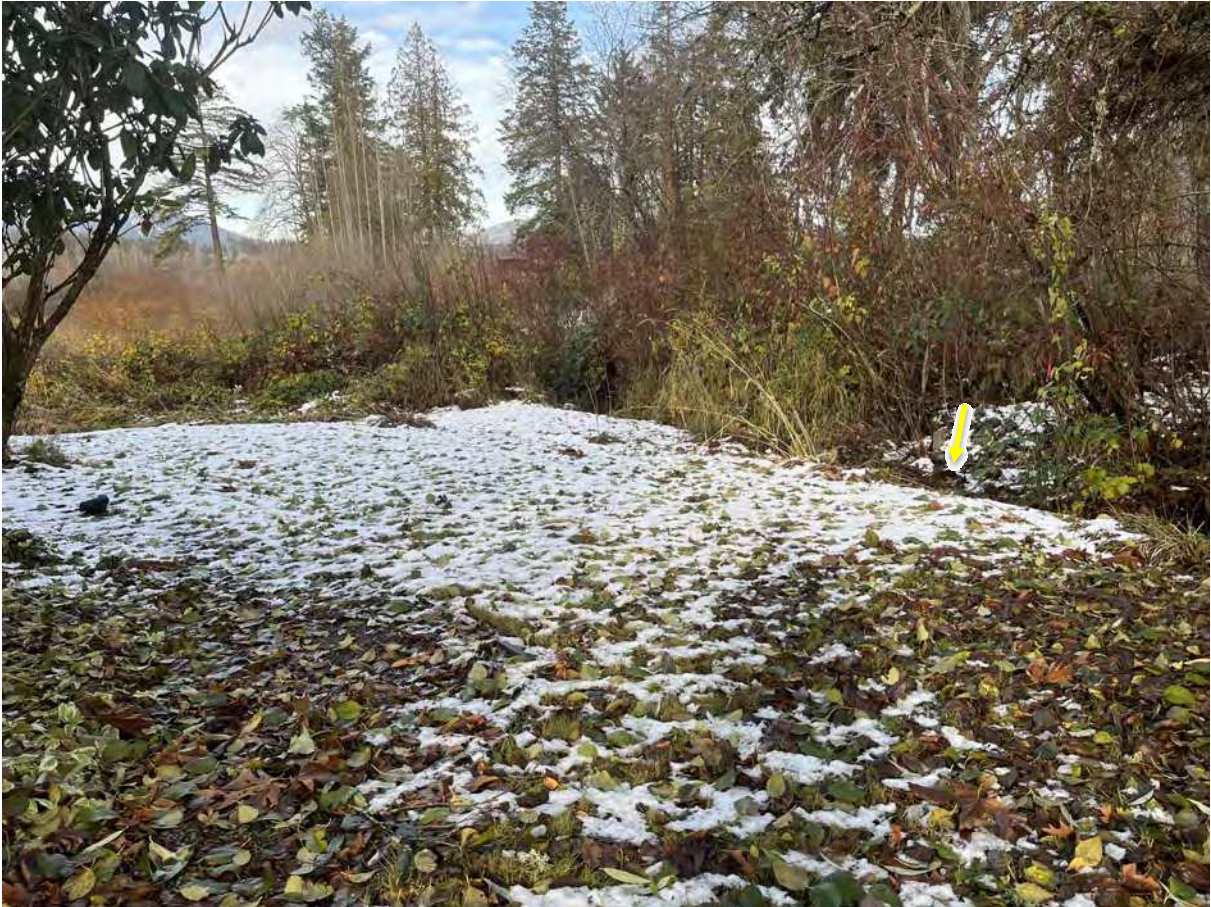
Figure 18. Looking downstream across the turf lawn on 1949 Maple Bay Road that lies along the west side of Ditch 1. Yellow arrow indicates the buried culvert outlet.

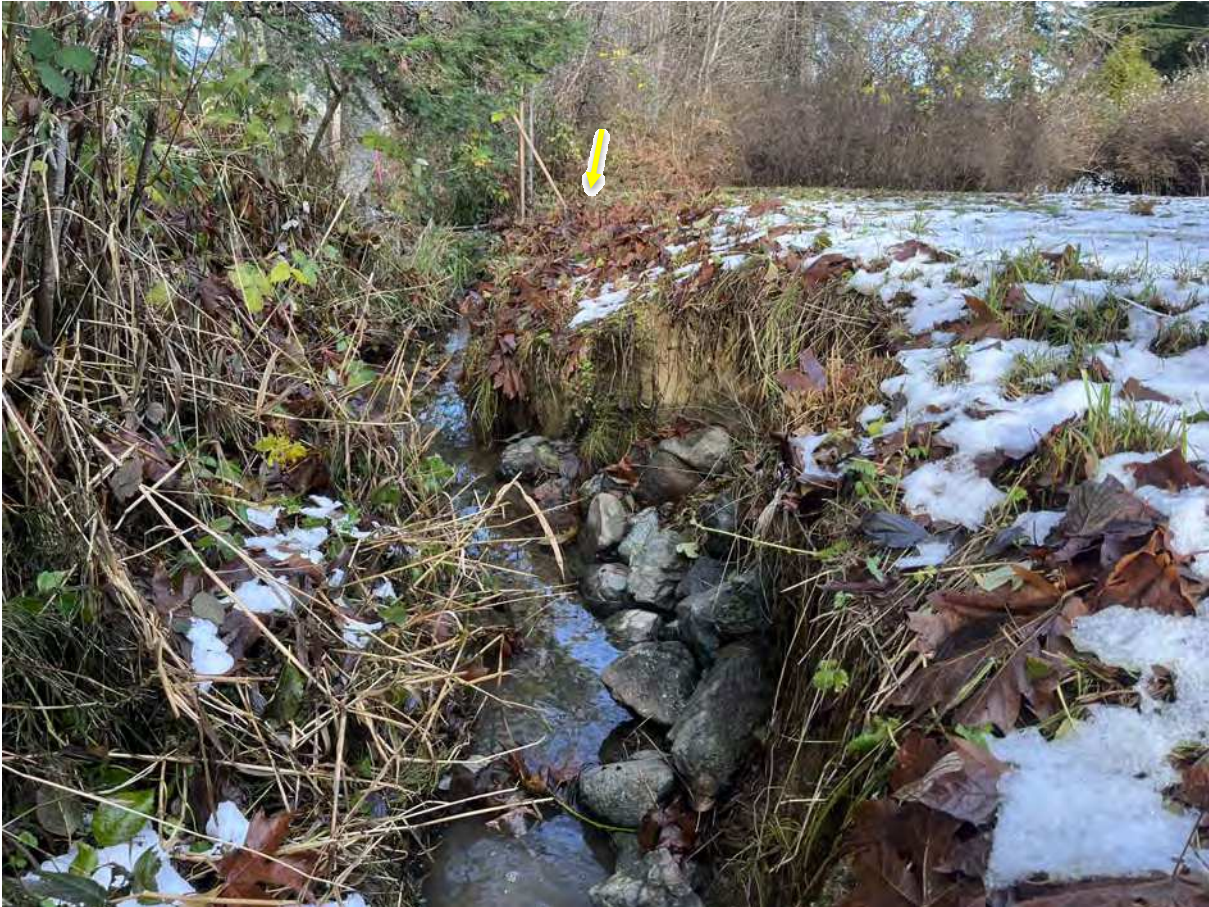
Figure 19. Looking downstream along Ditch 1 (1937 Maple Bay Road). Note the turf lawn on the east side of the channel, the moderate channel entrenchment, shrub understory on west bank, and the rock armouring placed in the channel to try and arrest bank sloughing on the east side. The yellow arrow indicates the property boundary between 1935 and 1937 Maple Bay Road (Figure 10).

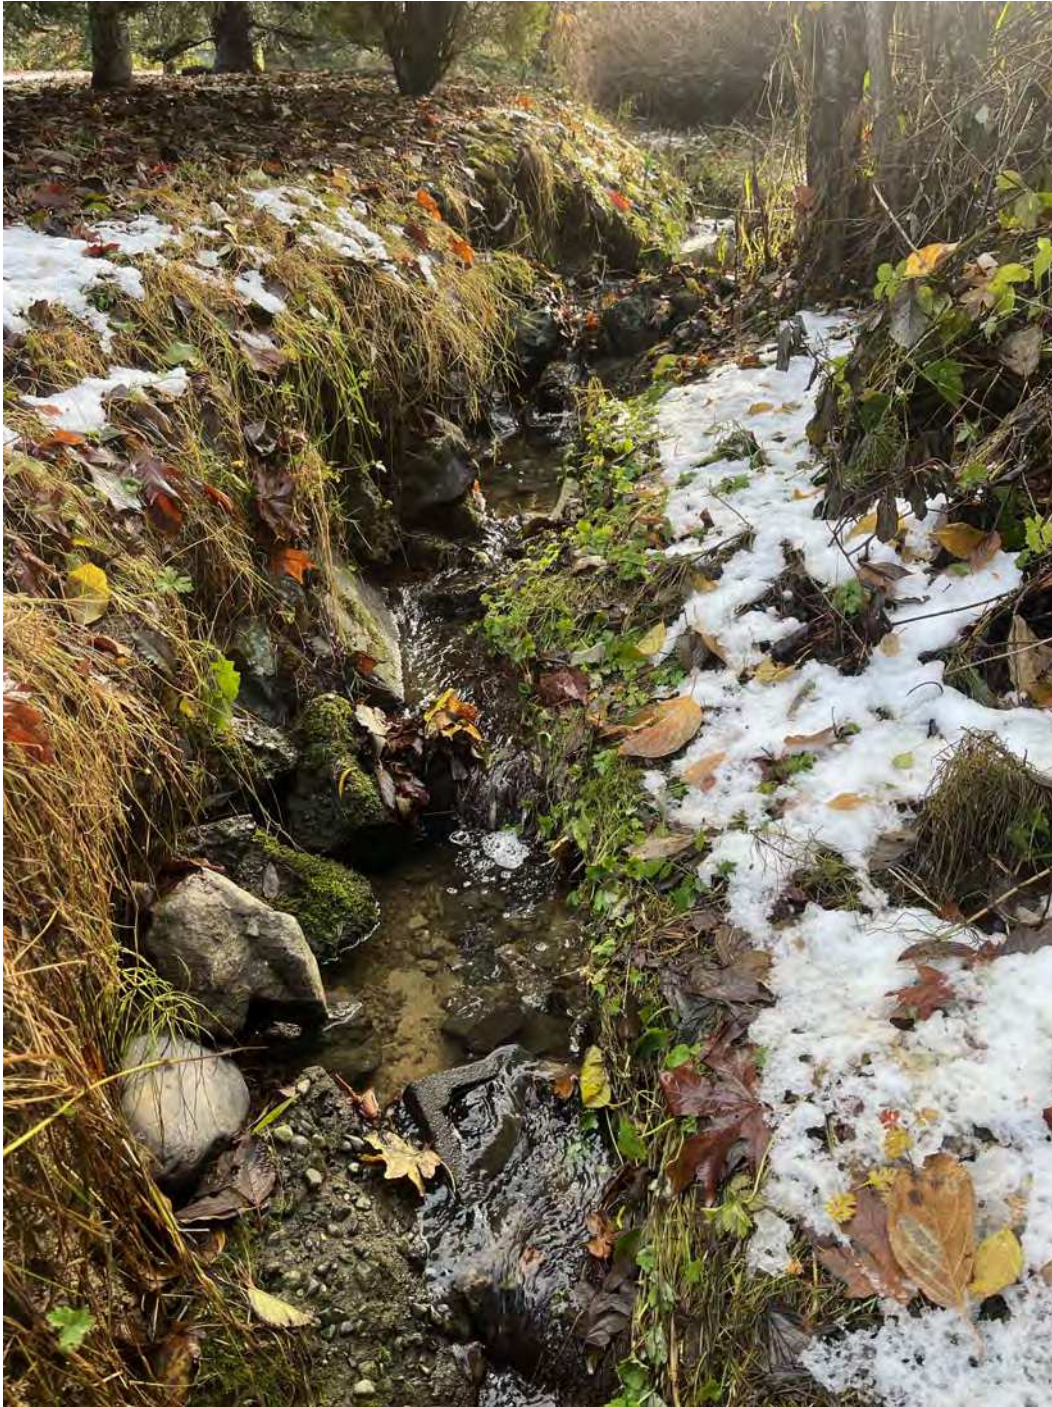
Figure 20. Looking upslope at the moderate entrenchment of Ditch 1 on the east bank and a terraced step on the west bank. Attempts at armouring the east bank have been made but with no success (this is not an appropriate method for protecting the bank). The grasses and small shrubs have stabilized bank soils on the west bank. The concrete, asphalt, and river rock have created small weirs and the flow tumbles over these structures, enhancing oxygen concentrations in the water. The few trees on the east bank do not contribute to bank stability, *i.e.*, their roots are too far from the bank soils to stabilize bank soils.

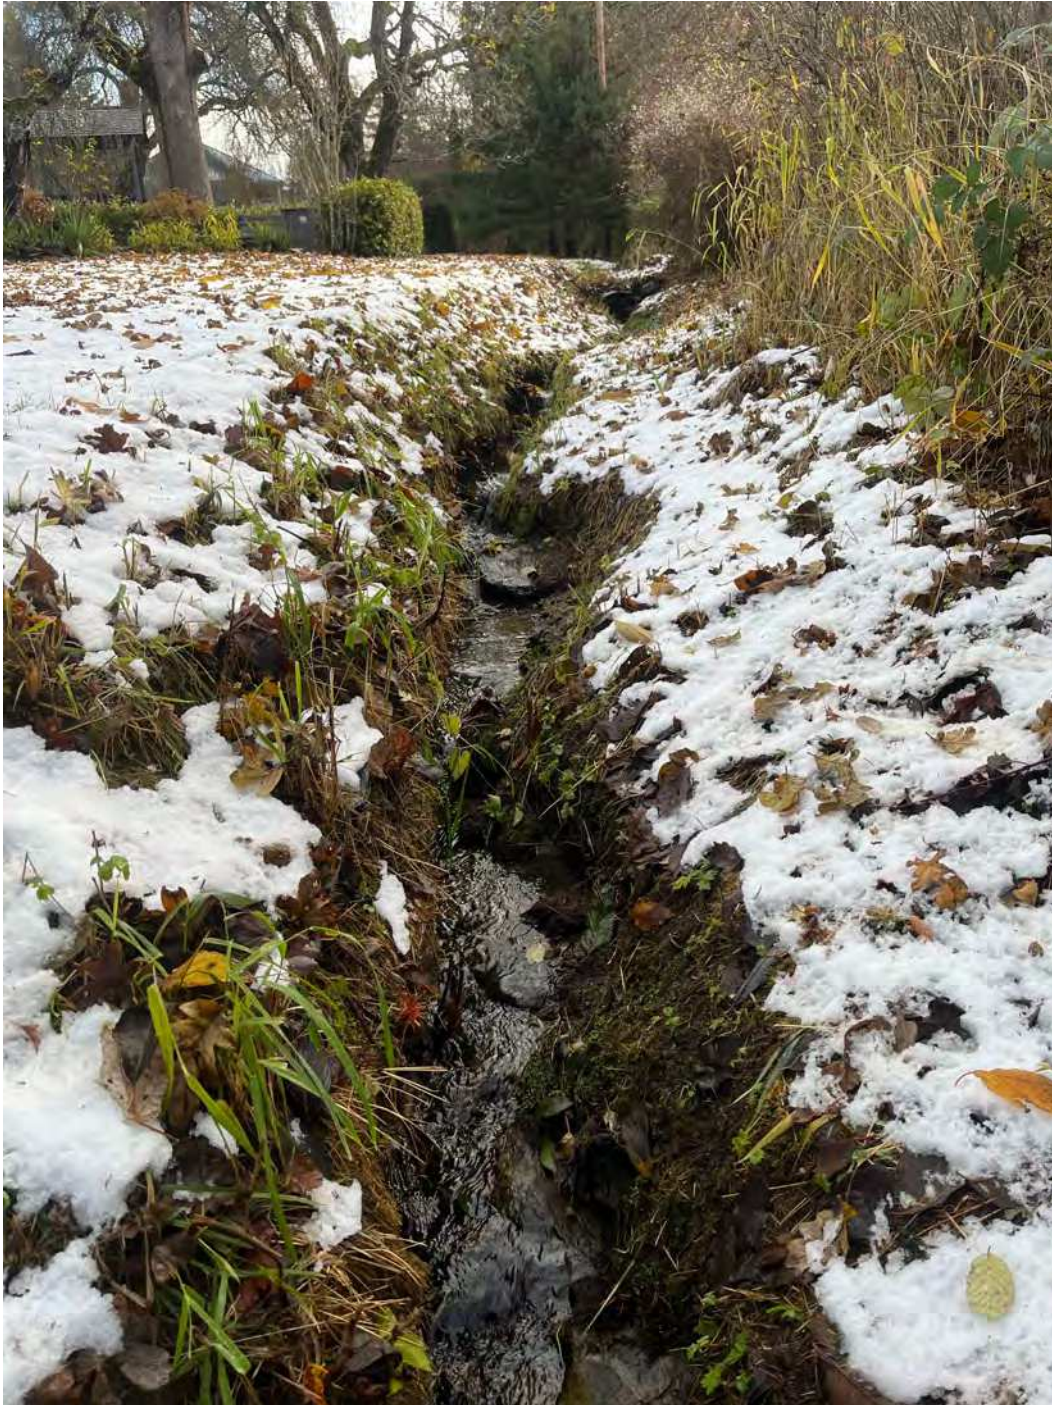
Figure 21. Looking further upslope along Ditch 1 in a section with moderate entrenchment on both banks. These upslope reaches would benefit from a shrub and tree planting program, to re-establish adequate root masses for stabilizing bank soils, for maintenance and recruitment, and shade.

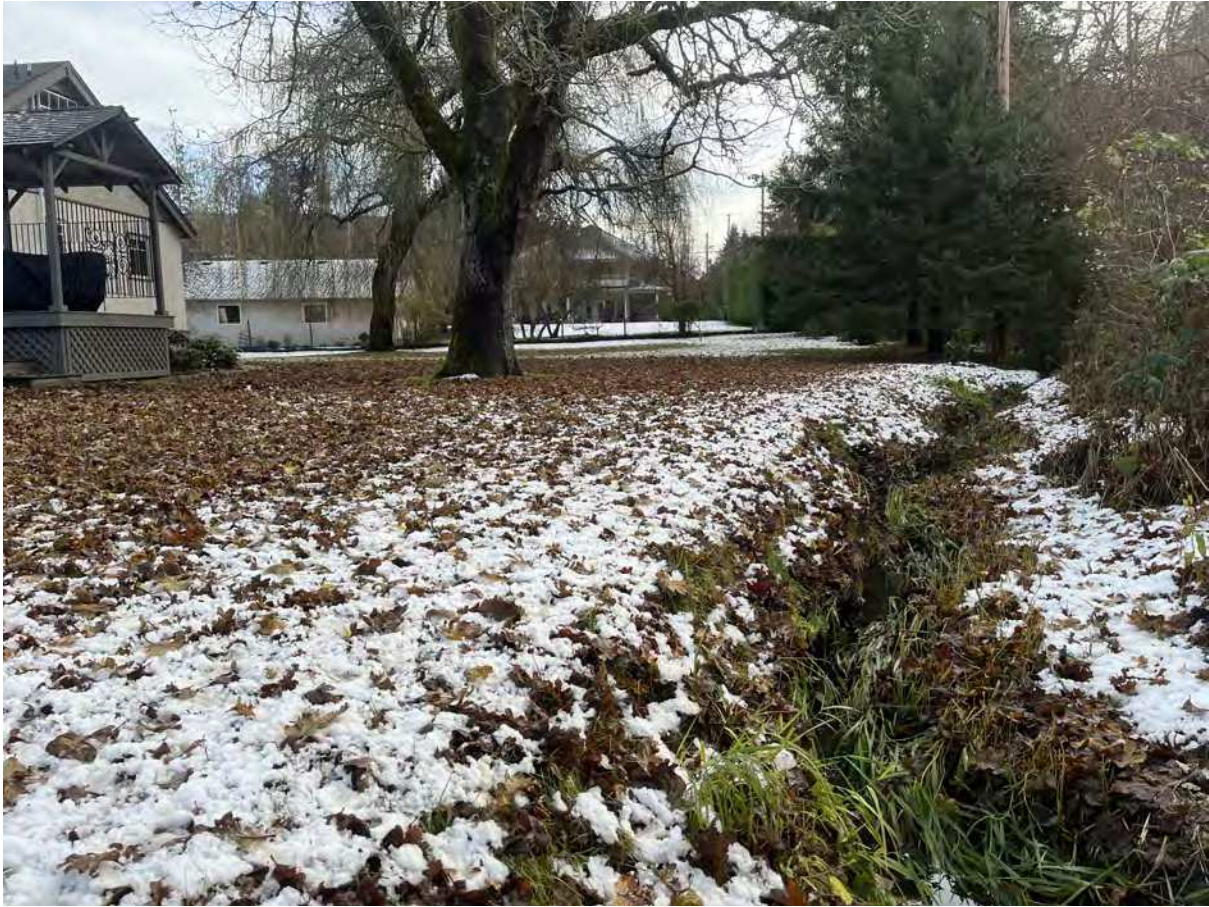
Figure 22. Looking further upslope along Ditch 1. The east riparian area is dominated by turf lawn, with entrenched banks on both sides of the channel. The vegetation on the west bank provides some shade during the summer months.

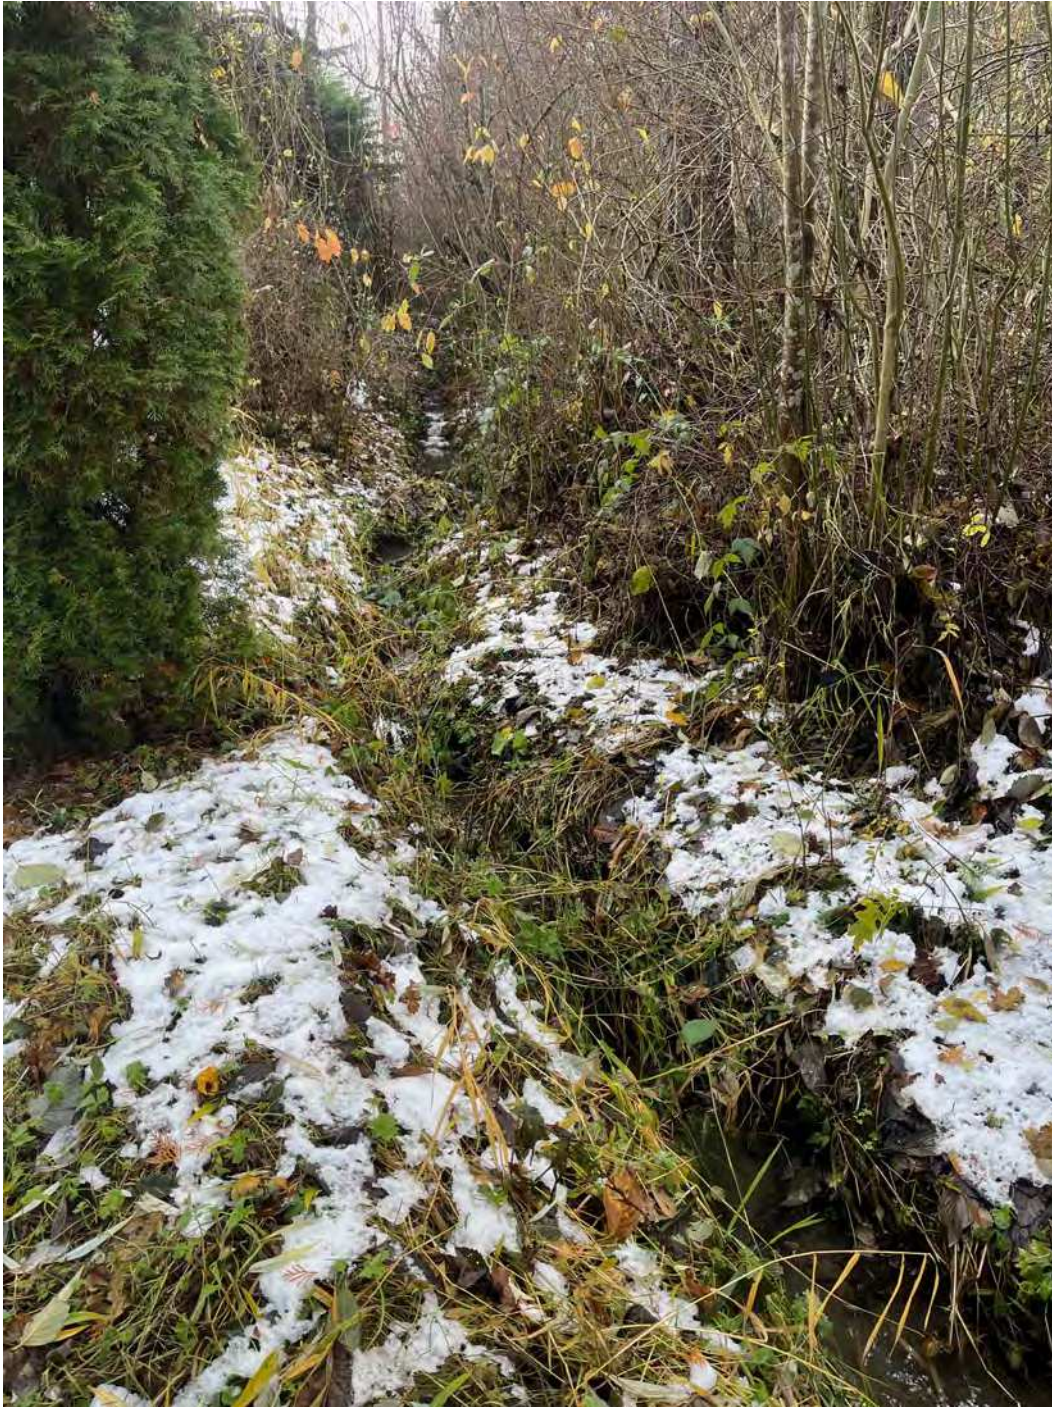
Figure 23. The uppermost section of Ditch 1 (~50m downstream of the culvert outlet under Maple Bay Rd) has a non-native cedar hedge on the east bank and a shrub-dominated vegetated west bank. The channel remains entrenched, with agronomic grasses assisting in providing some bank soil stability. This section has considerably more shading of the channel than the reaches downslope. There is moderate blackberry invading the hedge and shrub community.

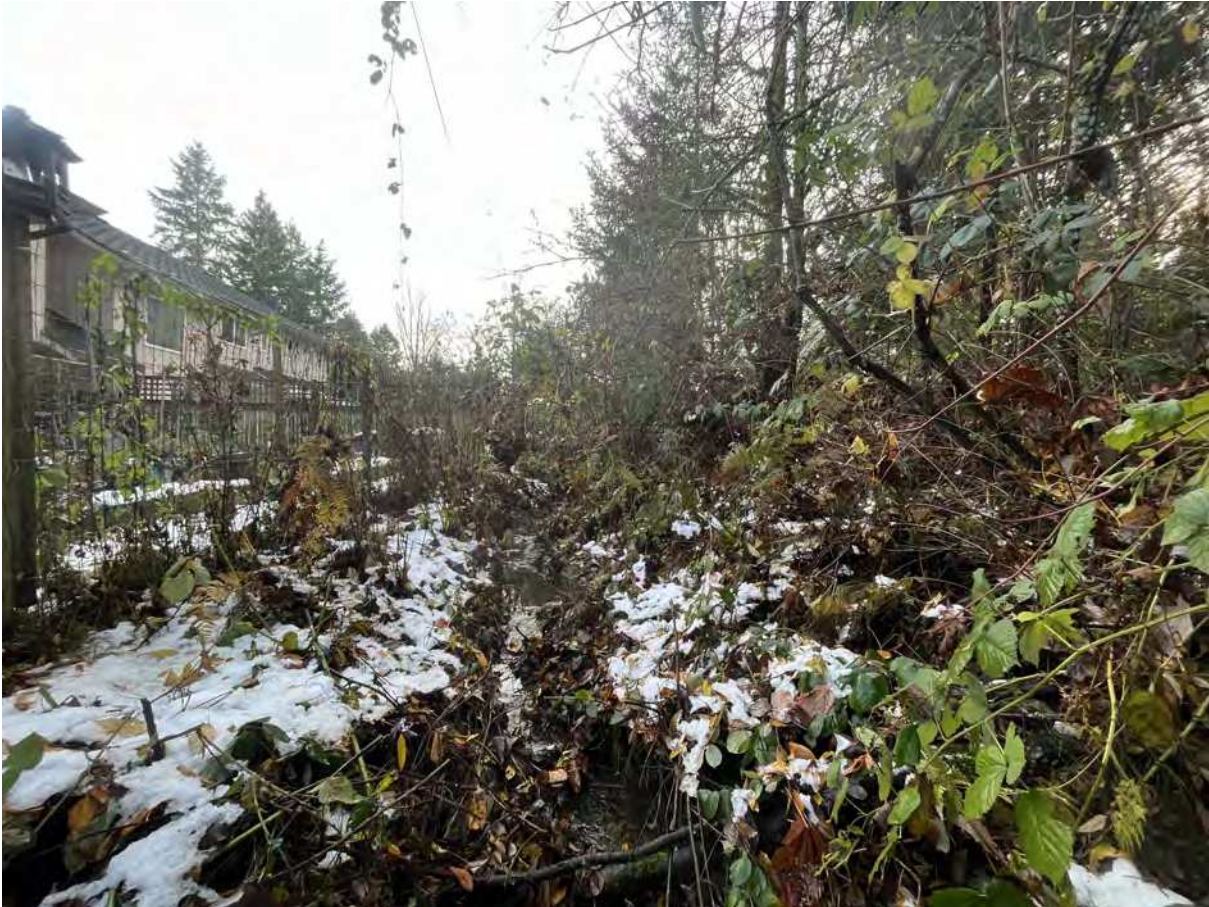
Figure 25. The uppermost section of the drainage channel has a sparsely vegetated east bank (which is fenced) and a mixed shrub / treed canopy on the west bank.

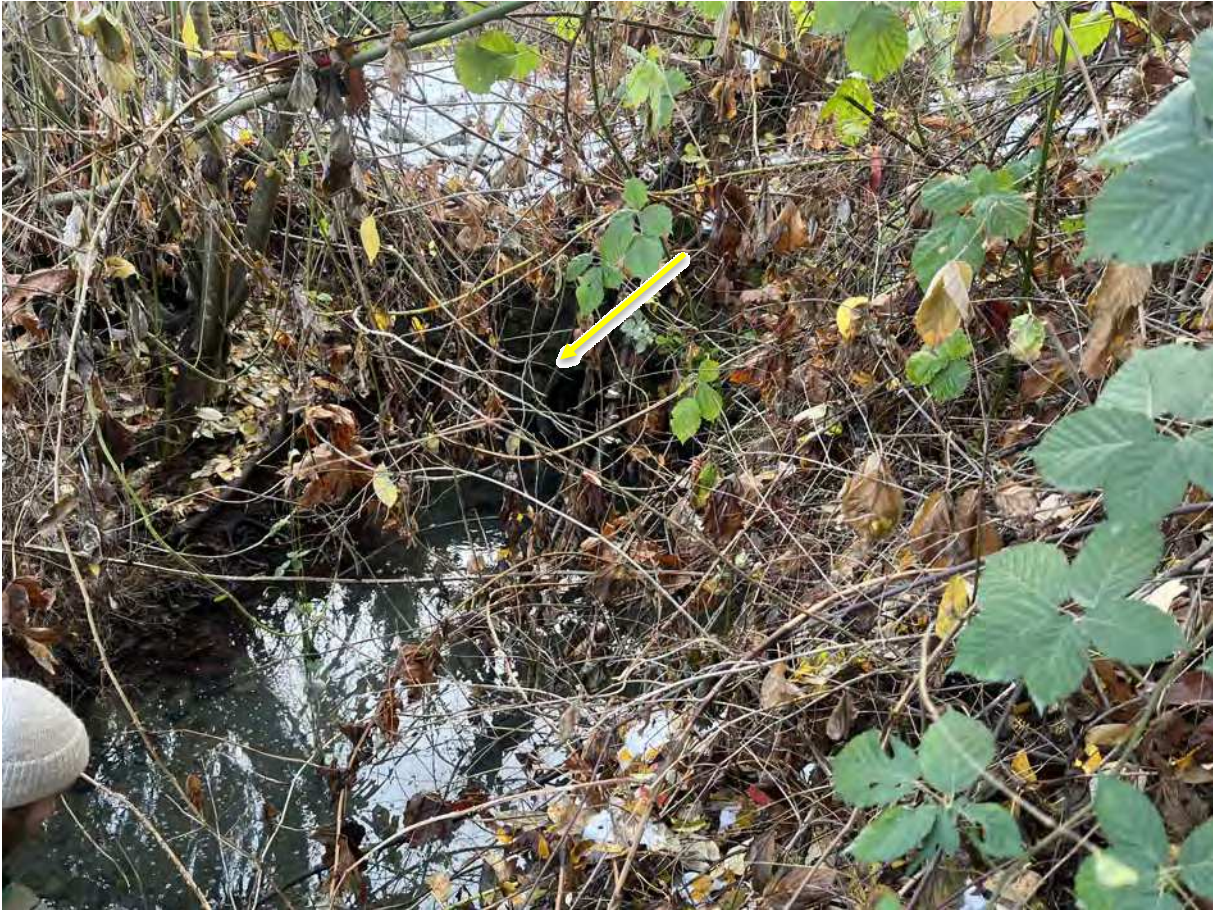
Figure 26. The culvert under Maple Bay Road (yellow arrow) discharges into a small, shallow plunge pool, whose banks are vegetated primarily with blackberry bushes.

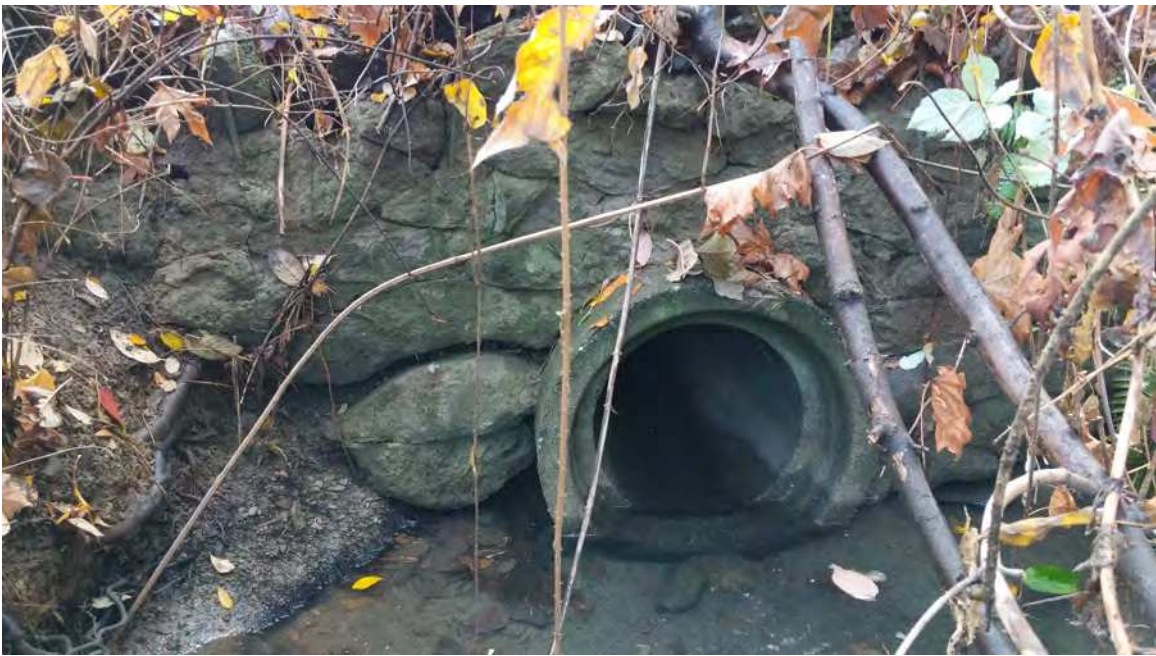
Figure 27. The outlet of the culvert under Maple Bay Road and its shallow plunge pool; the shallow plunge pool indicates there are typically insufficient stormwater volumes to scour a deep plunge pool at the outlet.
