1935 Maple Bay Road Unnamed Tributaries to Quamichan Lake

Riparian Areas Protection Regulation Assessment Report

December 15, 2022

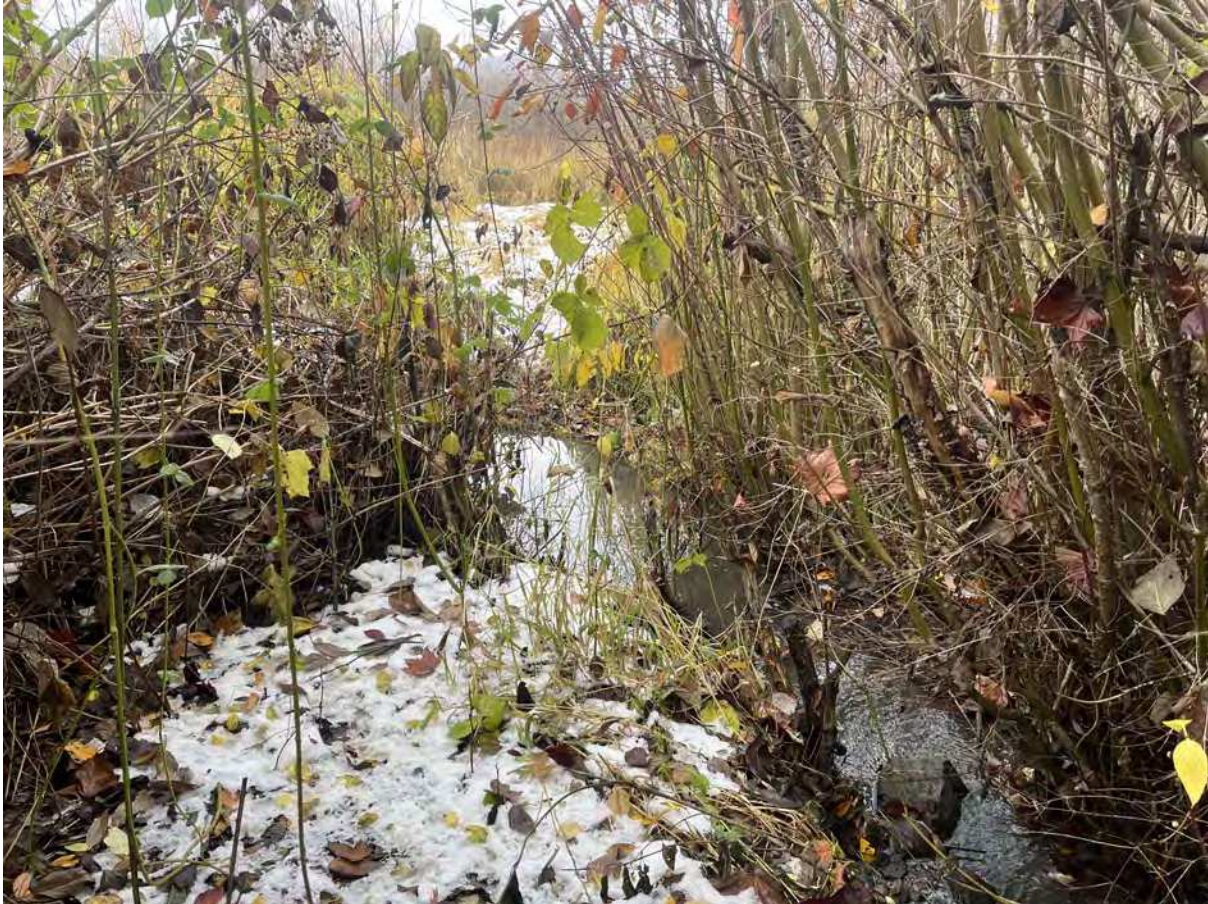
Figure 28. Looking downslope at the discharge end of the drainage ditch (Ditch 1) as it discharges into Wetland 1. This section of the channel has a wider channel width than the channel upslope of this section, with the banks being stabilized by a mixed agronomic grass and shrub plant community. The reed canarygrass field can be seen in the background.

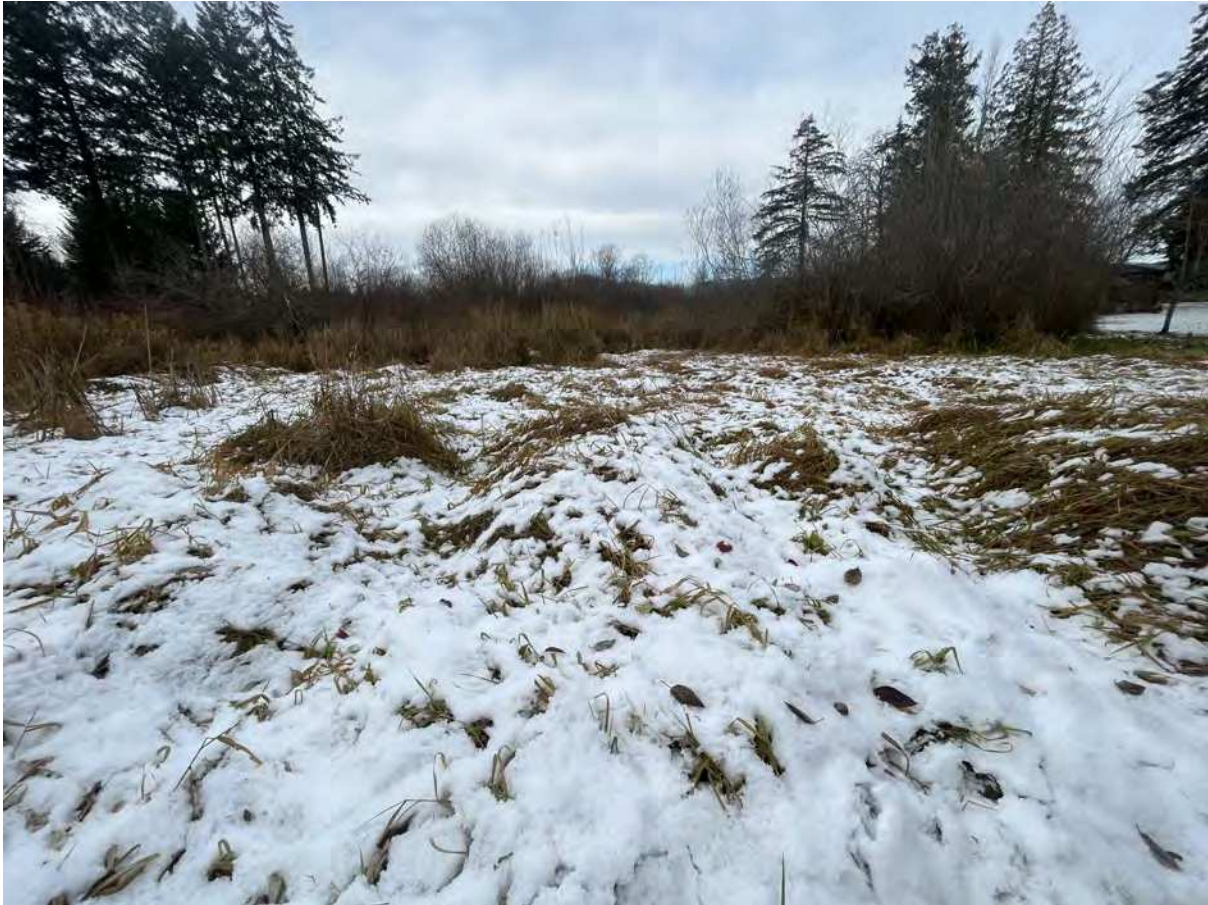
Figure 29. Looking northwest across the reed canarygrass field which is the extension of Wetland 1. This field functions to convert concentrated channel flows into sheet flow, functions as a large sediment trap, and stores significant volumes of infiltrated water, in its soils, during drier periods of the summer. The stored water slowly percolates downslope through the moist riparian soils, eventually flowing into Quamichan Lake.

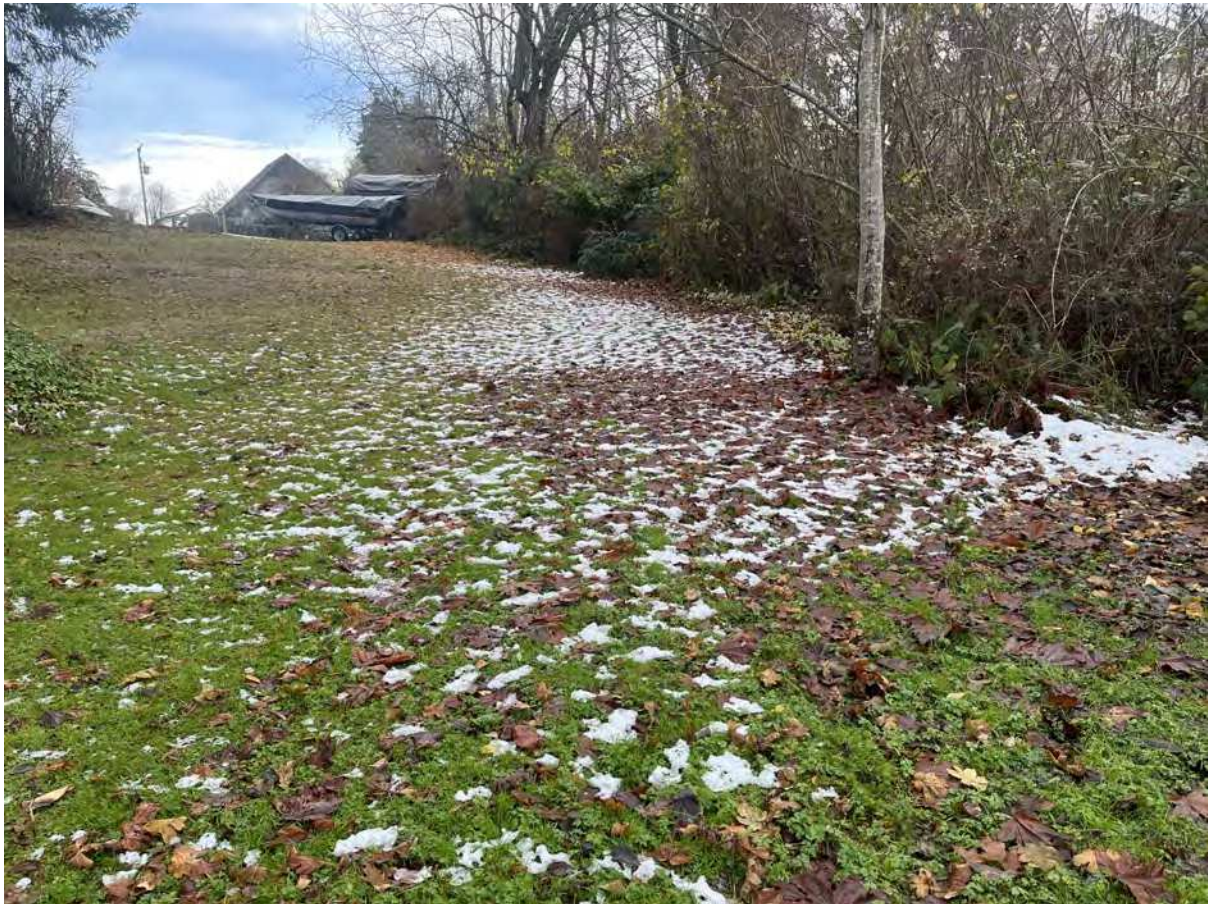
Figure 30. Looking south (upslope/ upstream) along the eastern edge of the drainage ditch (Ditch 1) inside the SPEA on 1935 Maple Bay Road. The plant community is dominated by shrubs, agronomic grasses, with a few red alders. A Douglas fir is just visible at the upper left hand corner of the image. This grass field is mowed on a regular basis, during the summer and early autumn. The undulating riparian plant community is ~5m in width.

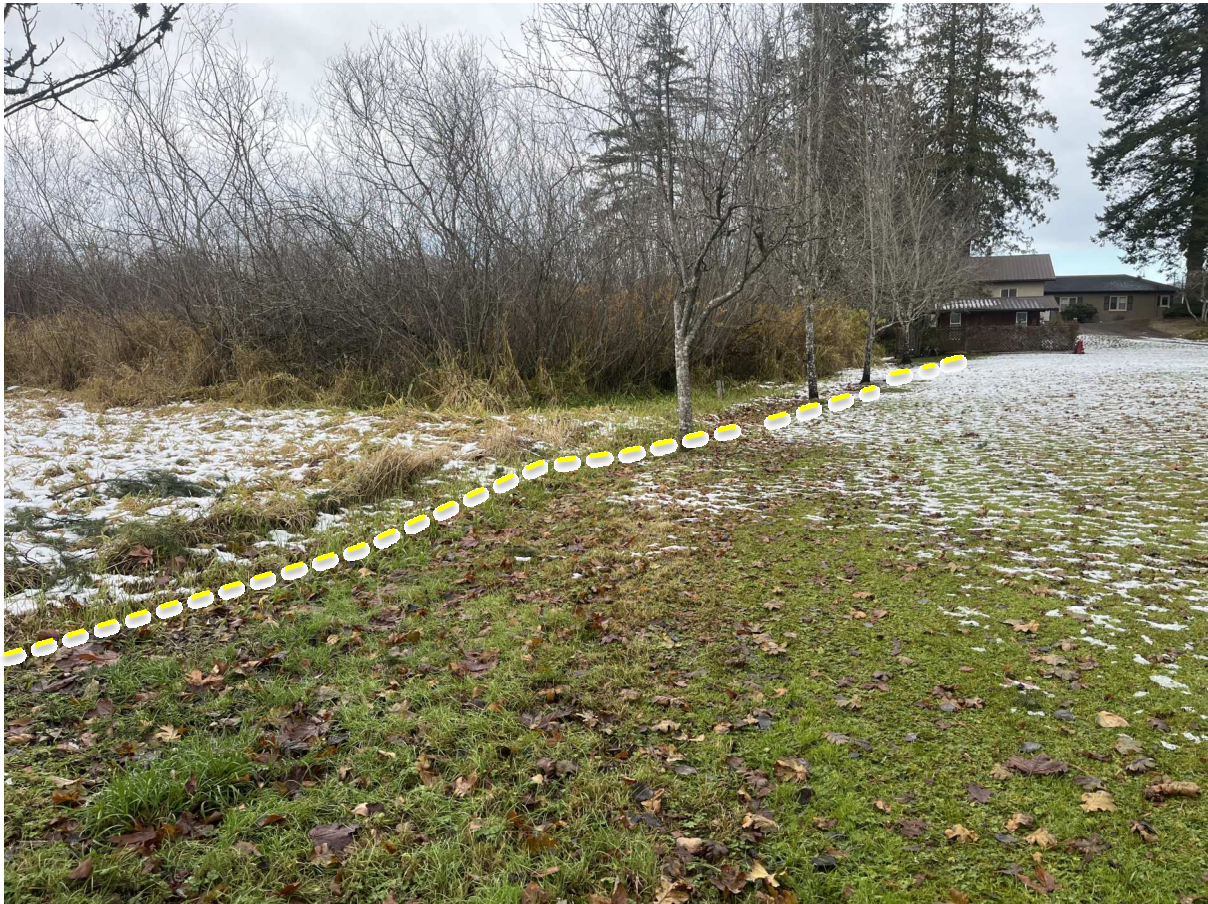
Figure 31. Wetland 1. The SPEA from this wetland extends onto the subject property on the right side of the photo. Looking north along the eastern edge of the wetland showing reed canarygrass and turf lawn. The dashed yellow line is the approximate eastern “edge of water” of the wetland (Figure 10). The dashed yellow line is the approximate eastern extent of the winter surface flooding. There are no channels in the reed canarygrass or in the shrub zone beyond the reed canarygrass, as this field functions under sheet flow.

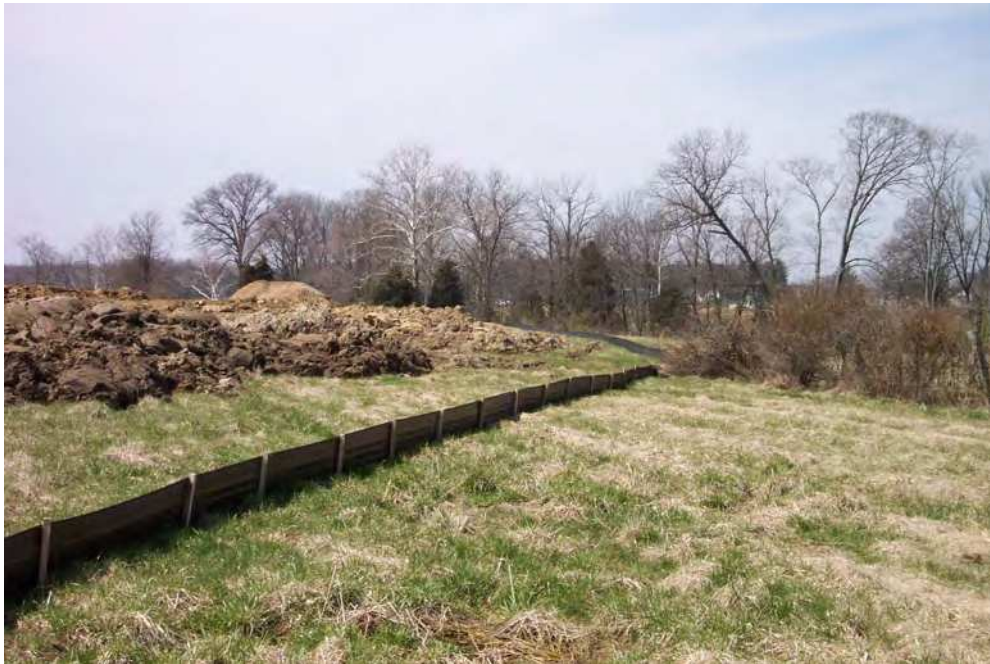
Figure 1. An example of a properly installed silt fence. The fence is tight and the posts are on the downstream (downhill) side. There are no gaps under the fence.

4. The posts anchoring the fence should be on the downstream (clean) side. This allows water to push fabric against the posts, rather than pull it away from the posts which could cause the fence to fail.

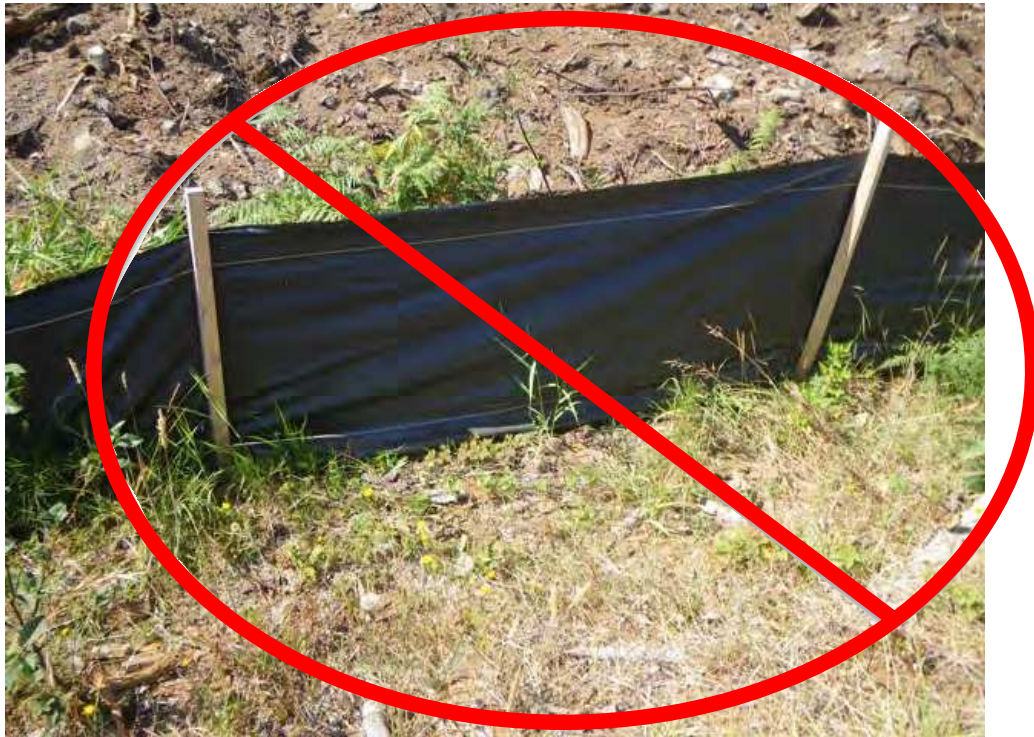
Figure 2. An example of an incorrectly installed silt fence. The posts are on the correct side of the fence, but the tail is not buried at all. The coloured line along the edge of the fence is still clearly visible, and it is less than 5 cm from the bottom. This fence will not control runoff.

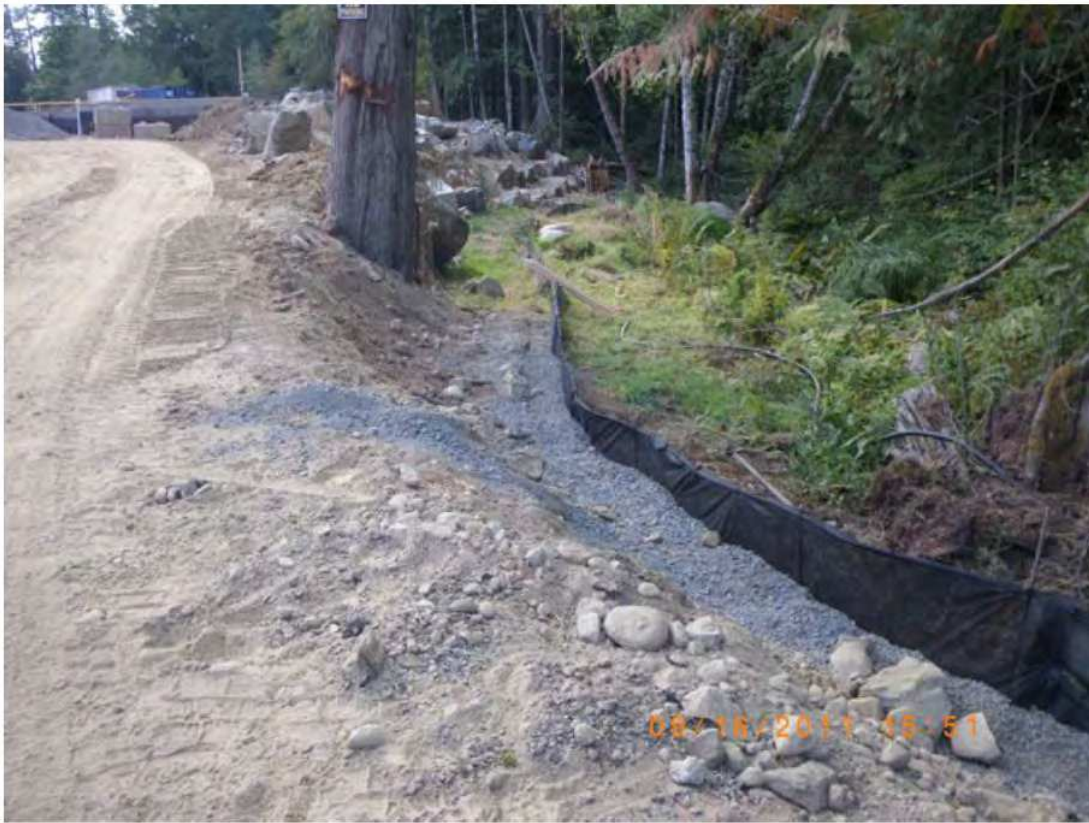
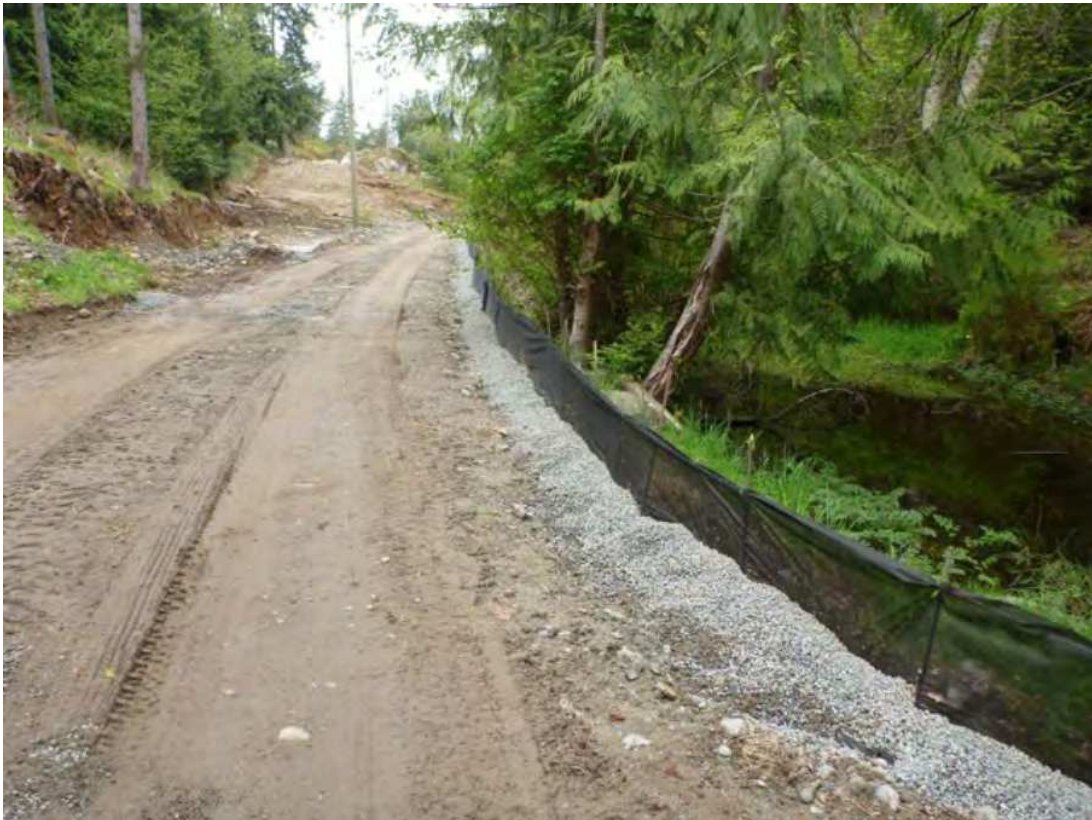
Figure 4. Two examples of silt fences installed with filtering pea gravel berms

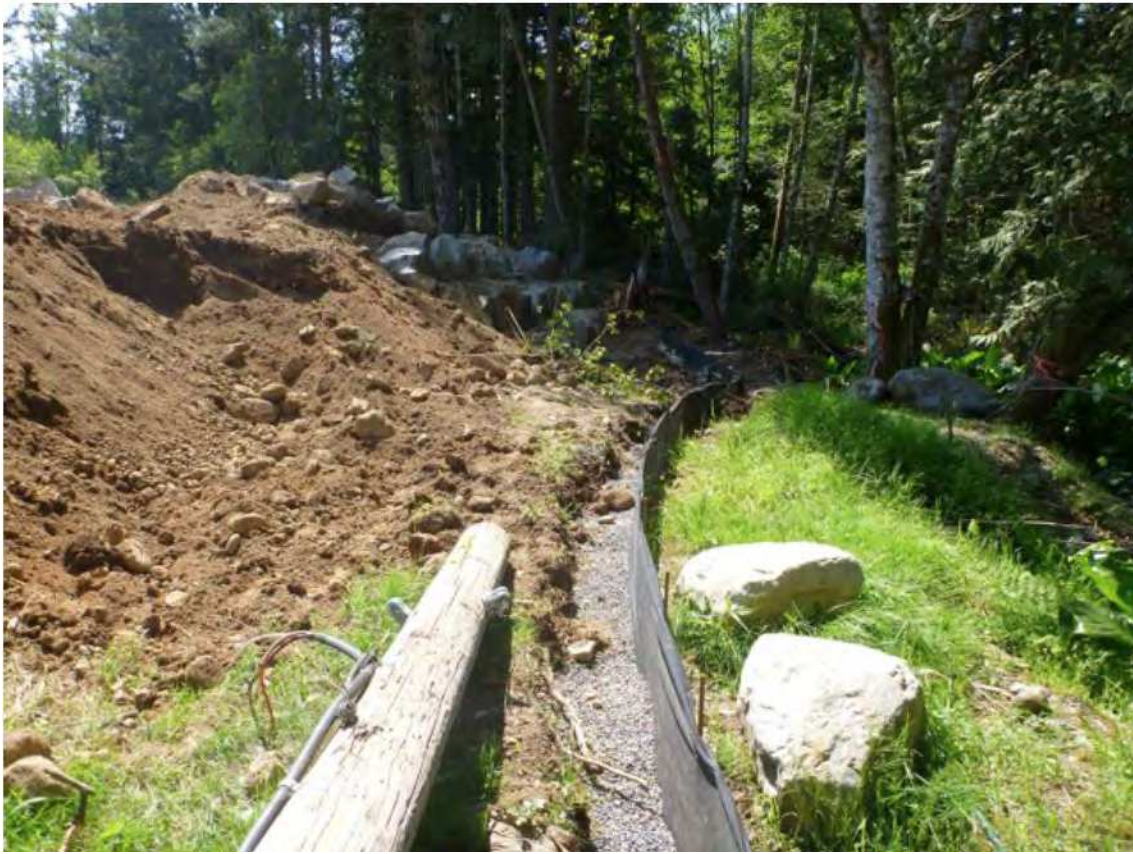
Figure 5. An example of a silt fences installed with filtering pea gravel trench.

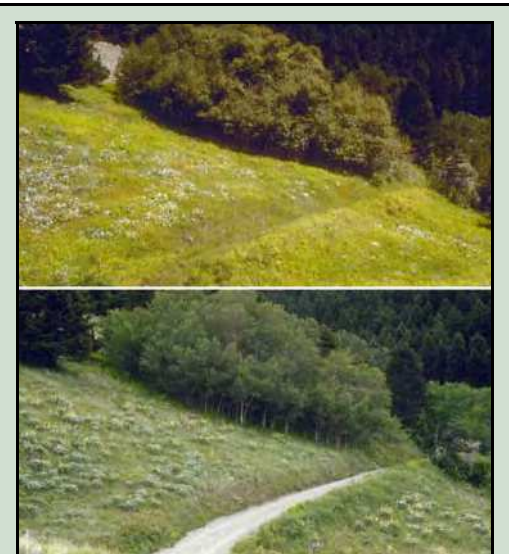
Figure 1—Photo point monitoring of a leafy spurge infestation before (A) and after (B) the introduction of copper leafy spurge flea beetles. (Photos adapted from Norman E. Rees, USDA ARS, www.forestryimages.org)

Photo point monitoring is an easy and inexpensive, yet effective, method of monitoring vegetation and ecosystem change (figure 1). It consists of repeat photography of an area of interest over a period of time, with photographs taken from the same location and with the same field of view as the original photo. With appropriate site marking and documentation, photos can be precisely replicated by different people many years apart.

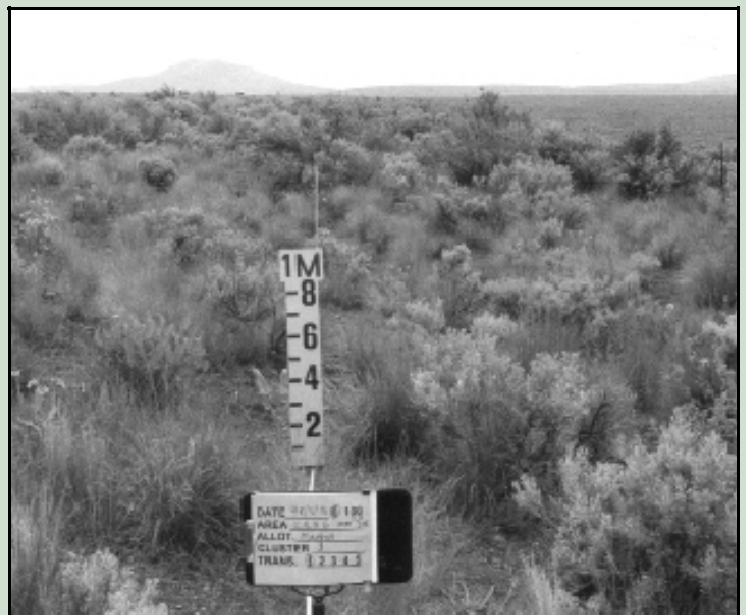
Figure 3—Photo point monitoring site showing a photo identification card and a meter board. (Adapted from Hall 2002.)

For topic photography, it may be desirable to place a meter board or other size control object at the photo point or near the subject of interest. A meter board provides a consistent point for camera orientation, a point on which to focus the camera, and a size reference that can be used to quantify change. Directions for constructing a meter board are provided in *A Weed Manager's Guide to Remote Sensing and GIS*. Meter boards are typically not used in general photography of scenes.
