Prepared By Gina Hoar, R.P.Bio.,
and Phaedra Douglass.

MUNICIPALITY OF NORTH COWICHAN SERVICE
AGREEMENT WITH THE SOMENOS MARSH
WILDLIFE SOCIETY
RIPARIAN RESTORATION REPORT 2024

Prepared for: Municipality of North Cowichan

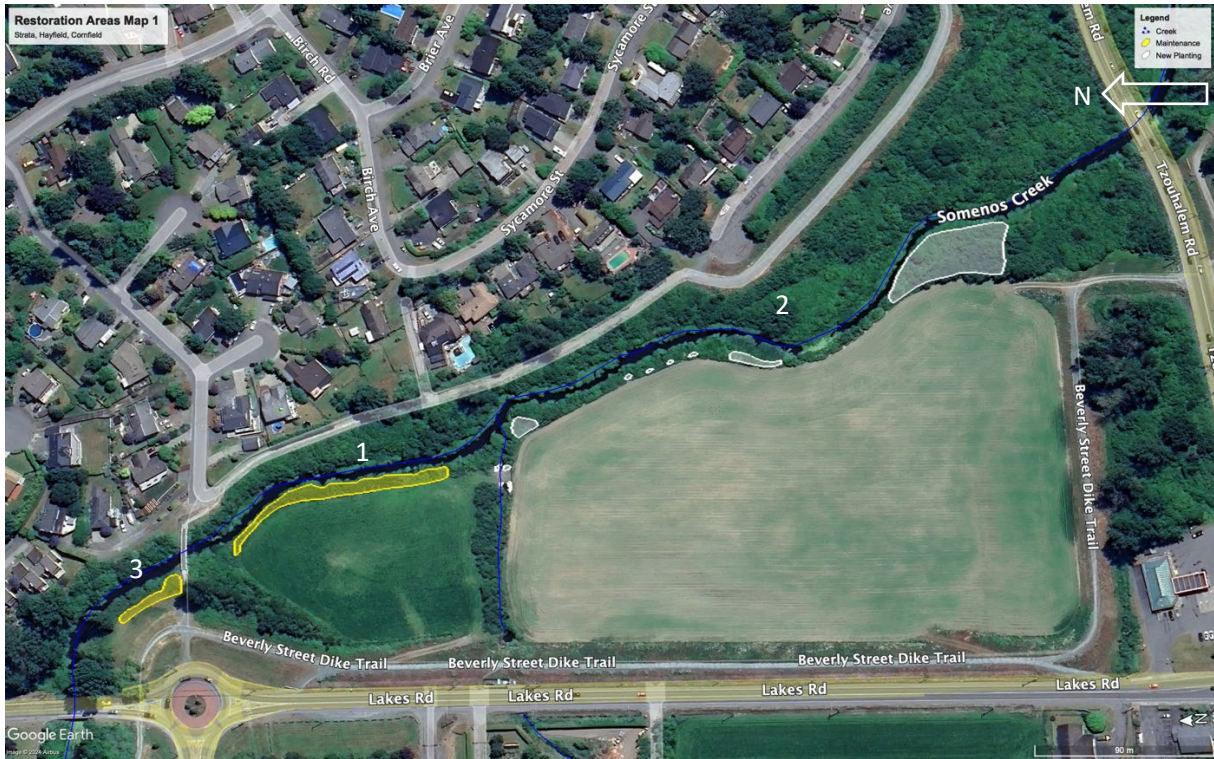
Figure 1: Map of 2024 planting locations along Somenos Creek. Yellow zones are maintenance planting sites (strata, hayfield), white zones are new (cornfield).

Four locations were chosen in 2024 to provide riparian shading (Figures 1-2). They include:

1. The hayfield south of the Lakes Road footbridge (hayfield)
2. The cornfield north of Tzouhalem Road (cornfield)
3. The southwest side of the Haycroft Chase Strata Property and Municipality of North Cowichan (MNC) Right of Way (strata)
4. The north side of Somenos Creek along the municipal park between Lakes Road and Seine Road (greenway).

The strata and hayfield were planted in 2023 with additional maintenance planting in 2024. The cornfield and greenway were new planting sites in 2024.

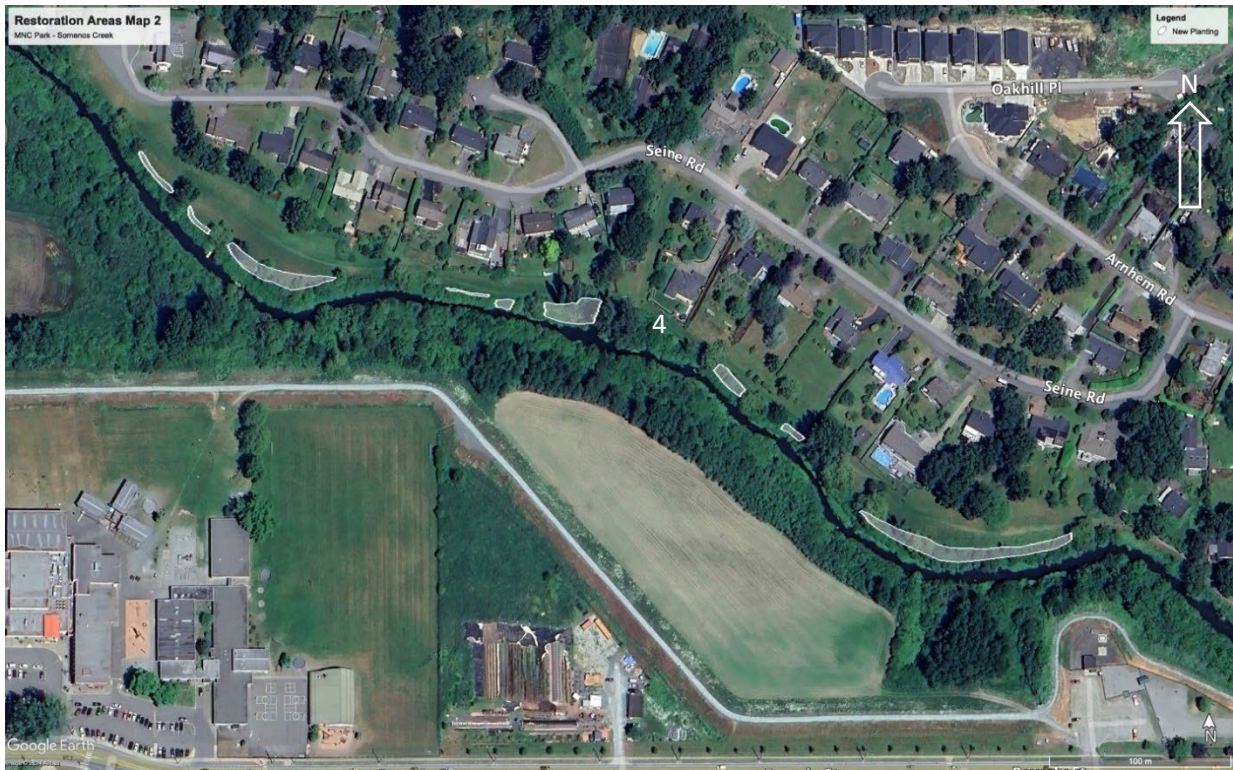
Figure 2: Map of 2024 new planting locations along Somenos Creek on the Municipality of North Cowichan’s Park greenway.

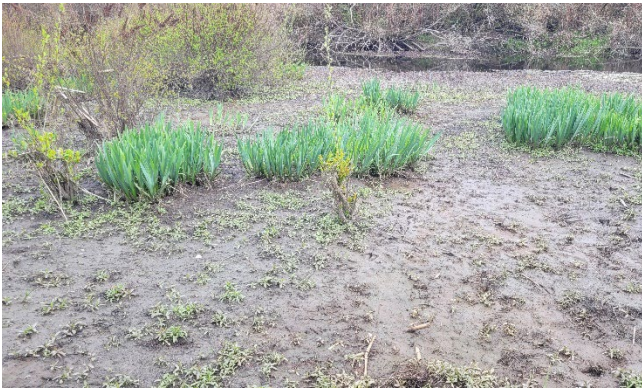
Figure 3: Image looking north along cornfield planting area, April 4, 2024.

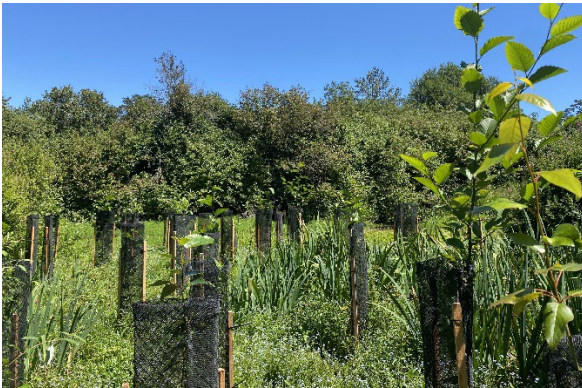
Figure 4: Image looking north along cornfield planting area, July 4, 2024.

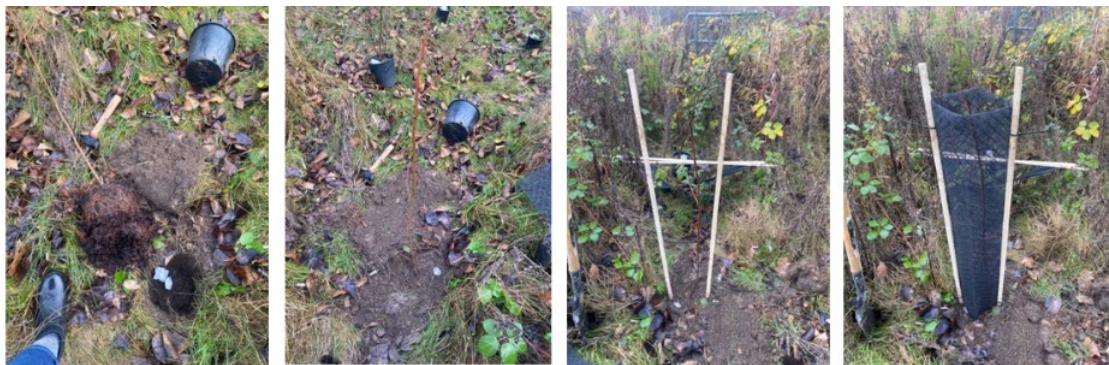
Figure 5: Photo series of the planting process.

After initial site visits in the spring of 2024, planting locations were identified and flagged on the shore side of the silt fence. Between April 25 and July 23, volunteers and SMWS staff planted one plant per square meter following the common practice of a high-density riparian restoration planting regime. Plants were planted in accordance with the Madrone report's recommendations: appropriately sized holes were dug, nutrient 'tea bags' were placed at the bottom of the hole, plants were removed from pots and root balls loosened then placed in the holes, ensuring that the base of the plant was flush with the surrounding ground. The holes were then filled in with the excavated soil and compressed to ensure no air pockets remained. After being planted, taller trees and shrubs were caged with two stakes and plastic premade caging, see Figure 5. Once planted, the plants in the northern section of the cornfield were watered until the soil around each plant was saturated. Plants in the southern half of the cornfield were not watered as the ground stayed saturated all summer. Periodically, the newly planted plants in the northern section of the field were checked and watered when needed.

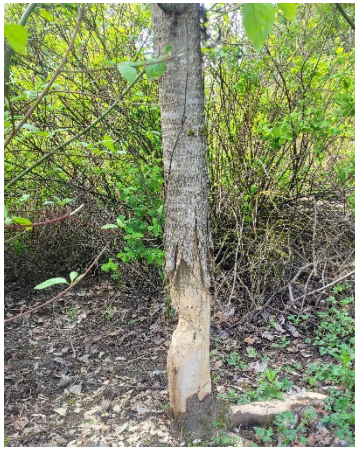
Figure 6: Spring survey identified browsing of existing trees along the Greenway April 29, 2024.

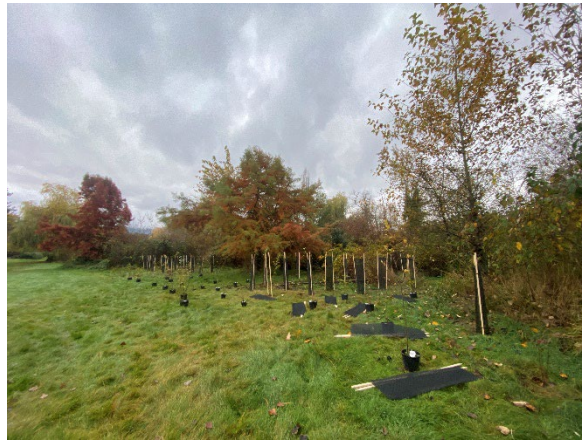
Figure 7: Greenway planting on Oct 31, 2024.

The planting site, located within the riparian zone along the eastern edge of Somenos Creek, is on the MNC greenway, between Lakes Road and the end of Seine Road. The greenway is a regularly mowed grassy park with limited riparian vegetation. Previous restoration efforts by the SMWS aimed to enhance the riparian area's function and provide shade for parrot's feather and were largely successful. However, some beaver activity was observed in early spring 2024, affecting uncaged trees (Figure 6). The MNC approved the planting of native trees and shrubs within the existing riparian area, extending a few meters into the greenway. Which allowed the SMWS to slightly expand the riparian zone and fill in gaps in the existing vegetation with tall trees and a diverse range of shrubs (Figure 7).

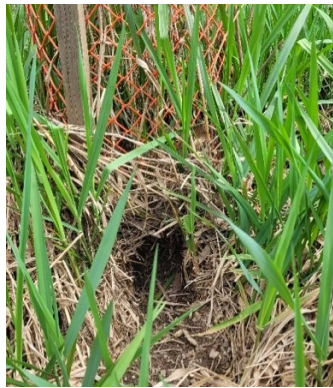
Figure 8: Image of a rodent hole which was using the reed canary grass as a winter nest. Chew marks around the base of the tree were observed.

A comprehensive inventory of the plant health took place on March 21, 2024. Initial monitoring results showed browsing from beavers, and other animals on the taller trees (red Alder, black cottonwood, and red cedar). Pear slugs (*Caliroa cerasi*) were also observed on some of the hawthorns and crabapples. To curtail future browsing, caging was set around existing select trees, and to control the pear slugs the leaves were sprayed with high pressure water during watering to rid them of the slugs. Watering occurred through the summer of 2024 weekly when needed and SMWS re-planting from April to June 2024. The new trees were caged to prevent future browsing. Planting methods followed those used at the cornfield, described in Section 2.3.1.2, and they were watered on a weekly basis through the summer.

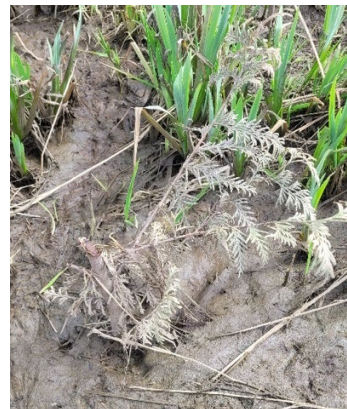
Figure 9: Cedars survived flooded conditions; however, all were uncaged and were browsed by beaver.

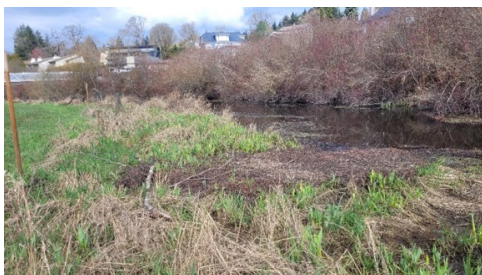
Figure 10: Parrot's feather also covered many trees planted close to the edge of the creek where it was prone to flooding. This area was not replanted.

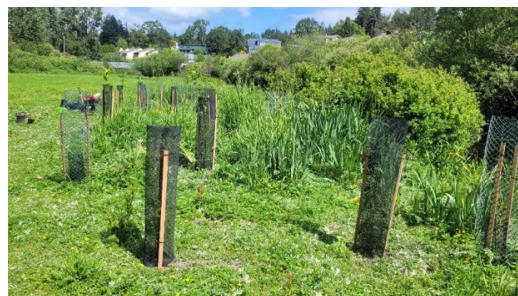
Figure 11: Image of hayfield replanted and caged looking north

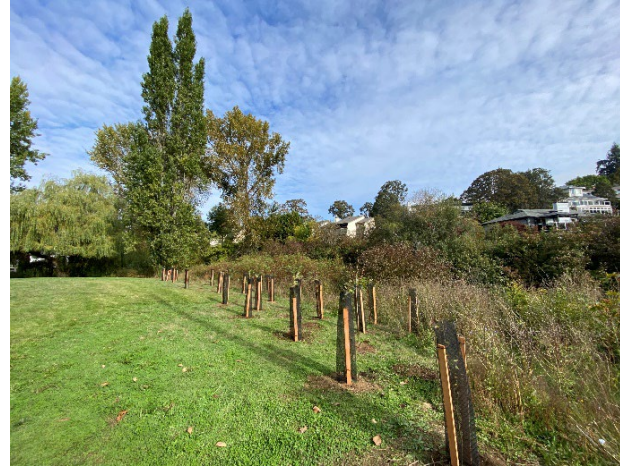
Figure 13: Image of completed plantings with cages at the strata.

Monitoring of the site in the spring of 2024 indicated that survivability rates were good amongst the trees planted closest to the creek bank, including the Sitka spruce, hardhack, and red osier dogwood. The Himalayan blackberries that were removed in previous years had encroached once again into the planting area; however, the amount had been reduced. Unfortunately, all the plants planted in the drier, more rocky section of the bank were accidentally mowed over. They did start to grow back by summer; however, they were mowed over a second time and did not survive. It became apparent that extra protection was required for each tree to limit future mowing damage and for pest protection. In October 2024, the blackberries were trimmed back, the mowed area was replanted and trees caged to protect them from browsing and easier to see when mowing.
