MUNICIPALITY OF NORTH COWICHAN SERVICE AGREEMENT WITH
THE SOMENOS MARSH WILDLIFE SOCIETY
PARROT'S FEATHER CONTROL PROJECT REPORT 2024

Prepared by Phaedra Douglass and Gina Hoar R.P. Bio.

Somenos Marsh Wildlife Society

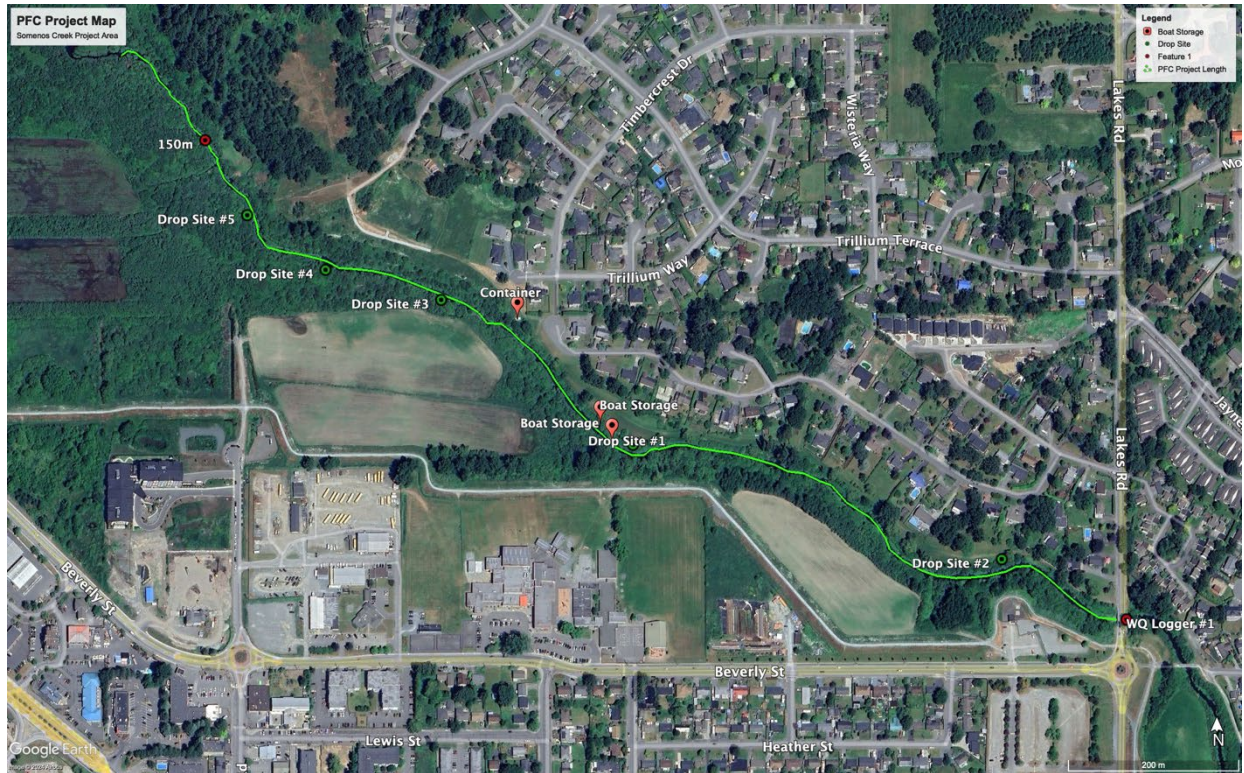
FIGURE 1: PARROT'S FEATHER CONTROL PROJECT AREA AND OTHER IMPORTANT LOCATIONS ON SOMENOS CREEK.

The project took place in Somenos Creek, extending downstream from where parrot's feather is established for a total distance of 1.44 km to Lakes Road bridge (Figure 1), extending the project length by 844m from phase one in 2023. The Society started clearing operations 300m from the head of the creek, where the parrot's feather begins growing. Surveys by the Society from 2021 to 2023 show that the dense growth of other aquatic plants, including great yellow pond-lily (*Nuphar polysepala*) and smartweed (*Polygonum* spp.) at the head of the creek appear to be a barrier to the spread of parrot's feather into the lake. The section of the creek in which the project took place is relatively wide, measuring about 4-5 meters in most sections, with few sections any narrower than 3 meters during the dry season. The banks are steep, and the water is approximately 1.5 to 2 meters deep. The creek has very limited observable flow, if any, during dry summer months (Preikshot, 2019), and riparian and aquatic vegetation cover most of the creek in some sections.

Previously cut parrot's feather was collected from the creek using the rakes and pitchforks, drained of as much water as possible, and then placed in the totes (Figure 3), once the totes were full, they were brought to a drop of point on the bank, see Figure 1 for all drop-off locations. The totes were tipped over the side of the boat to remove any excess water and then hauled onto the bank. The parrot's feather from each tote was inspected for any fish, invertebrates, or other aquatic life before being spread out to dry.

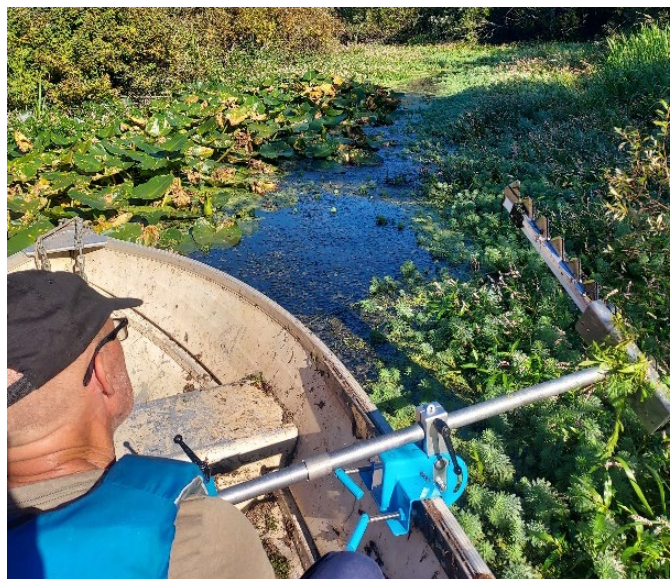
FIGURE 1: THE AQUATIC MOWER ATTACHED TO THE GUNWALE OF THE BOAT.

The aquatic mower was mounted on the starboard side of the boat onto the reinforced gunwale (see Figure 2). This meant the NE side of the creek was cut while moving upstream and the SW side while moving downstream. Most of the cutting was completed using the aquatic mower; however, in some sections where growth was encroaching on the cleared channel, hand-cutting tools were used during collection events to remove sections of the parrot's feather.

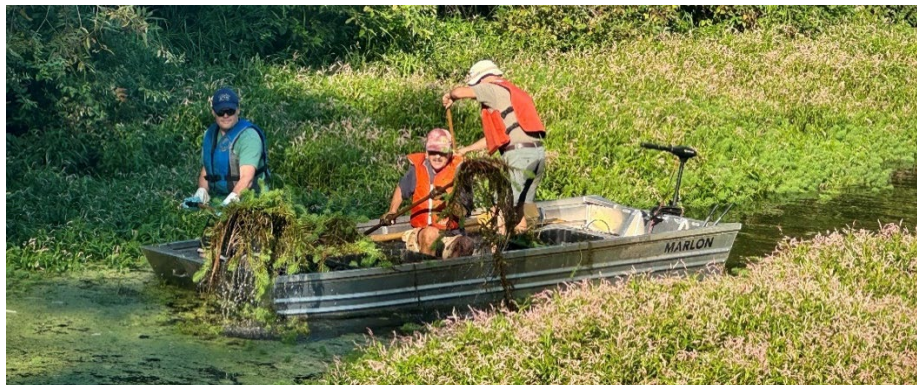
FIGURE 3: PARROT'S FEATHER COLLECTION IN SOMENOS CREEK.

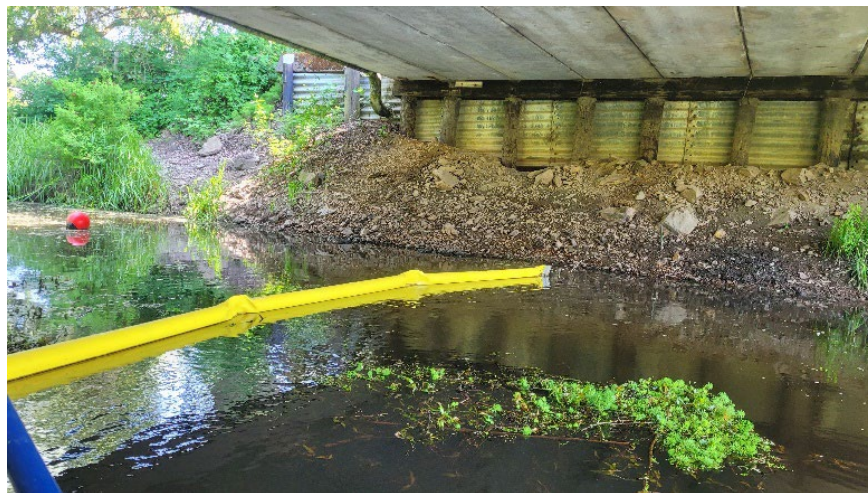
FIGURE 4: BOOM PLACEMENT UNDER LAKES ROAD BRIDGE WITH A CHUNK OF CUT PARROT'S FEATHER.

To meet requirements laid out in the 2024 permits for work in the creek, certain mitigations were undertaken by the Society. A boom was left in the Creek to catch any parrot's feather fragments that may have floated downstream between work events during times when the creek was flowing. Accumulation of the parrot's feather at the boom was only observed during the early stages of the project in June and when the Creek began flowing again in October. Most notably, the collection of common duckweed (*Lemna minor*) was quite significant. The collection of plant material when the Creek was flowing shows that the boom was effective at stopping material from being carried downstream from the project area. A seine net was not utilized this year as results from phase one deemed it unnecessary, and no parrot's feather was seen moving past the boom.

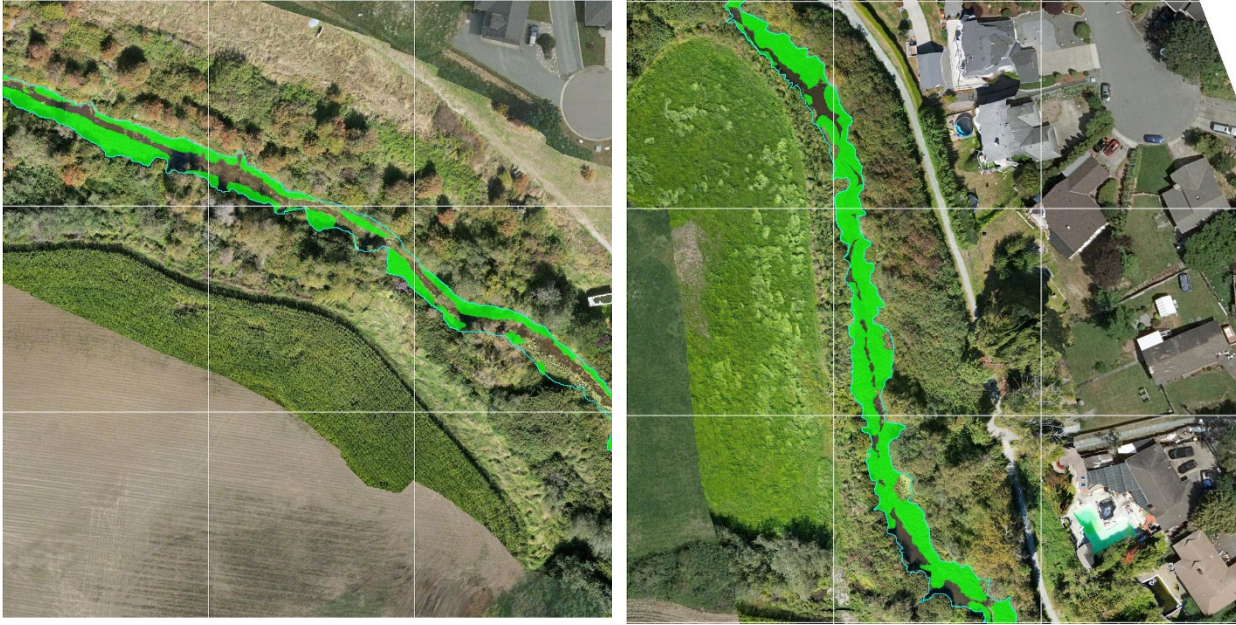
FIGURE 5: IMAGES OF PARROT'S FEATHER COVERAGE IN THE PROJECT AREA (LEFT) AND BELOW PROJECT AREA (RIGHT). THE CLEARED CHANNEL CAN BE SEEN CLEARLY IN THE PROJECT AREA PHOTO.

Using the gunwale mounted aquatic mower, the Society cut the leading edge of the parrot's feather, once cut, the Society returned with the boat to collect and remove the cut parrot's feather and bring it to shore. This process was successful at creating a 2-to-4-meter-wide channel (depending on the width of the creek and overhanging riparian vegetation) free of parrot's feather in the creek. For each cutting event completed in the creek, on average, three removal events were needed to remove all cut material. In some reaches of the creek, cutting by hand was needed during collecting events to maintain a clear channel. By mid-August, the top 150 meters of the project area had grown over completely, leading to the boats being unable to move upstream beyond the 150m mark, see Figure 1. As the Society was focusing on collecting material that had been cut in June and July, by the time the upper 150 m section was reached, the cut parrot's feather had reattached itself and continued growing in the cleared area, making the reach inaccessible by boat, and therefore the Society was unable to return to the area to cut. In total, the society removed 58.45m³ of parrot's feather from Somenos Creek, measured by 573 102-litre plastic totes. All collected parrot's feather was discarded at the drop sites, shown in Figure 1. No fish species were observed caught in the cut and removed parrot's feather, only green (*Lothobates clamitans*) and bull (*Lithobates catesbeianus*) frog tadpoles, aquatic snails, and a few species of benthic invertebrates such as unidentified dragonfly nymphs. All species caught in the cut parrot's feather were removed carefully and placed back in the creek. After being discarded, the parrot's feather was observed as decomposing well over the project duration. Based on the first phase results from 2023, the Society believes that all discarded parrot's feather will be decomposed and not biologically viable for regrowth in the spring of 2025.

Parrot's feather surveys were not completed monthly as they were in 2023. However, the Municipality did conduct an aerial drone survey of the creek on the 12th of September 2024. Results from the September survey demonstrate the outcome of the project as less coverage of parrot's feather on the project section of the Creek compared to survey results from below the project area, see Figure 5, where, in previous years, the society's surveys indicated similar coverage of parrot's feather in the creek. Based on these data, it is shown that the project had a substantial impact on the growth and coverage of parrot's feather in the project area. See Appendix A, Figure 2, for the full parrot's feather survey results.

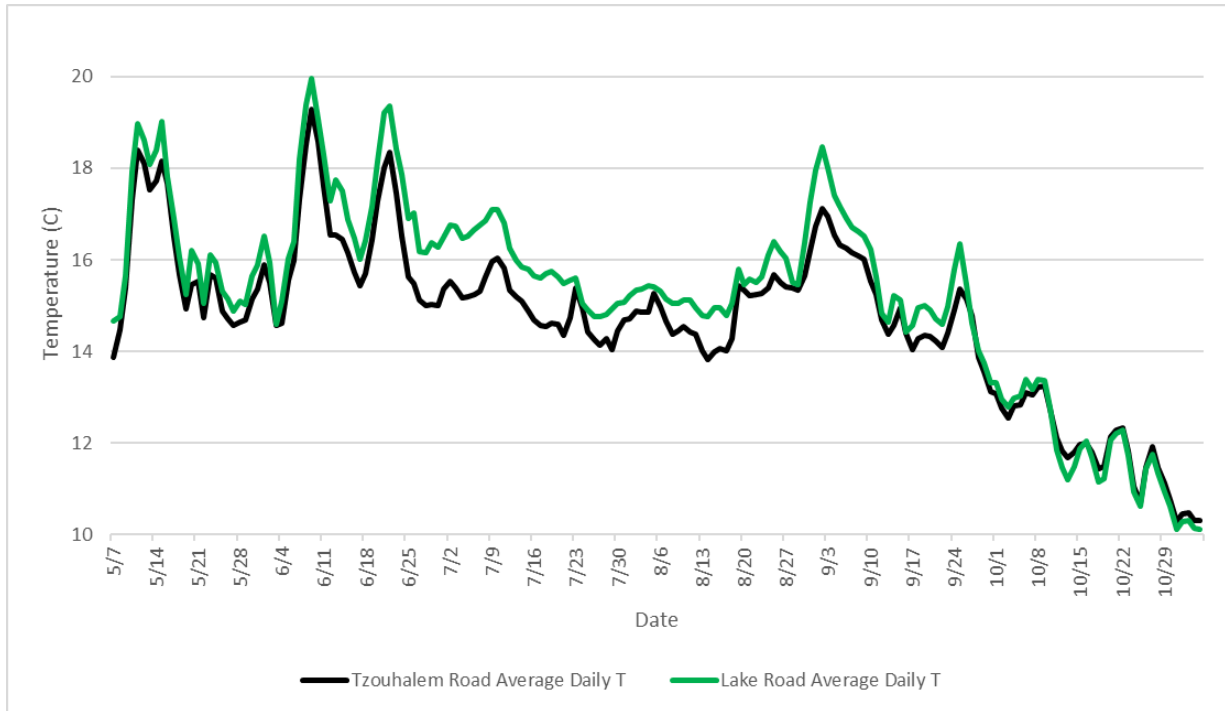
FIGURE 6: AVERAGE DAILY TEMPERATURES OF SOMENOS CREEK AT THE CONTROL (TZOUHALEM ROAD) AND PROJECT SITE (LAKES ROAD)

Two data loggers were installed in Somenos Creek, which measured dissolved oxygen content and temperature every ten minutes for the project's duration. The first data logger was placed at the Lakes Road bridge to capture water quality directly below the project area. The second data logger was placed at the Tzouhalem Road bridge (Appendix A, Figure 1), around 660m downstream from the Lakes Road bridge, to act as a control site and capture any differences in water quality between sections of the creek where parrot's feather removal was undertaken and where it was growing freely. Data from the loggers were collected, and sensors were cleaned weekly as algal growth on the sensors was noted to impact the data quality. The outliers that occurred when the probe was taken out of the water were removed from the dataset. The graphs in Figures 6 and 7 show the average daily temperatures and dissolved oxygen levels.

Water quality measurements in Somenos Creek have shown to be highly variable during the summer months since the Society began regularly recording data. Low flow, groundwater influence, decomposition and aquatic vegetation likely play important roles in the Creek leading to uncertain results. Even with these variables, the logger at Lakes Road appears to regularly have higher dissolved oxygen and temperature readings within the parrot's feather control project area than at the control site at Tzouhalem Road (see Figures 6 and 7). T-tests were run on the temperature and dissolved oxygen data to determine if the observable differences between sites were statistically significant, both results were $P < 0.05$ which shows that they were significantly different. It is difficult to determine if this significant difference is due to natural causes or from clearing the parrot's feather biomass out of the creek. More baseline data could be collected to determine the cause of the difference. Detailed water quality data is available at Somenos Marsh Wildlife Society upon request.

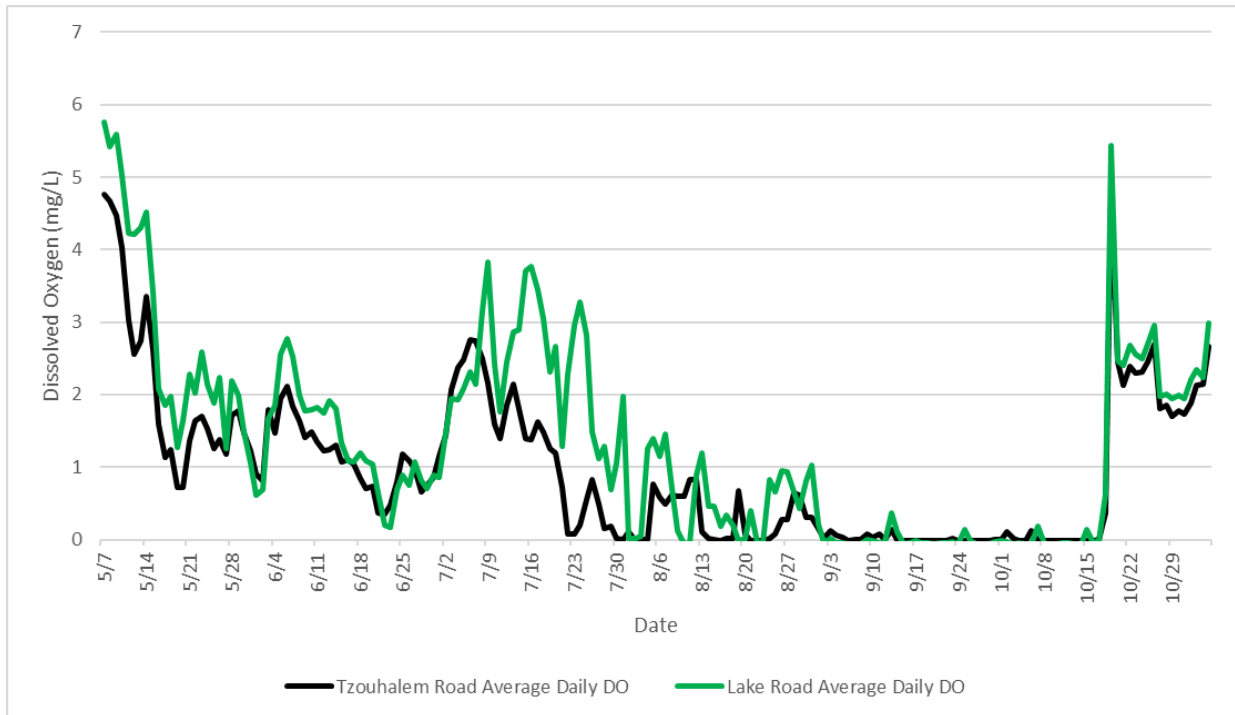
FIGURE 7: AVERAGE DAILY DISSOLVED OXYGEN OF SOMENOS CREEK AT THE CONTROL (TZOUHALEM ROAD) AND PROJECT SITE (LAKES ROAD)

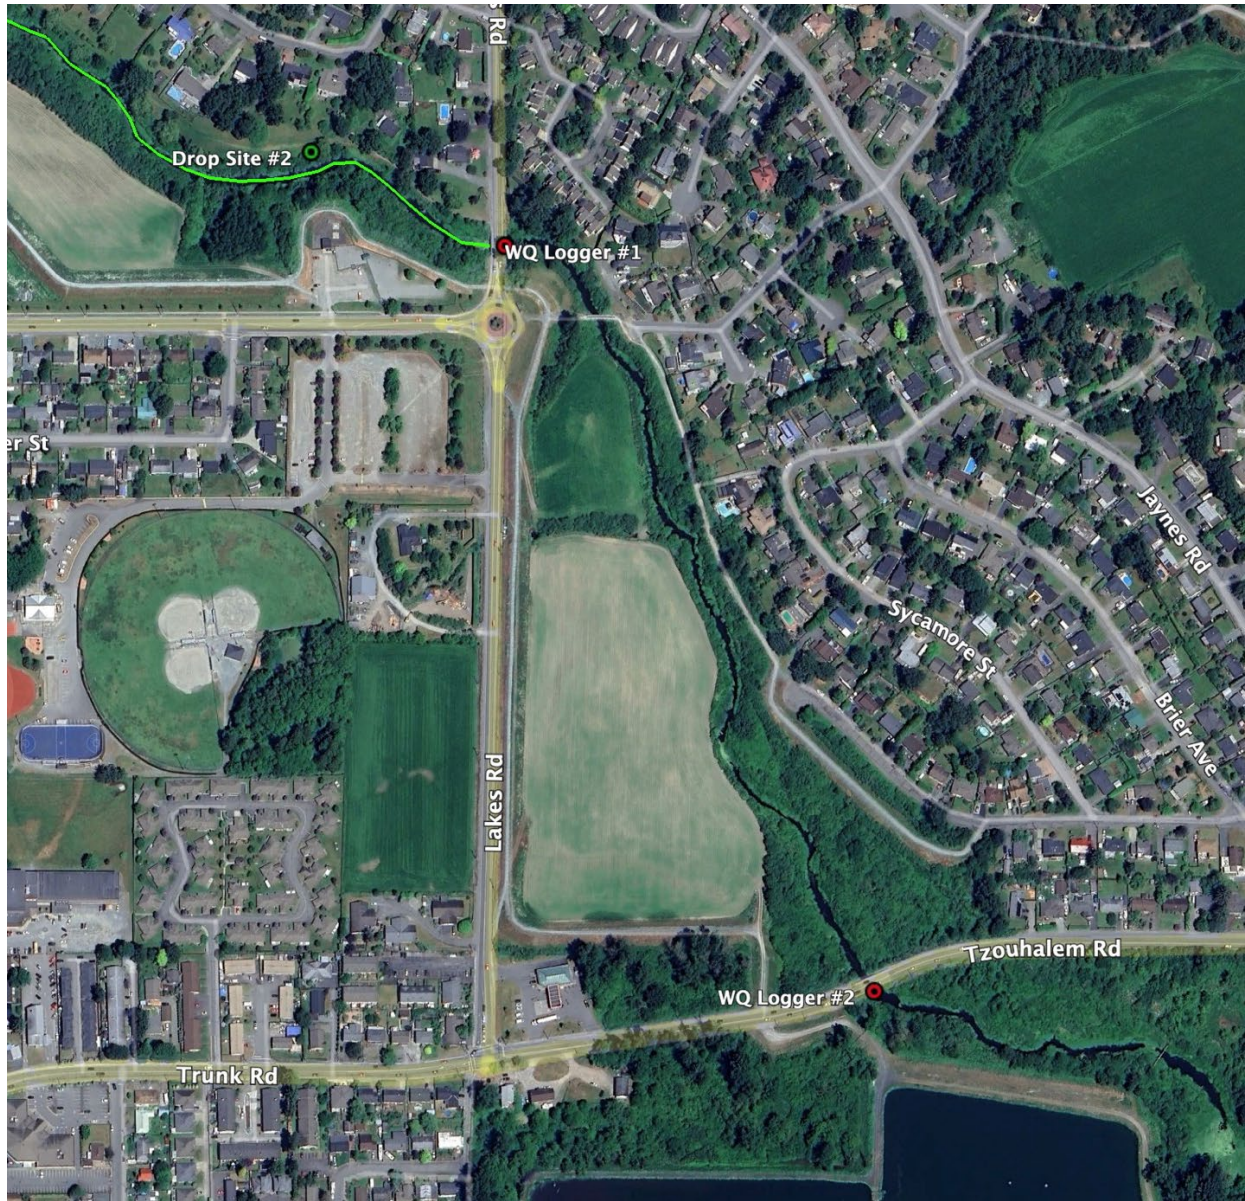
FIGURE 1: SATALITE IMAGE SHOWING WATER QUALITY LOGGER LOCATIONS IN SOMENOS CREEK.

Water quality was monitored by the data loggers (U26 probe) that measured temperature and dissolved oxygen every 10 minutes throughout the project's duration. The first data logger was installed at Lakes Road bridge, 0.5 m under the surface, mid-channel, to capture the impact of the project on the water quality. The second data logger was installed at the Tzouhalem Road bridge, 0.5m below the surface, mid-channel, and served as a control site for water quality in the Creek (Appendix A, Figure 1). Data was collected from both loggers weekly. The data loggers will be left until December 2024 to monitor water quality through the fall flush.

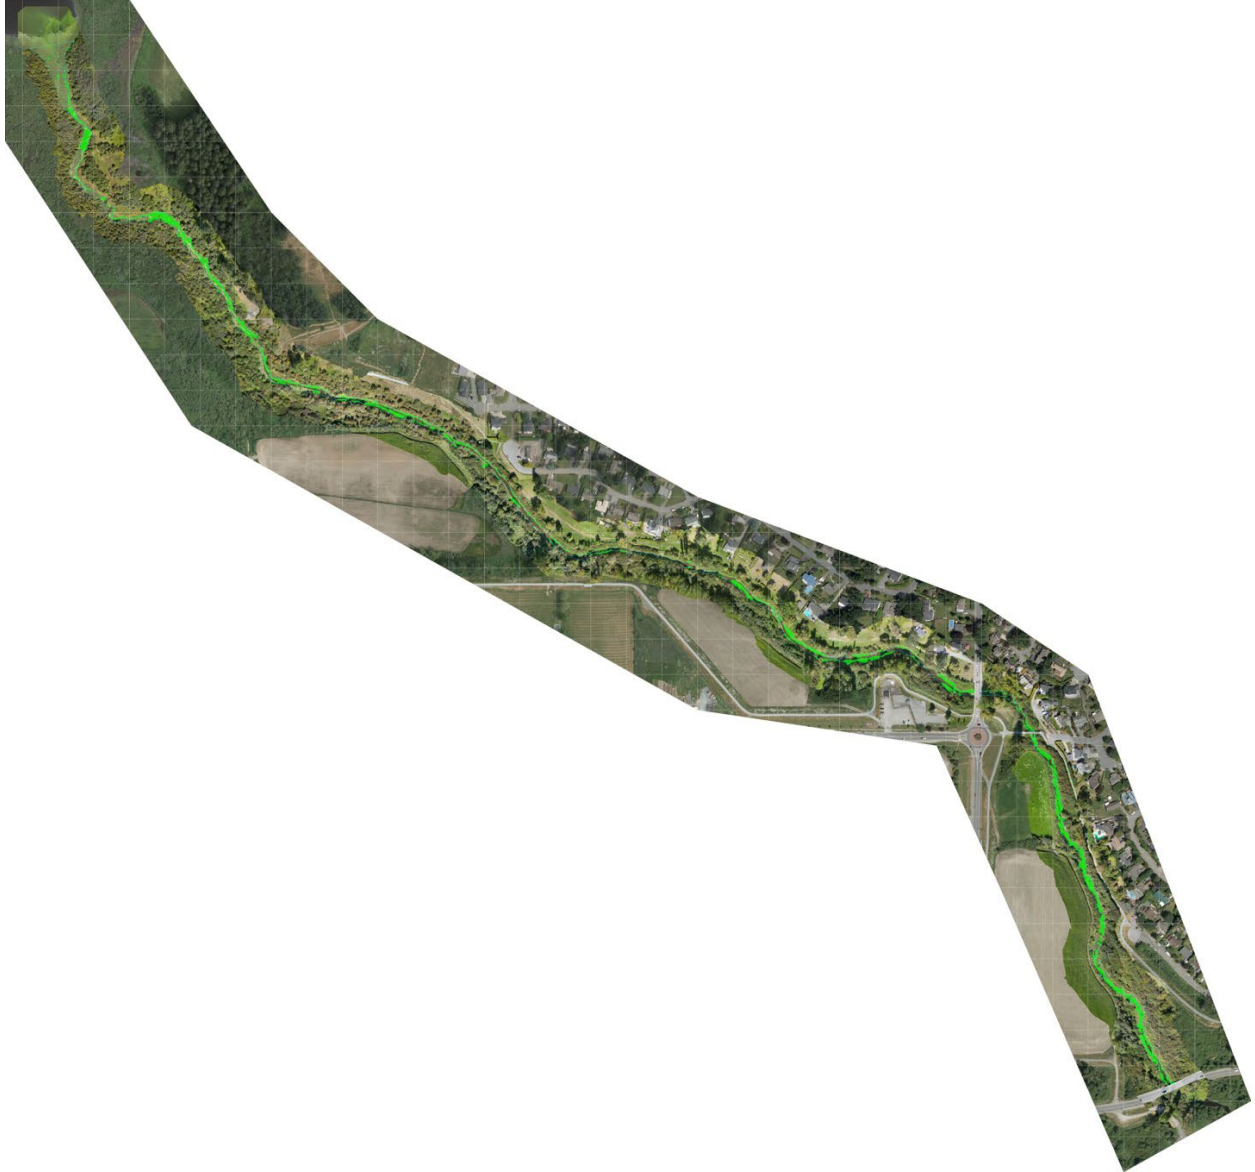
FIGURE 2: FULL IMAGE OF PARROT'S FEATHER SURVEY COMPLETED BY THE MUNICIPALITY OF NORTH COWICHAN ON SEPTEMBER 12TH, 2024.
