# ENVIRONMENTAL & MARINE BIOPHYSICAL ASSESSMENT

360 ARBUTUS AVE  
DUNCAN, BC

CORVIDAE PROJECT #2023-147  
JANUARY 2024

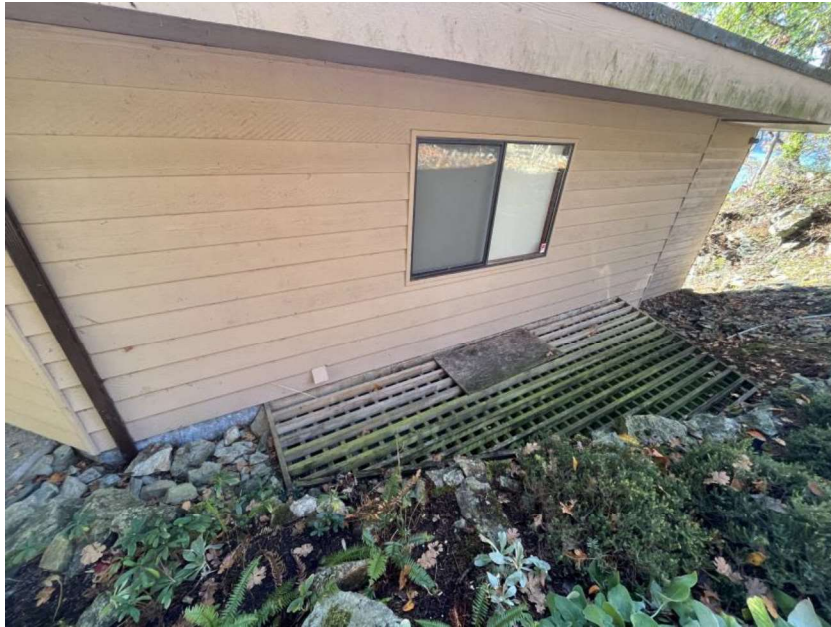
**Photo 5. Looking southwest at the north side of the house where the existing stormwater drains discharge underneath the house, below the wooden cribbing. November 9<sup>th</sup>, 2023.**

- Stormwater drainage improvements to alleviate previous flooding issue.
  - The property is steeply sloped southwest towards the ocean. Somenos notified Corvidae of previously flooding issues where surface water overwhelmed the existing infrastructure and flooded into the house. Ryzuk Geotechnical (Ryzuk) was onsite on November 17<sup>th</sup> to conduct a geotechnical inspection of the existing stormwater network onsite and discuss upgrades to prevent future flooding. Ryzuk will be preparing a geotechnical report to outline the proposed stormwater upgrades to the Site. Upgrades discussed onsite include installing new catch basins and California drains, reshaping the driveway, installing a 12-16" HDPE pipe underneath the house where an existing drainage ditch runs, and rerouting where this drainage ditch discharges to the foreshore ~2 m east to help alleviate slope creep issues. Somenos also expressed interest in stabilizing an approximately 3 m length bank along the foreshore with a boulder wall with geotextile and drain rock in behind that would be less than 2 m in height. The area shows signs of slope creep and minor erosion as two drainages flow through the area and groundwater also seeps out of the bank.

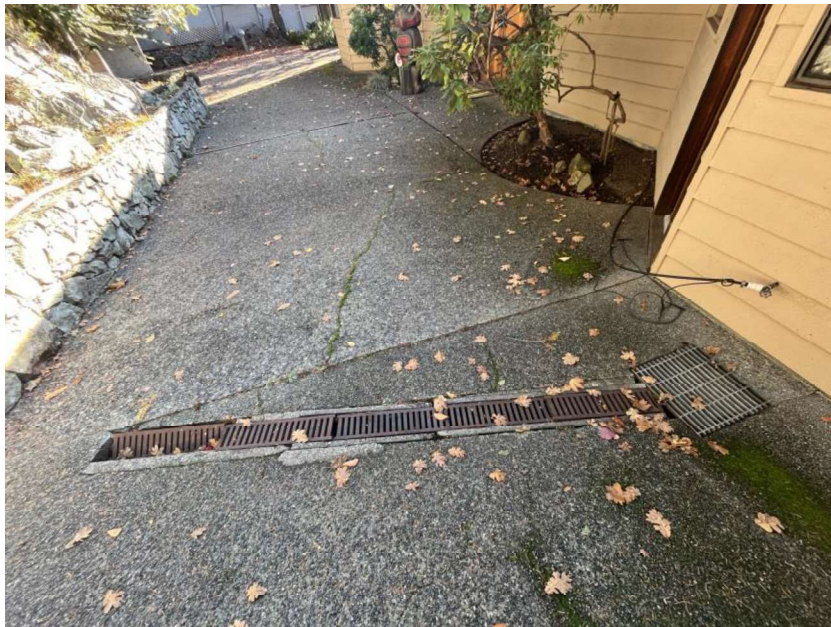
**Photo 6. Stormwater drainage perpendicular to the north side of the house, facing east. November 17<sup>th</sup>, 2023.**

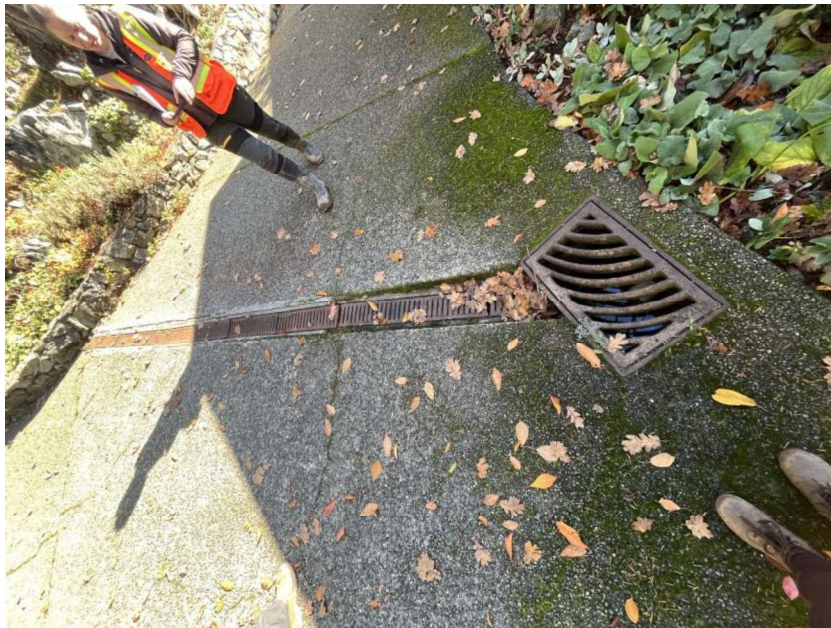
**Photo 7. Stormwater drain, perpendicular to the north side of the house. November 17<sup>th</sup>, 2023.**

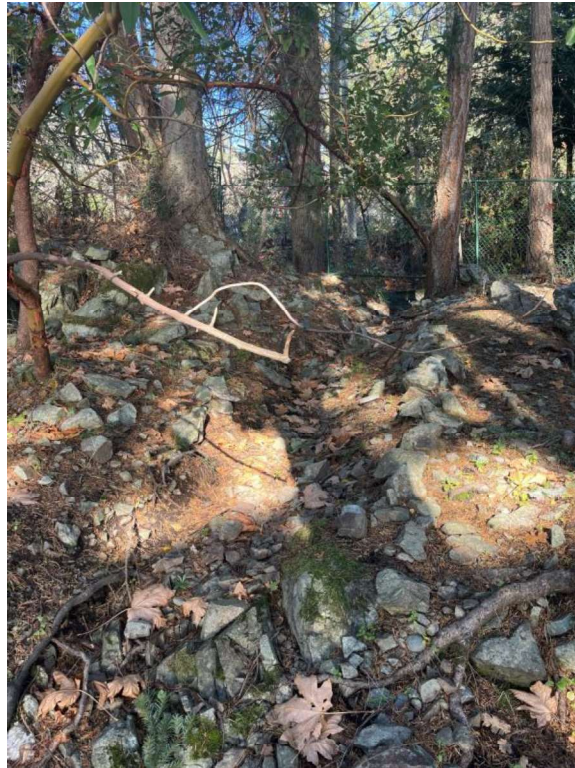
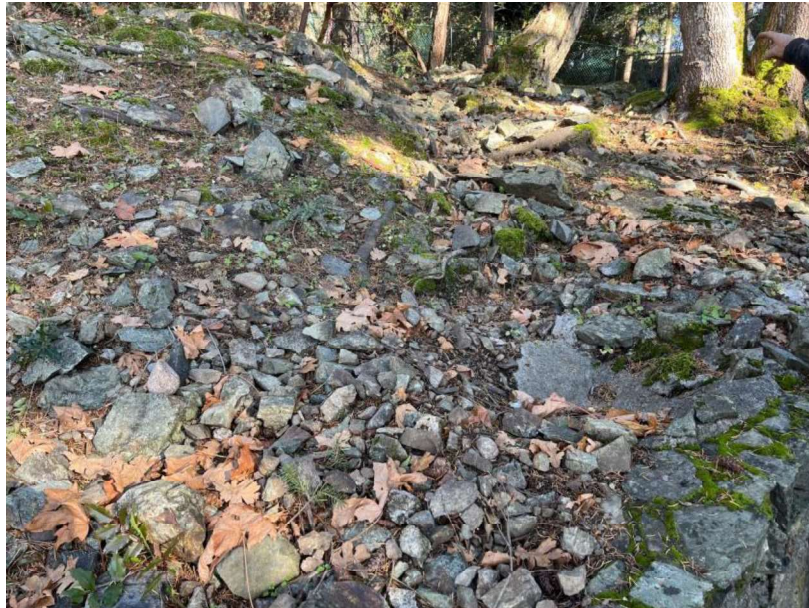
**Photoset 9. Looking north at drainage channel downslope of Arbutus Ave and upslope of the house, on west side of driveway. November 17<sup>th</sup>, 2023.**

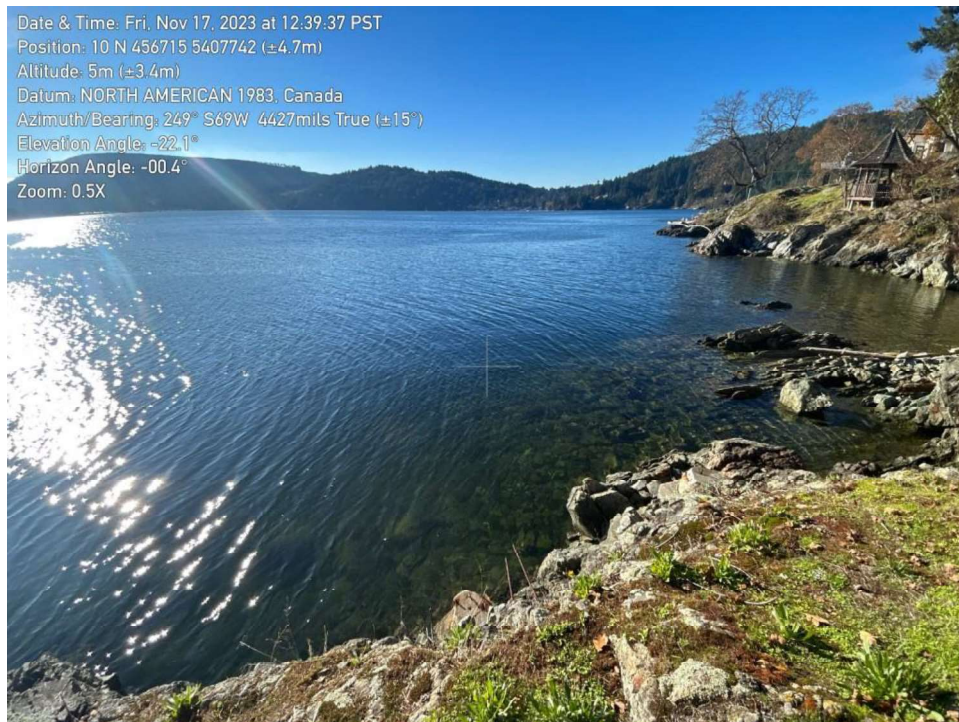
**Photo 10. Southwest view of offshore area, comprised of a rock shelf with some cobbles in the western corner and few marine species. November 17<sup>th</sup>, 2023.**

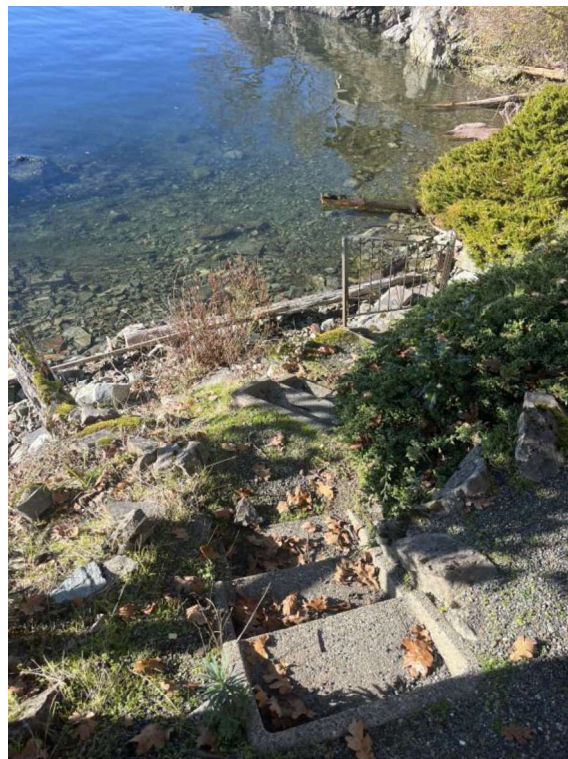
**Photo 11. Southwest-facing view of existing beach stairs and juniper vegetation. November 17<sup>th</sup>, 2023.**

- The owners would like to repair/replace and extend the stairs within the foreshore area to connect to the new decking. The existing stairs are concrete and narrow and would likely be replaced with wider, stone stairs that resemble the foreshore stairs of the neighbouring residence.

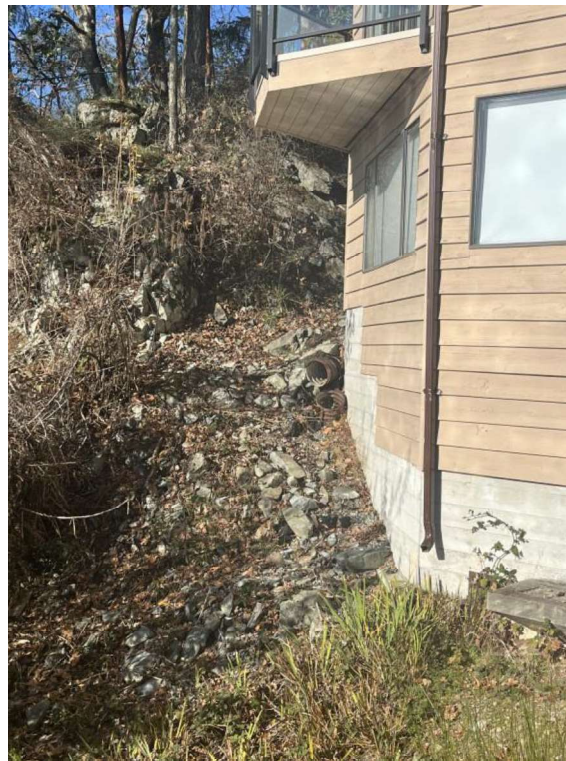
**Photo 13. Drainage/culvert alongside west side of house from driveway. November 17<sup>th</sup>, 2023.**

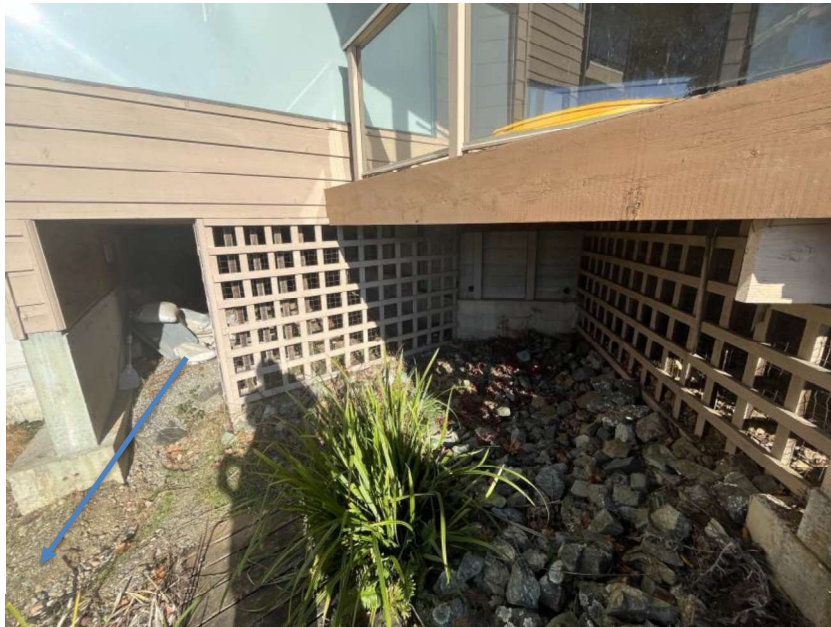
**Photo 14. Crawl space underneath house and deck, on southwest corner of house. Currently a drainage channel that flows underneath the house (blue arrow) is proposed to be piped. November 17<sup>th</sup>, 2023.**

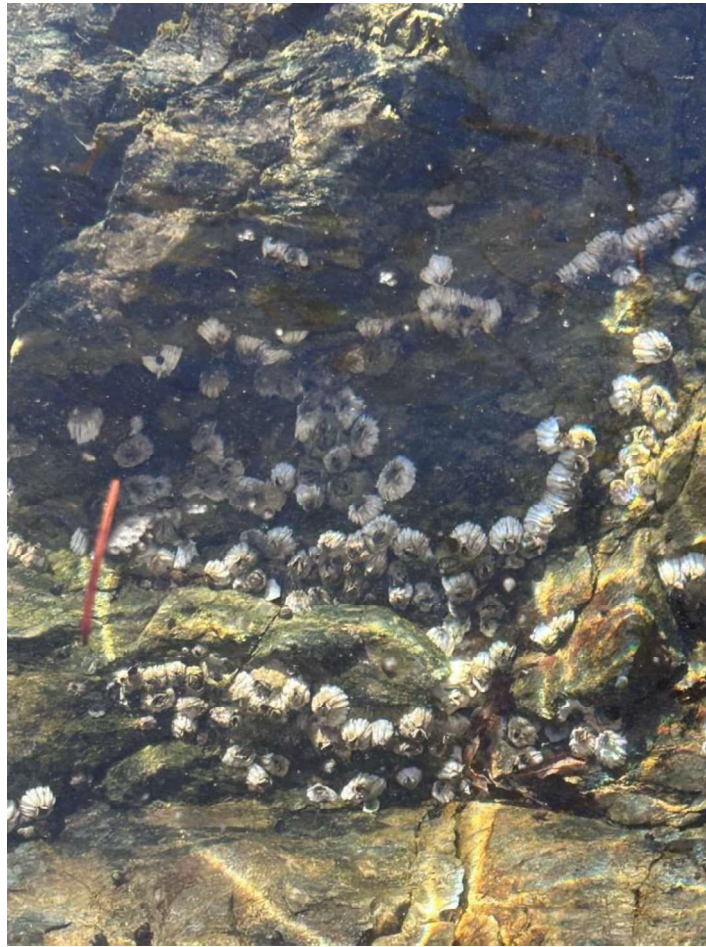
**Photo 16. Drop camera footage of acorn barnacles.**

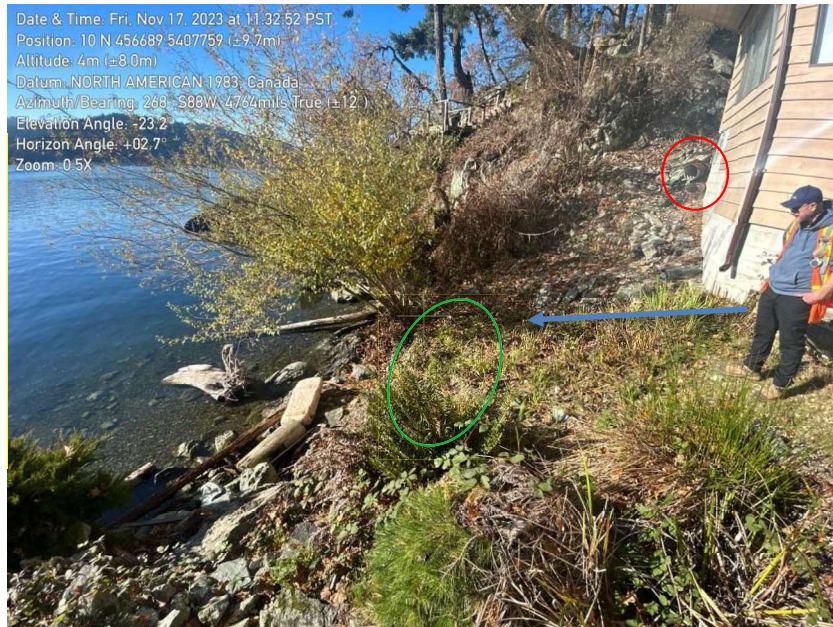
**Photo 17. West-facing view of backshore area. November 17<sup>th</sup>, 2023. See culvert outlet (circled in red), drainage pathway that surfaces beneath house (shown in blue) and gutter drainage all collecting in one area compiled with groundwater seepage that is causing slope creep in the area circled in green. A seawall ~3 m long comprised of boulders with geotextile and drain rock in behind is proposed to stabilize the area from future erosion.**
