## **Erosion of Anchor Estates**

This presentation is to demonstrate how, I believe, North Cowichan's Stormwater Management is causing stream bank erosion of Anchor Estates Greenspace and a number of strata properties bordering that Greenspace The following is an email I received in response to my concerns about erosion of Properties and Anchor Estates Greenspace. In the following presentation I hope to challenge the statements in paras one and two. As for para three, the disclosure statement filed by the developer advises that North Cowichan had stated that there is no flooding issues with the Anchor Estates development.

# Erosion

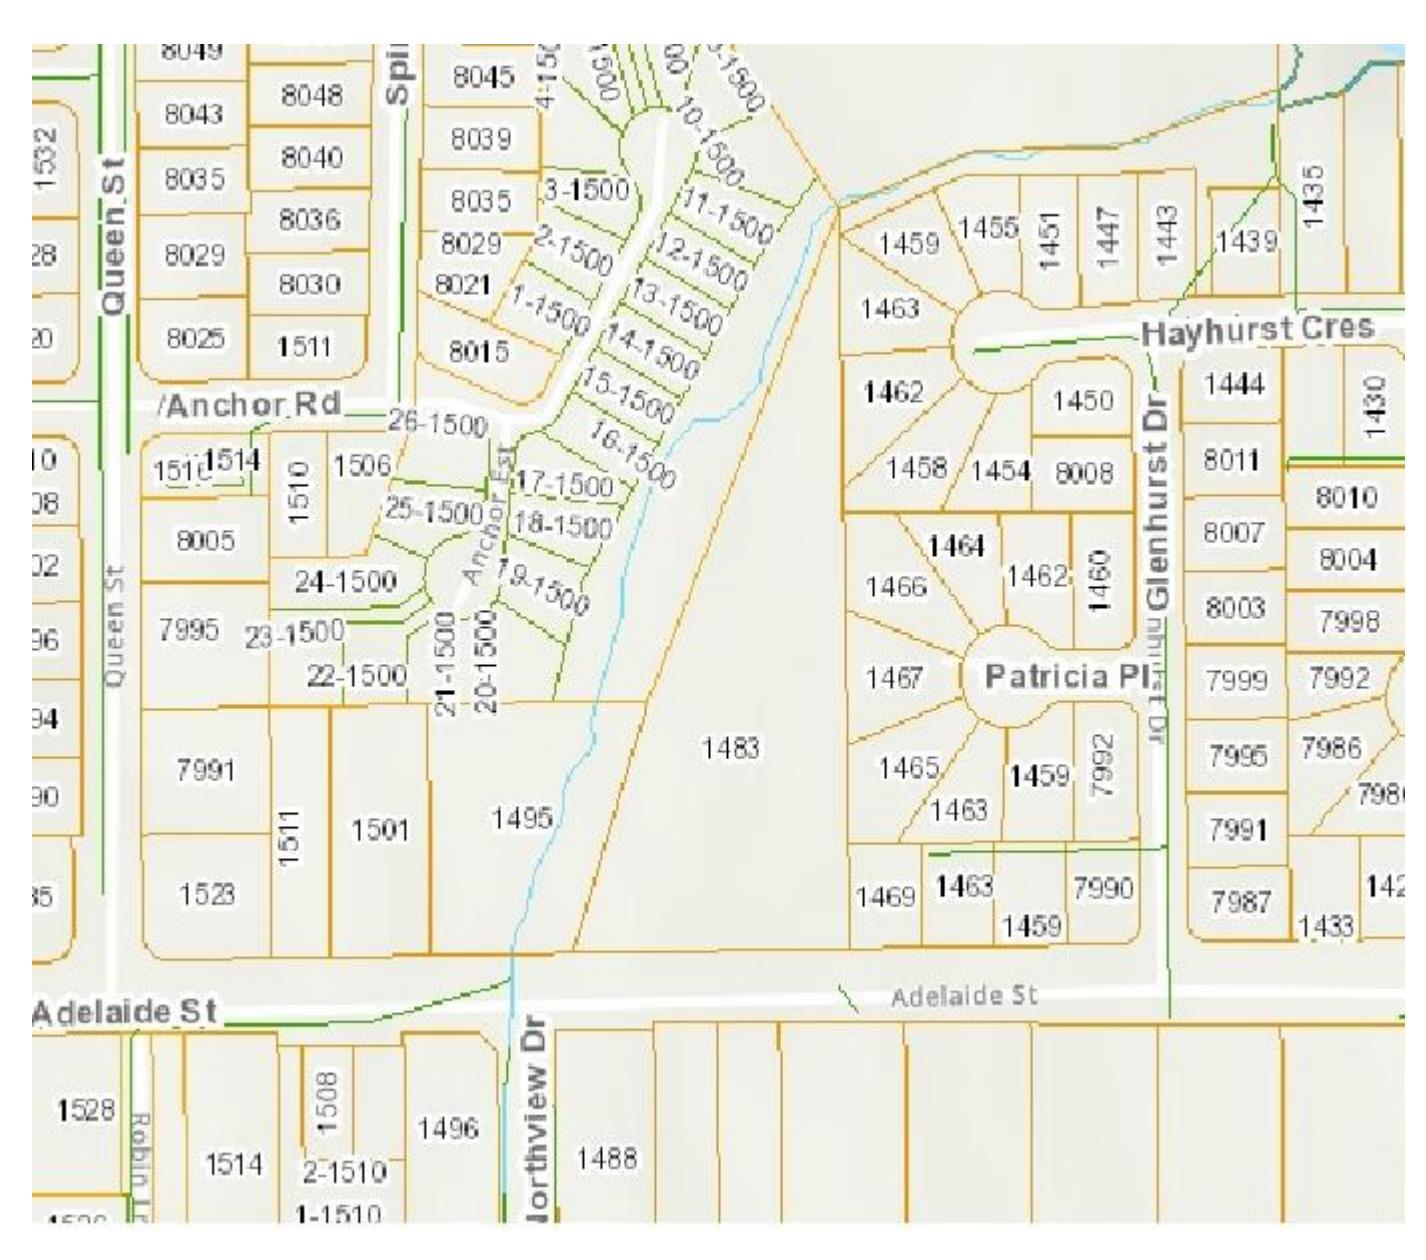
## Map of Stream thru Anchor Estates

This slide shows the approximate location of the stream (Marked in light blue) flowing from a 1200mm culvert under Adelaide street thru Private Property lot #1495, then thru Anchor Estates (Strata) greenspace alongside lots #20-1500 thru Lot #10-1500 inclusive. The area that borders the above stata lots is classified as "Common Property which is owned by all 26 strata property owners and which **BC** Assessment considers in property assessment values

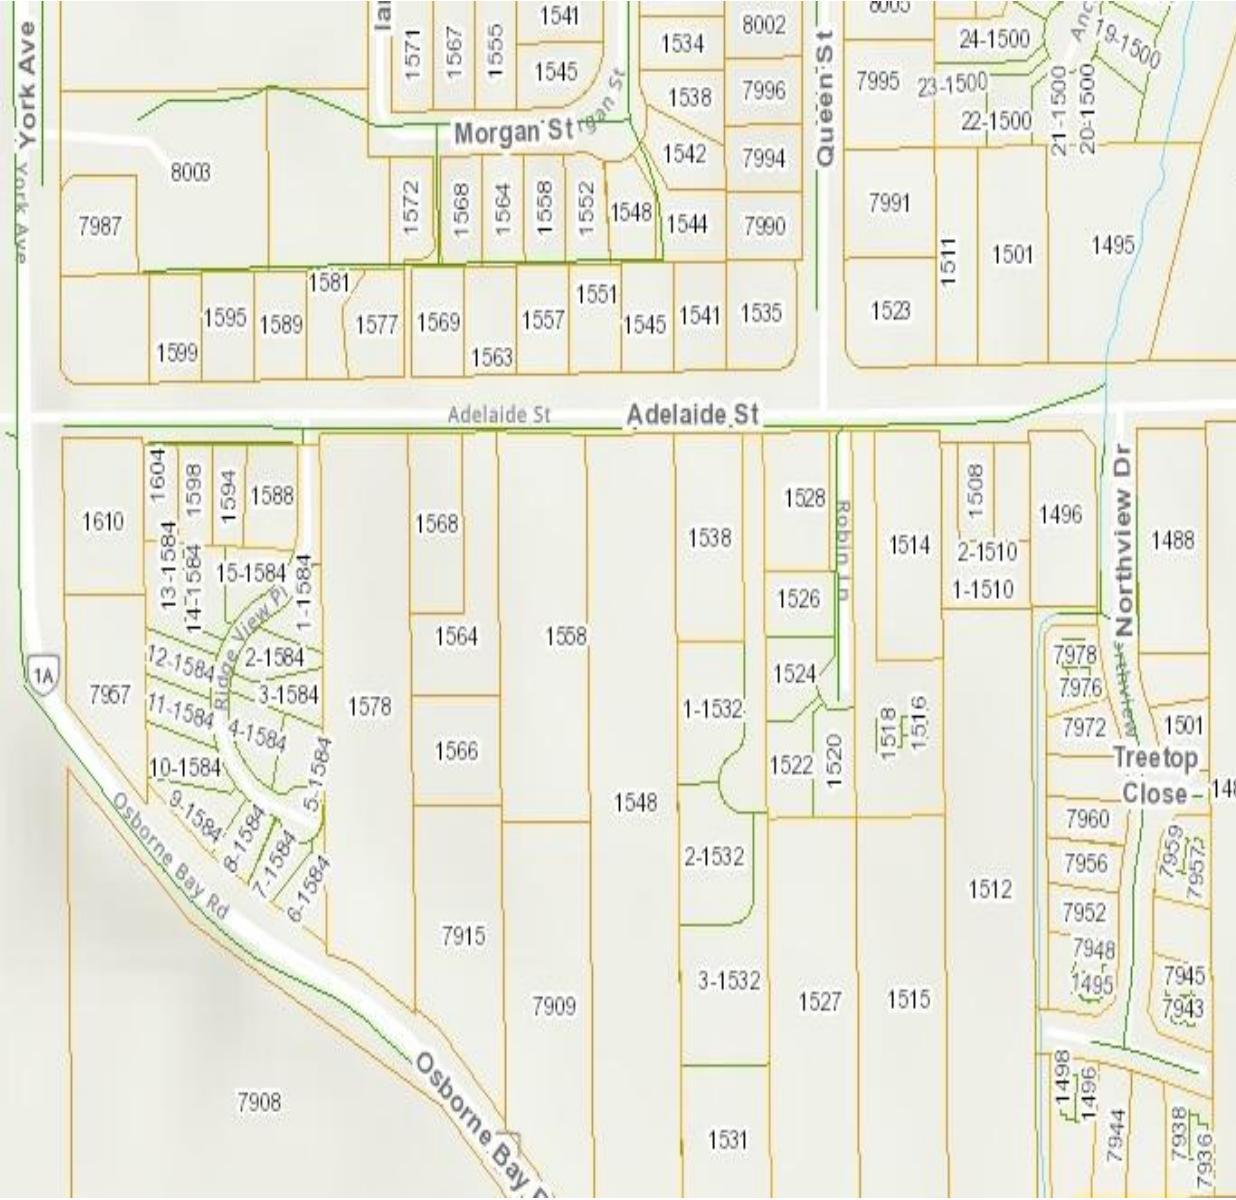
# Drainage Sewer System Adelaide

This shows the drainage pipe system (light green lines) on Adelaide along with the properties that feed into that system. As you can see the stream that use to flow through the Northview Dr area (Pre Development) has been straightened and has two 1200mm concrete culverts at the top and bottom of the left side of the subdivision and shows as part of the Close - 1482 stormwater drainage system. There are approximately 70+ properties using this drainage system. 45+ have been built and added to the system since Anchor Estates development was approved in 1992.

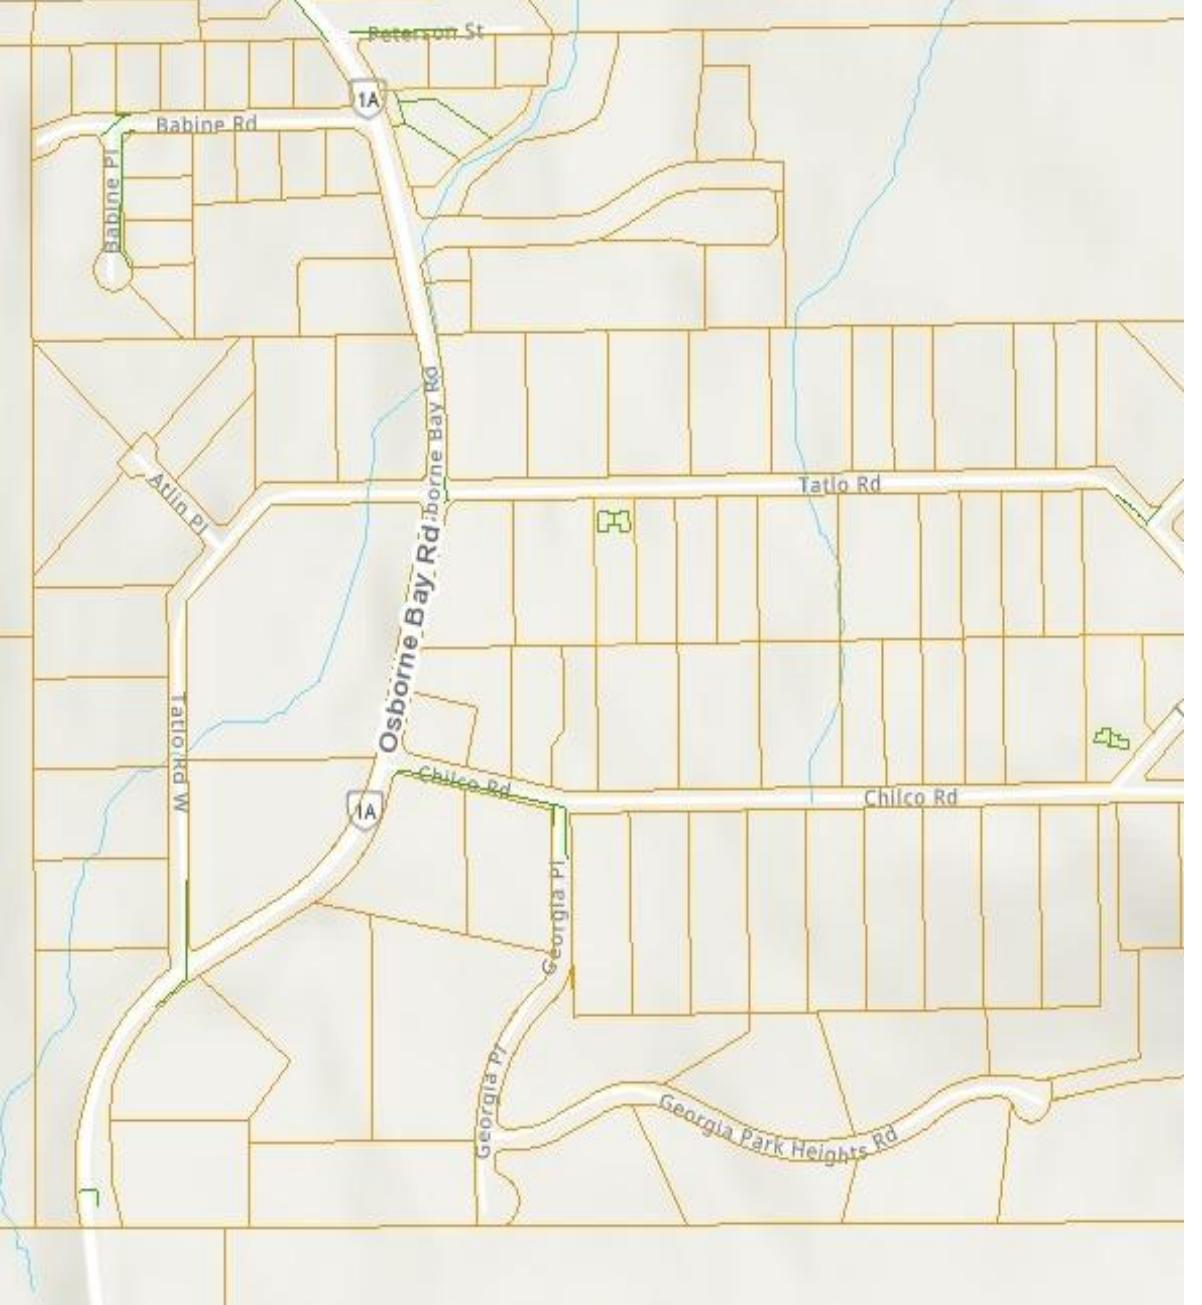
## Drainage Area Above Adelaide

This shows the drainage area for the stream (left side light blue line) as it flows from just below the old Crofton dump thru Tatlo Way area, crossing under Osborne Bay Rd (2 smaller galvanized steel culverts), thru another 1200mm Concrete culvert past 3 newer properties just south of Peterson St. then down a ravine and entering the culvert at the top of Northview Dr. Here I believe that parts of both Maple and Richards mountain along with parts of Osborne Bay Rd., Tatlo Rd., Chilco Rd, Georgia Place, Georgia Park Heights Rd, all of Tatlo Way and Peterson St. drain into this stream. Again about 75+ properties. The area is relatively flat and most drainage is thru Ditches. Here there are less than dozen houses that have been built since 1992.

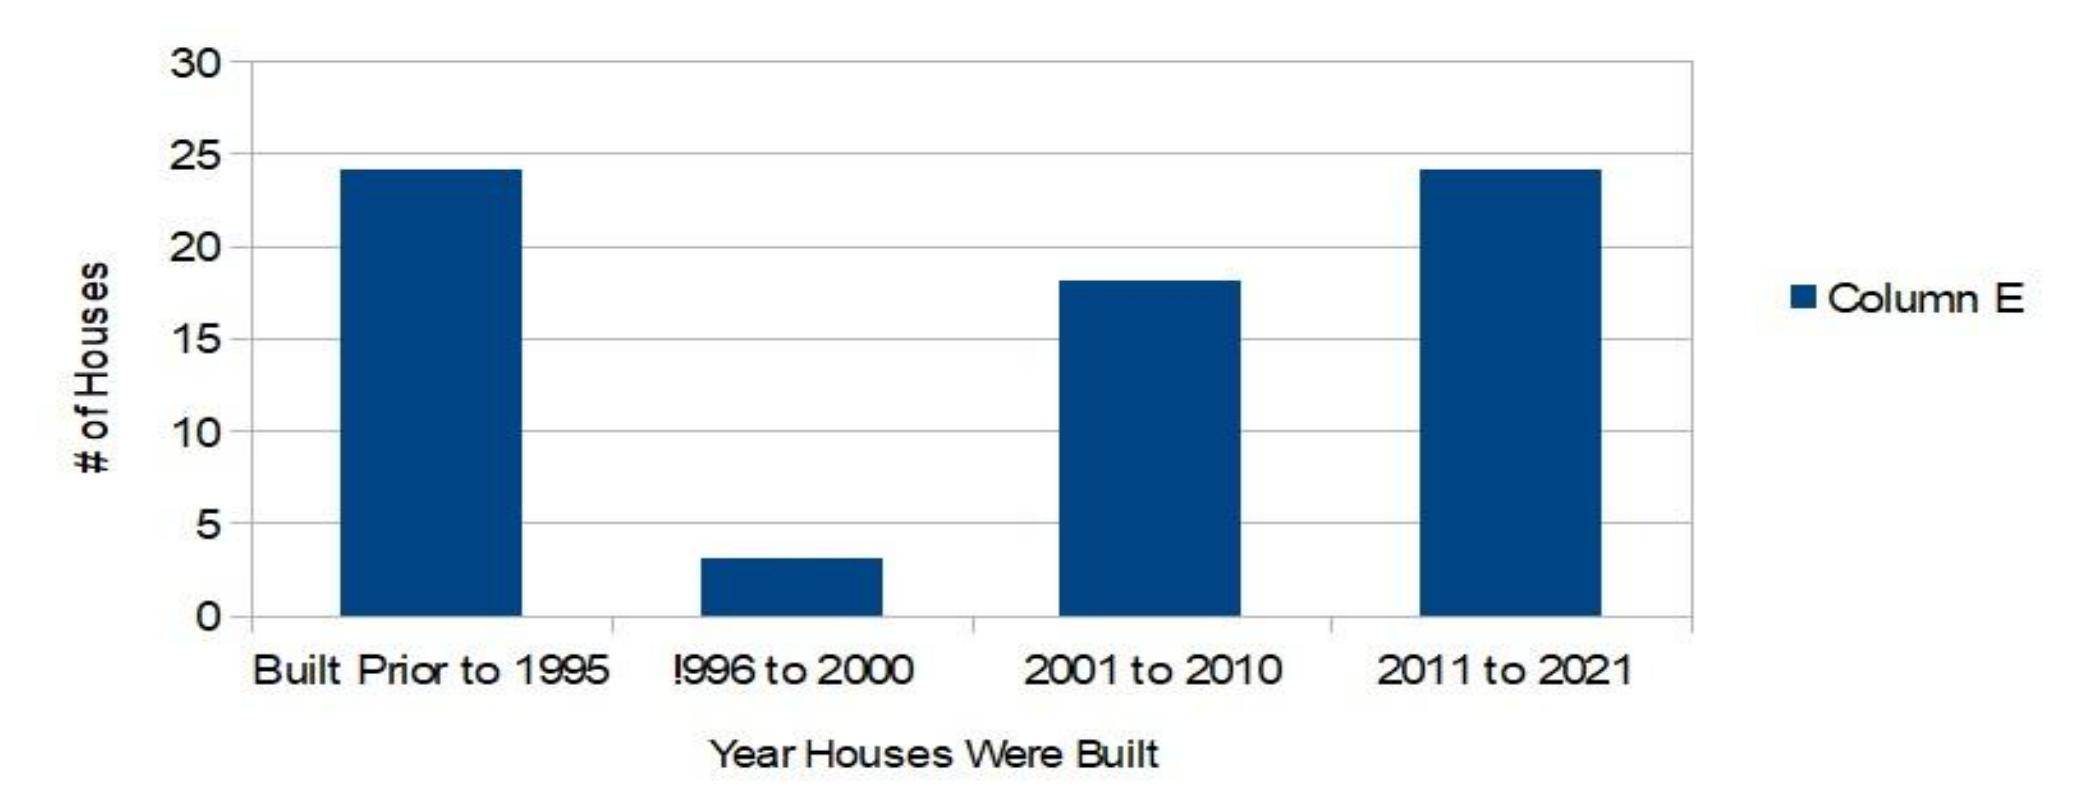
### Houses On Adelaide Storm System

Anchor Estates Subdivision Built in 1992

An average lot has about 200 sq meters of impervious surface (Roofs, Driveways, etc), therefor 50 lots would have about 10,000 sq meters of impervious surface producing 10,000 litres of stormwater for every millimeter of rainfall. This does not include roads and sidewalks that service these lots. That is 10 cubic meters of water every hour for 1 millimeter of rain. Over 40 times this winter hourly rainfall totals exceed 4 mm per hour. I believe that this is a significant increase in water flow, especially as you can see the water flow increase in the creek almost as fast as the rain event intensifies.
