ECOLOGICAL ASSESSMENT (EA)

6824 Stoney Hill Road, Duncan, BC

May 9, 2019

DOSSIER: 19.0125

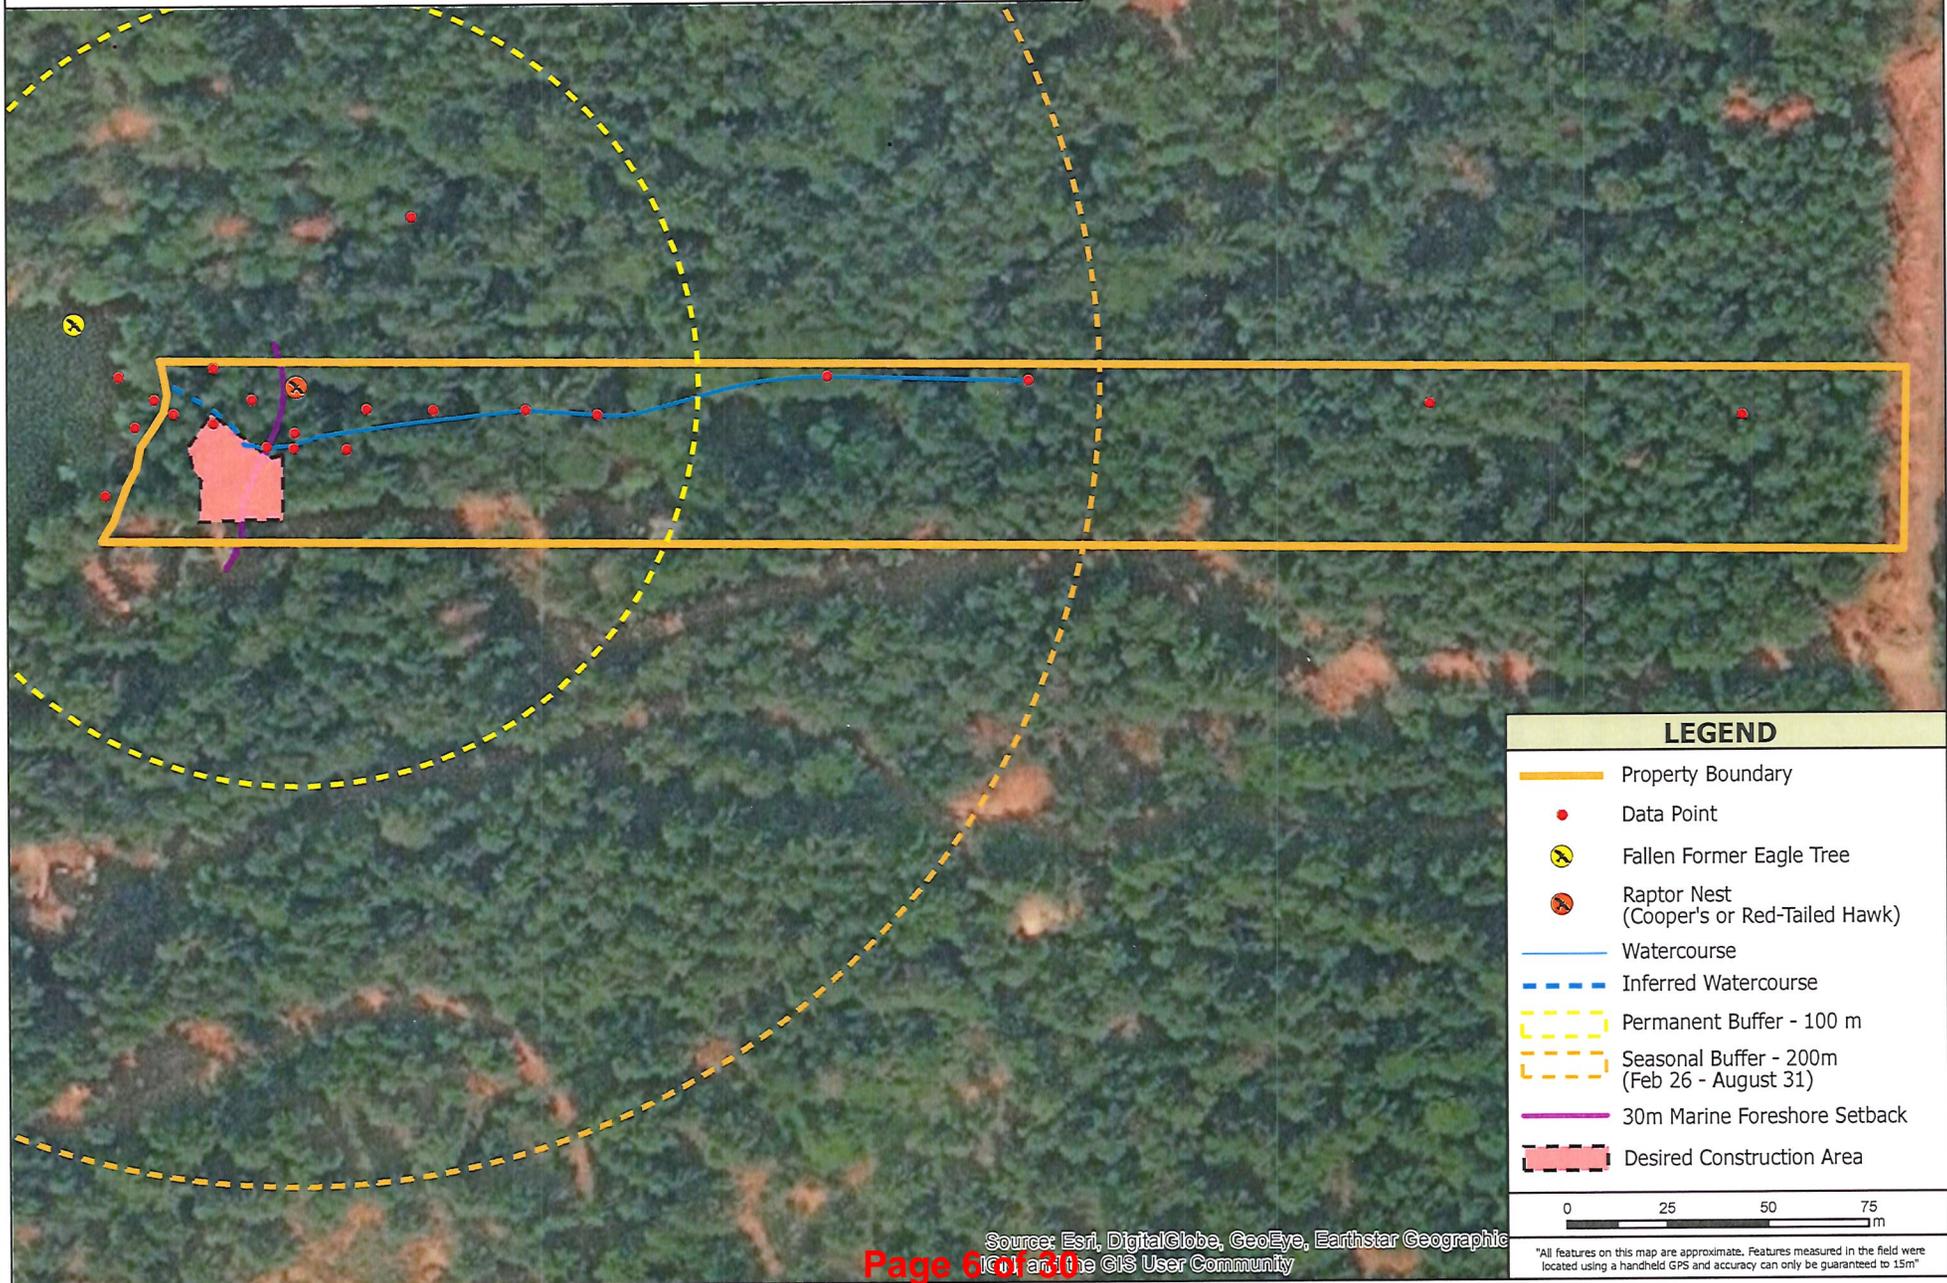
FIGURE 1 : Site Plan Showing Location of Desired Construction Area

The watercourse noted by the landowner was found on the property during the site assessment, and its location is shown on Figures 1 and 2. There were signs of water movement in a few places – such as scouring – but there was no water flowing in the creek at the time of the site visit. The wetted width of the watercourse varies between 50 – 75 cm. Furthermore, at about the edge of the 30 m DPA, any ephemerally-flowing water appears to go to ground, with no obvious channel occurring. In addition, any surface water would drop over a short but steep bank down to the beach. The surrounding vegetation lacks any well-developed riparian vegetation. Instead, the composition of the riparian zone mirrors the vegetation of the surrounding forest.

A raptor nest was found in a 35 cm diameter Douglas-fir tree close to the northern property line (Figure 1), but no birds were identified on the nest or in the immediate vicinity. No recent signs of use (e.g. whitewash, pellets and/or prey remains) were noted underneath the nest. Based on the time of year, evidence of use around the base of the tree would likely be scarce - even if the nest were active. It is also possible that an incubating female could have been on the nest, due to the fact that it was difficult to look into the nest, because of its height. The dimensions of the structure suggests that the most likely species to use the nest would be either Cooper’s Hawk (*Accipiter cooperii*), or Red-Tailed Hawk (*Buteo jamaicensis*).

With regard to the raptor nest on the subject property, the status of the nest could not be confirmed, meaning that the default is to consider it active. As per the Guidelines for Raptor Conservation (MoE 2013), a 100 m permanent buffer is recommended around nests belonging to species that have a moderate to high ability to co-exist. A seasonal "quiet" buffer of 200 m is recommended during the breeding season. As per Figure 1, both these buffers encompass the proposed construction area. Based on the width of the property, the limited distribution of potential building sites and the understandable desire of the landowner to take advantage of the oceanfront property, constructing inside the 100 m buffer is deemed acceptable in this case. The majority of the buffer would remain intact on the subject property, due to the fact that one of the main recommendations of the EA is to maintain the balance of the forested stands on the property beyond the construction footprint. There will be an undisturbed buffer of approximately 12-15 m between the northern edge of the development area and the nest tree.

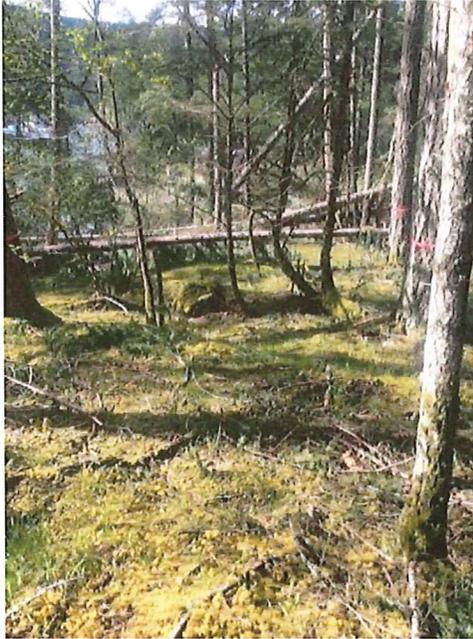
Another view of the house site – looking west with Bird's Eye Cove visible in the background.

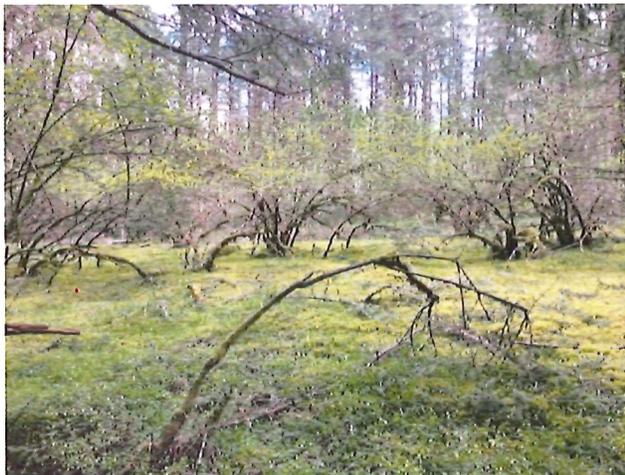
Photo of forested area in eastern portion of the property. The shrub in this photo is ocean spray (*Holodiscus discolor*).
